Phase 1 Environmental Site Assessment (ASTM E1527-05)
Former Louisiana Pacific Pulp Mill
APN# 401-112-021, Humboldt County, California

# APPENDIX O

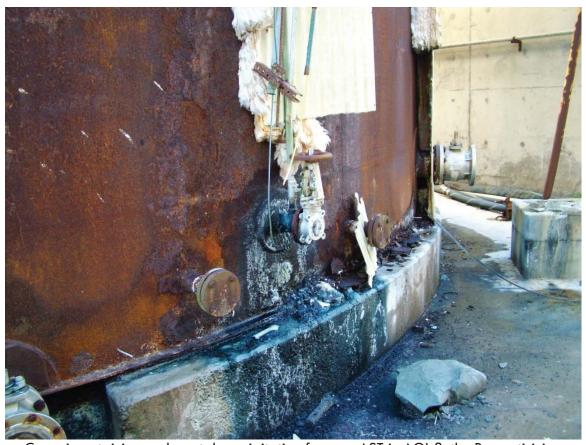
Corrosion, staining and crystal precipitation from an AST in AOI-3, the Recausticizing Area.

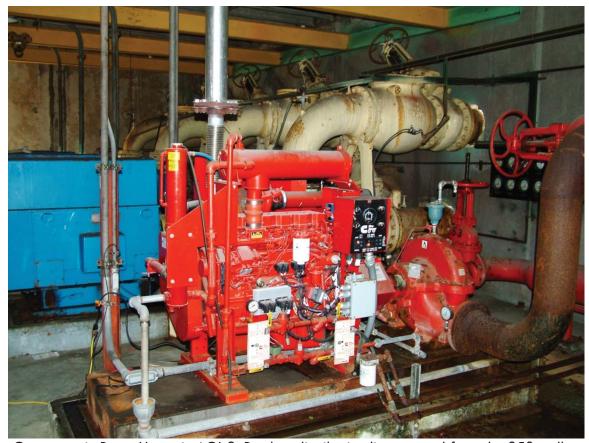
Generator in Pump House in AOI-3. Product distribution lines extend from the 250-gallon AST to the generator, and the lines are rusted.

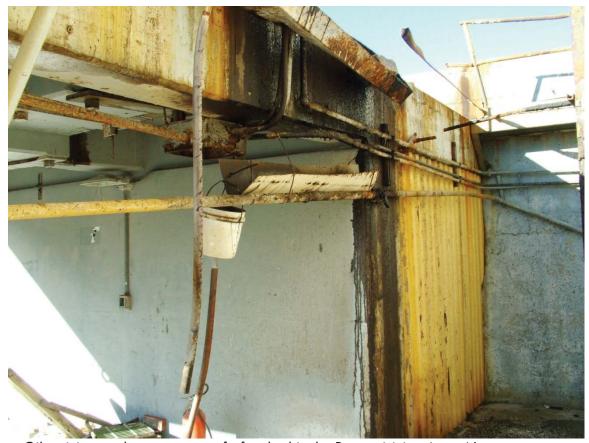
Oil staining on the concrete roof of a shed in the Recausticizing Area. Note attempt at containing the oil by placement of a section of roofing gutter beneath spill, directing the fluids to the bucket, and a hose from the bucket to another container (not shown).

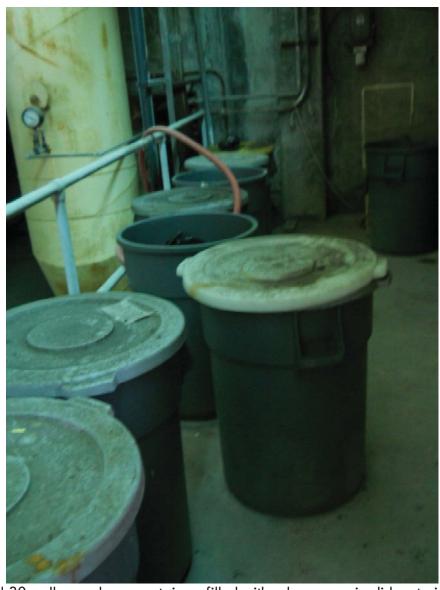
Unlabeled 30-gallon garbage containers filled with unknown semi-solid material, located inside of the Water Treatment Plant.

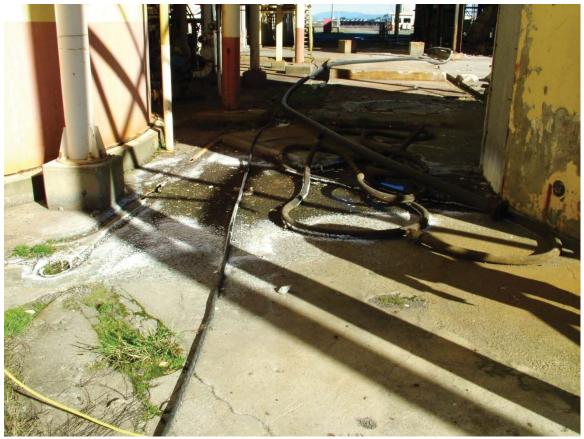
Precipitation of unknown crystals adjacent to the smoke stack in AOI-1 Black Liquor Process and Recovery Area. Photograph taken facing northeasterly.

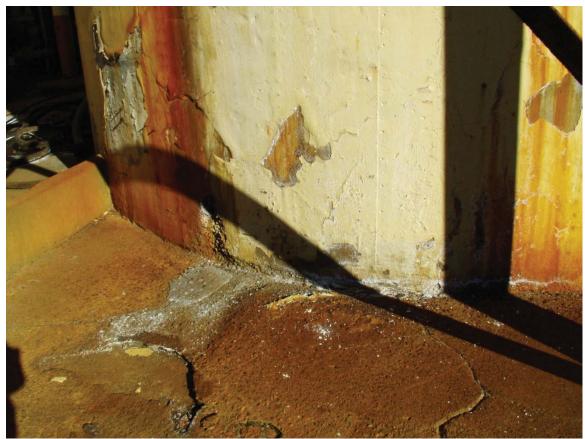
Iron staining and etching of concrete at base of smoke stack in AOI-1 Black Liquor Process and Recovery Area. Photograph taken facing northerly.

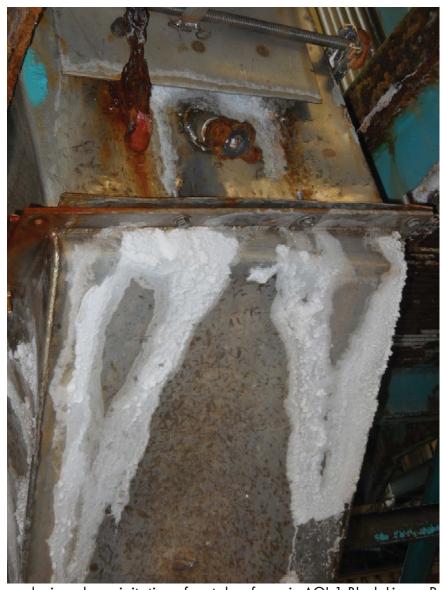
Oxidation and mineral precipitation of metal surfaces in AOI-1 Black Liquor Process and Recovery Area.

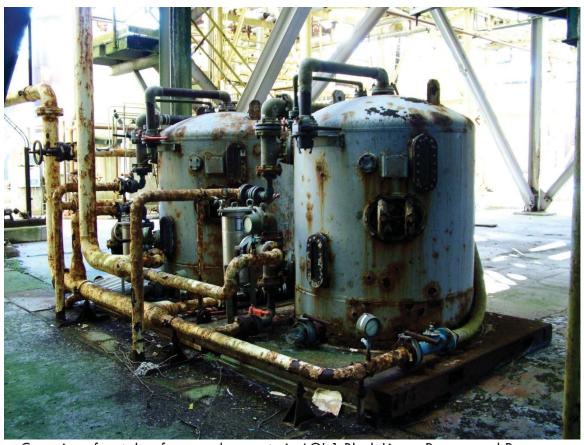
Corrosion of metal surfaces and concrete in AOI-1 Black Liquor Process and Recovery Area.

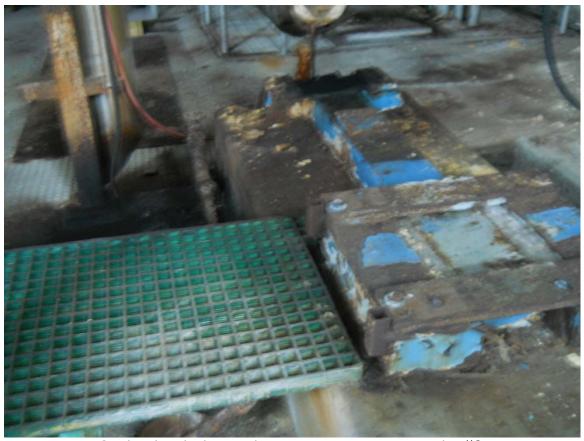
Oxidized and oil-stained motor mount in Recovery Boiler #3.

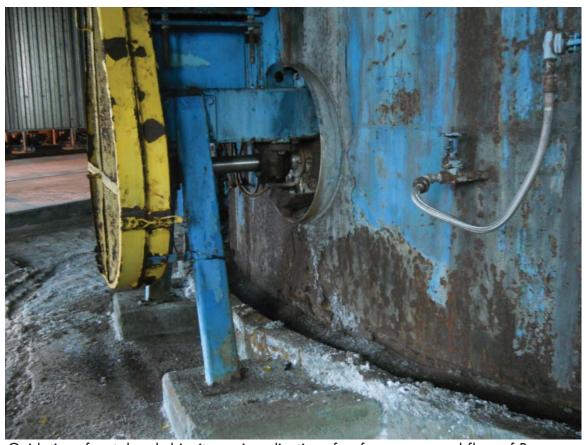
Oxidation of metal and ubiquitous mineralization of surfaces on ground floor of Recovery Boiler #3.

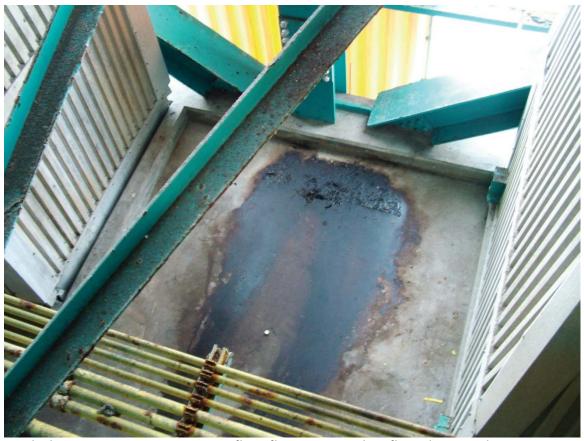
Black Liquor staining on concrete floor flowing towards a floor drain inside Recovery Boiler #3.

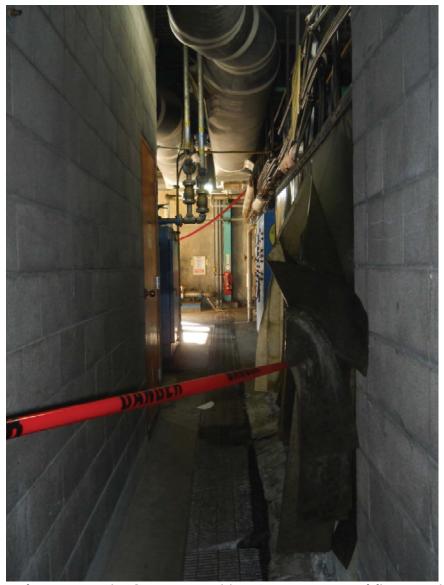
Unsafe entry into the Generator Building. Note presence of floor trench.

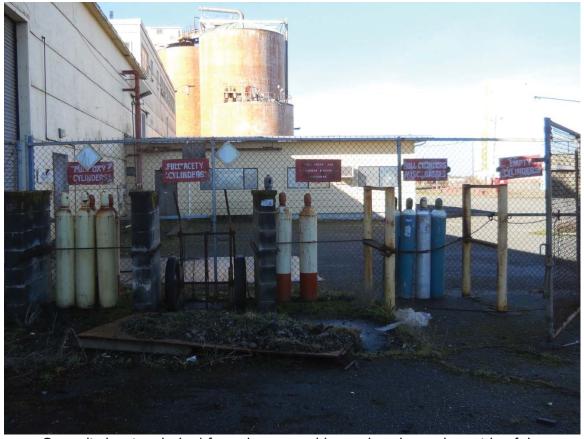
Gas cylinders in unlocked fenced compound located on the northern side of the Offices/Shops/Stores Building. Some cylinders were full. Photograph taken facing westerly.

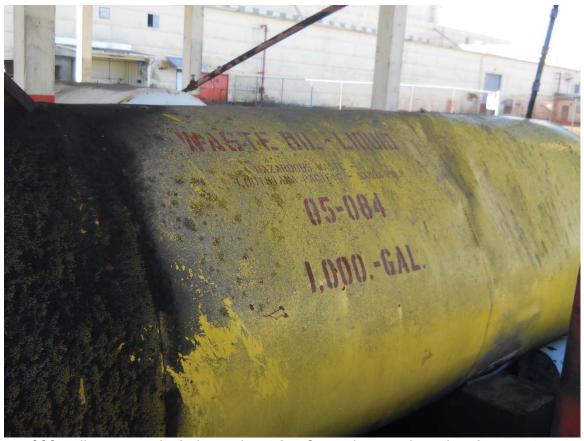
1,000-gallon waste oil AST located at AOI-10 Petroleum Hydrocarbon Storage Area. Note evidence of overflow by the accumulation of oil on exterior of AST. Oil is present on water in the containment, and the fill gauge indicated the presence of oil above the level of the tank (i.e. oil fills the fill tube into the tank).

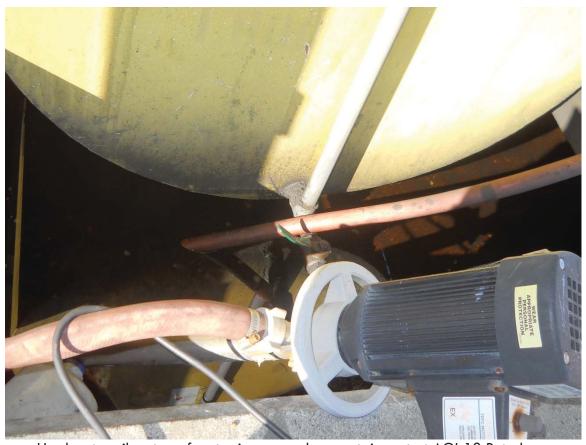
Used motor oil on top of water in a secondary containment at AOI-10 Petroleum Hydrocarbon Storage Area.

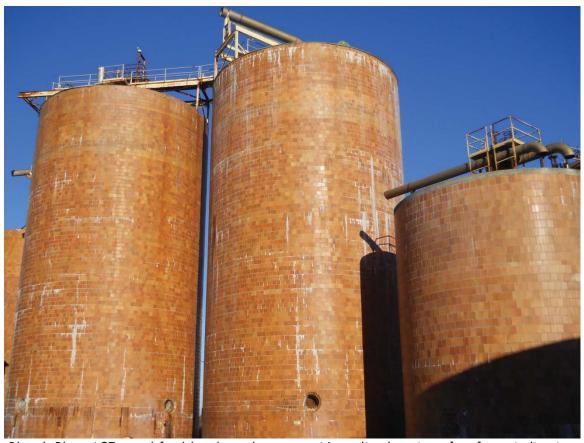
Bleach Plant ASTs used for bleach stock storage. Note discoloration of surfaces indicating leaking occurred. Photograph taken facing southwesterly.

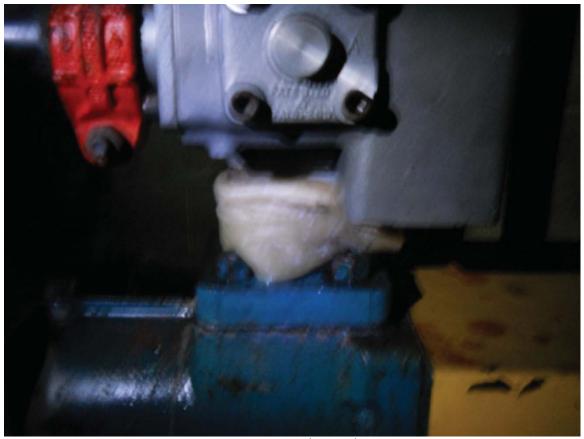
Adsorbent pad on hydraulic pump for Offices/Shops/Stores building elevator. Darkness was a limiting factor in this room.

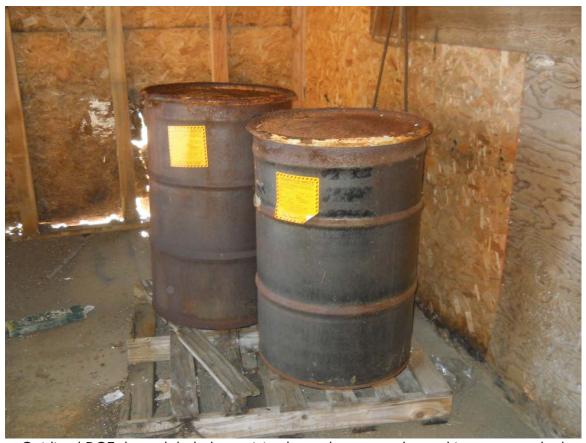
Oxidized DOT drums, labeled containing hazardous waste, located in a storage shed attached to the southern side of Warehouse 2.

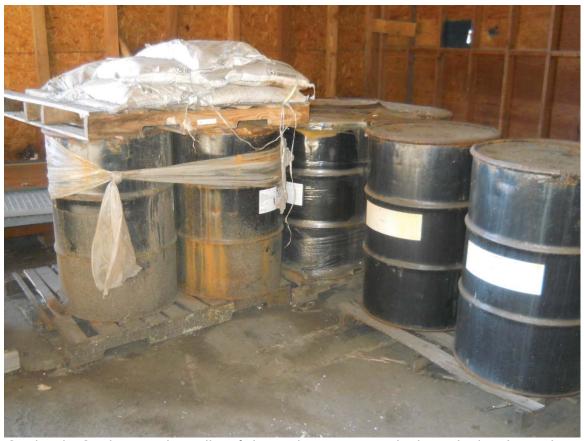
Oxidized DOT drums and a pallet of chemicals in a storage shed attached to the southern side of Warehouse 2.
