Phase I Environmental Site Assessment

1938 King Salmon Avenue and Assessor's Parcel Numbers
305-162-006, -008, and -011
Eureka, California

Humboldt Bay Harbor, Recreation & Conservation District

December 2017

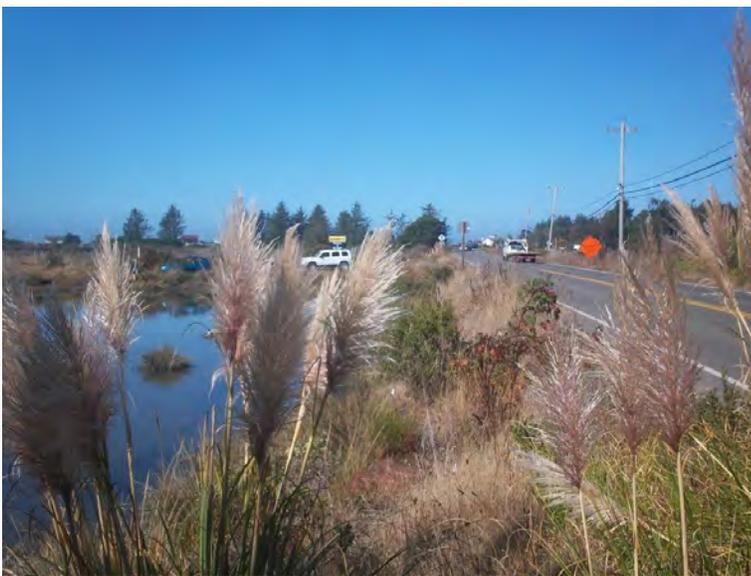
Photograph No. 3:
Northeastern boundary of the subject property. Subject property is visible on the left hand side of image, and King Salmon Avenue is visible on the right hand side. Image taken facing north. Entrance driveway visible where vehicles are parked in the background.

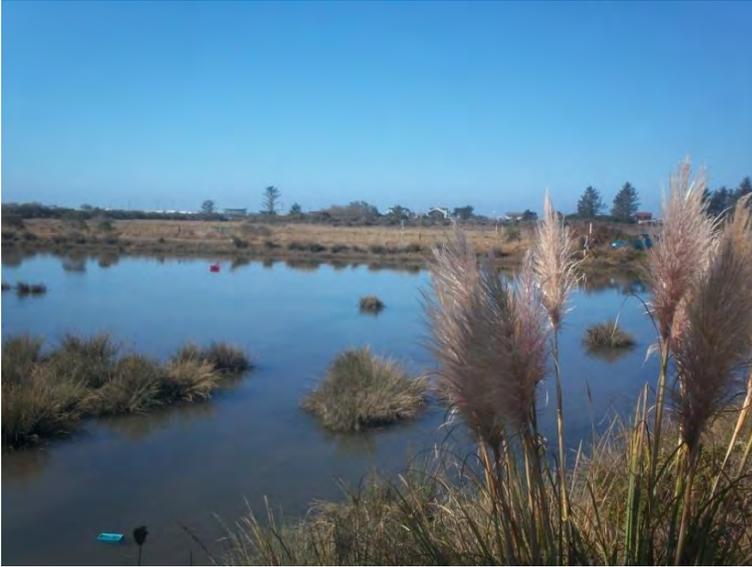
Photograph No. 4:
Subject property lagoon, with floating debris, and adjoining parcel to the north visible in this image. The unincorporated community of King Salmon is visible in the far background.

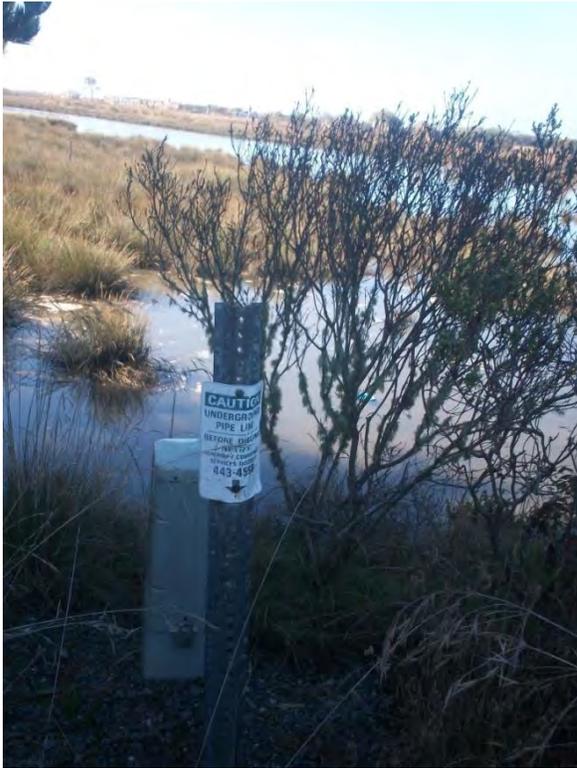
Photograph No. 15:
An underground pipeline marker and box located at the eastern corner of the subject property. Image taken facing west.

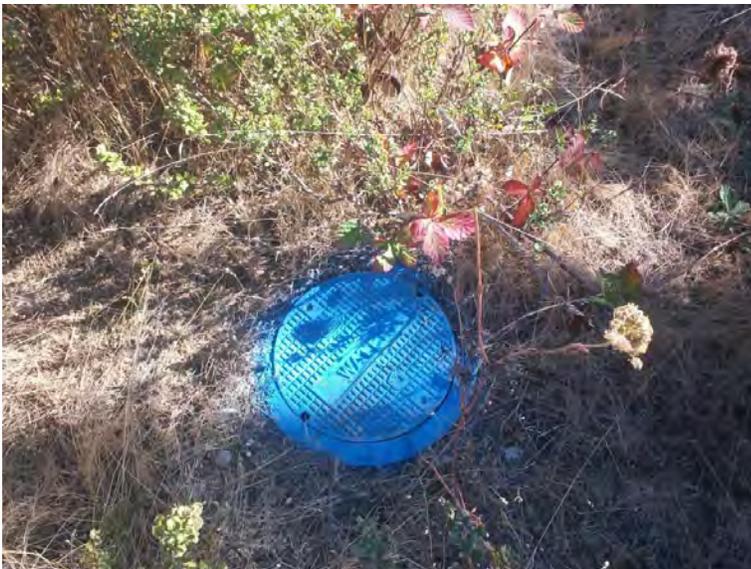
Photograph No. 16:
A water valve box located near the pipeline marker in Photograph No. 15.

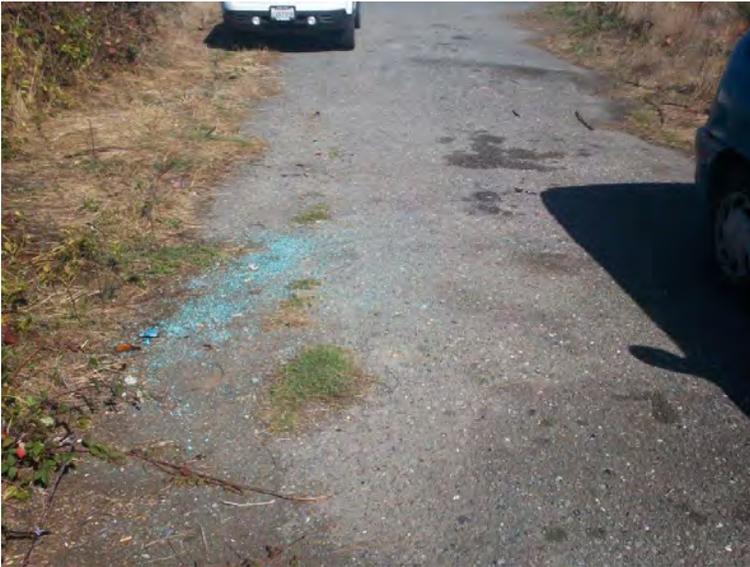
Photograph No. 17:
Broken auto glass, random debris, and fluid staining assumed to have resulted from abandoned and vandalized vehicles at the gated driveway for the subject property. Image taken facing northeast.

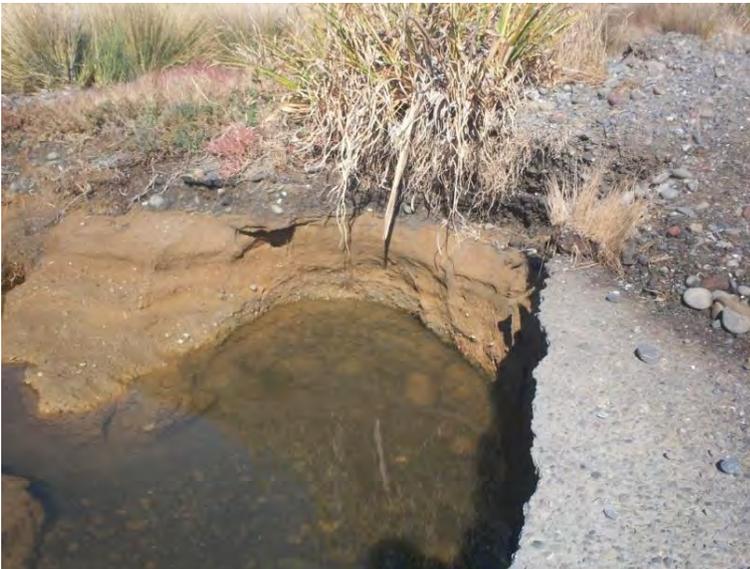
Photograph No. 19:
River run gravel fill (unknown origin), the asphalt driveway, imported sandy silt/silty sand fill (unknown origin), and erosional scour along the northern side of the subject property driveway.

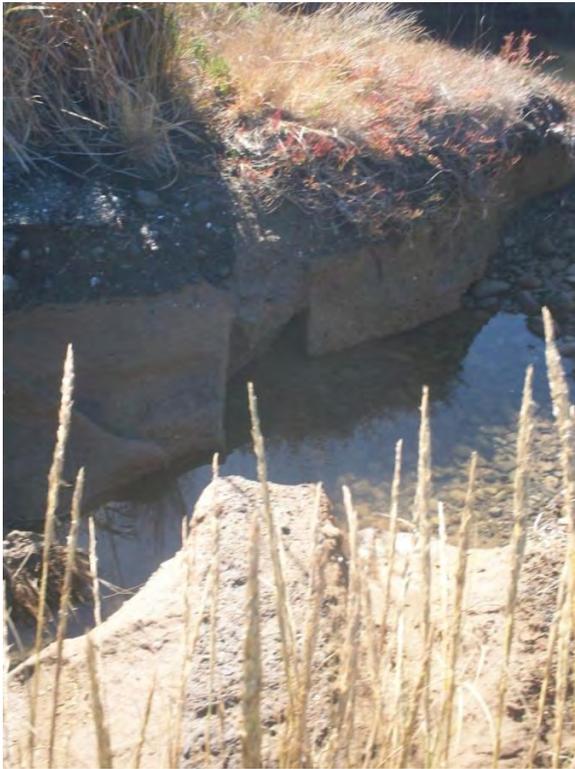
at the approximate property boundary along the northern side of the driveway; the trench was distinctive from the surrounding soils due to the trench backfill containing fine gravel and having a slightly different color. No piping was observed in the trench. Wooden 4-inch by 4-inch fence posts are present along the northern property boundary. The fill prism area expands in width/area approximately 580 feet southwest of King Salmon Avenue, forming a roughly 400-foot by 240-foot polygon that comprises the former parking lot, aquarium, and pump house footprints. A significant portion of the parking area south of the driveway appears to be regularly inundated by tidewater, as indicated by the presence of pickleweed and saturated soil. Multiple round 3-foot tall concrete planters were observed along the eastern and northern property boundaries. The planters are painted blue, and, based upon the timing of operation of the subject property until the mid-1970s and the vibrant color remaining on the planter boxes, the paint may have been lead based.

Photograph No. 21:
The scour feature exposed a trench cut into the imported fill underlying the asphalt driveway. Vertical cuts in the fill, and trench backfill with slightly different color and particle size distribution differentiate the trench from the surrounding fill prism. No pipes or other features anticipated to be contained in a trench were observed. The depth of the trench is unknown.

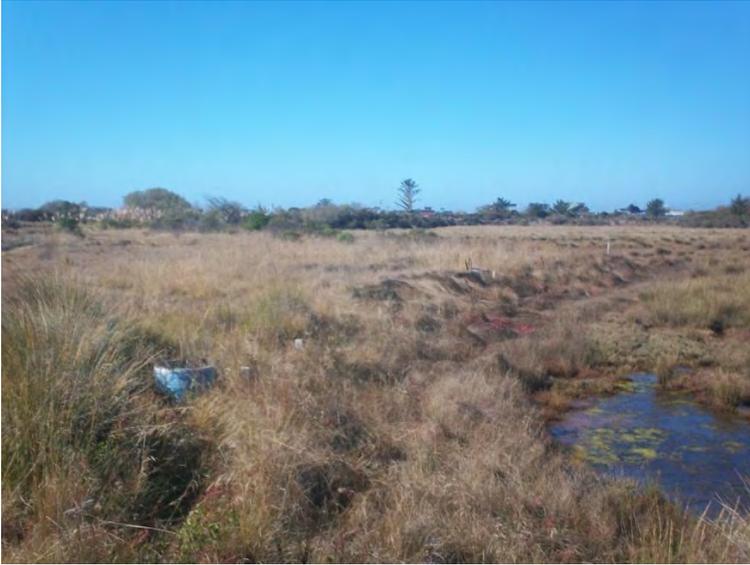
Photograph No. 22:
Northern boundary of the subject property; imported fill and the subject property are visible in the central and left hand side of the image. Painted concrete planters were observed near the northern property boundary, suspected lead based paint colors the planters. Image taken facing north.

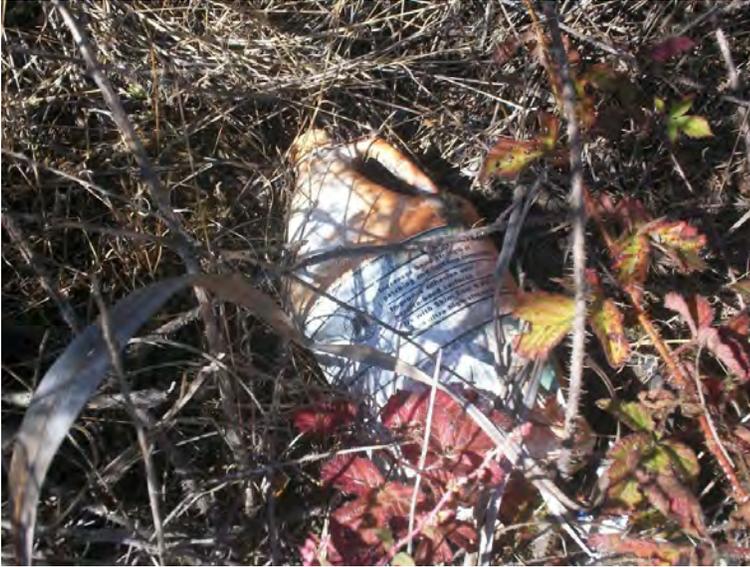
Photograph No. 28:
One of several concrete curing containers
discarded in vegetation near the northern
property boundary.

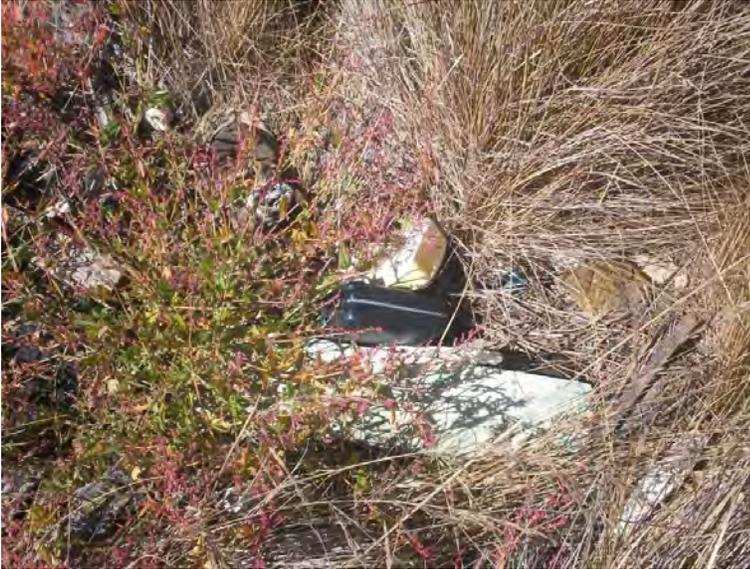
Photograph No. 33:
Empty oil containers and other random garbage
near the northern property boundary.

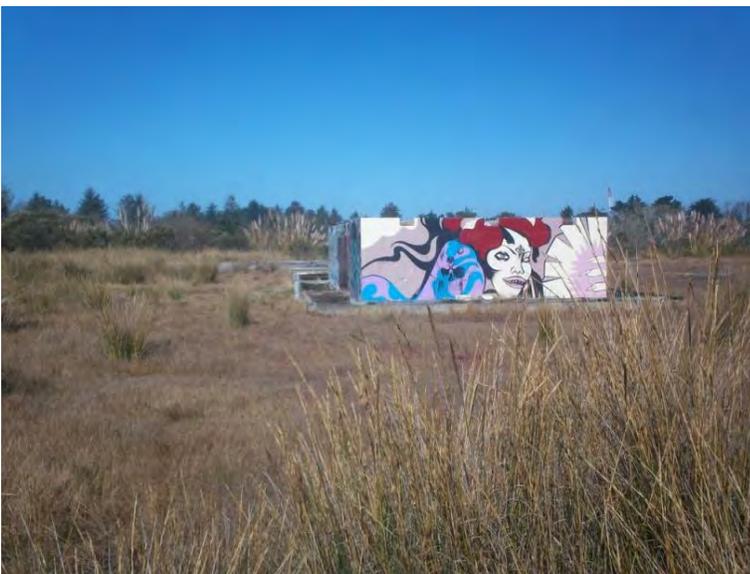
Photograph No. 37:

The remnants of the pump house comprise a 20-foot by 60-foot concrete floor and foundation with a sill plate. Seven aboveground concrete cells, approximately 6 feet tall, are present on the western and southern sides of the floor remnant. The cells are lined with fiberglass, and have drains. Debris and vegetation were observed in the cells. Multiple piping runs of unknown function extend from the floor surface, and have been cut off near the floor; others extend several feet above the ground surface. Asphalt roofing debris covers much of the concrete floor. Three approximately 4-foot diameter concrete sumps were observed around the pump house exterior; all had plumbing and were debris and water filled. The total depth of the sumps is unknown. The ground surface west of the pump house had a significant coating of what appeared to be roofing materials (tar, tar paper, and gravel), woody debris, blankets, and other miscellaneous household items. The area north of the pump house contained most of the garbage observed at the subject property, and the garbage was typically household in nature (food and product containers, clothing, shoes), demolition debris (such as, a collapsed structure with roofing, siding, hoses, and so on), appliances (a washing machine, stove), and automotive related debris (empty oil containers, tires). Many spray-paint aerosol cans were observed throughout the subject property, as were empty motor oil containers, but outside of the spray paint cans and empty motor oil containers, none of the observed containers had markings consistent with petroleum products or hazardous waste; none had a volume greater than 5 gallons.

Remnant of the pump house as viewed from the south. Fiberglass lined concrete cells, a foundation, and a concrete floor remain. A portion of the western levy is visible in the background.

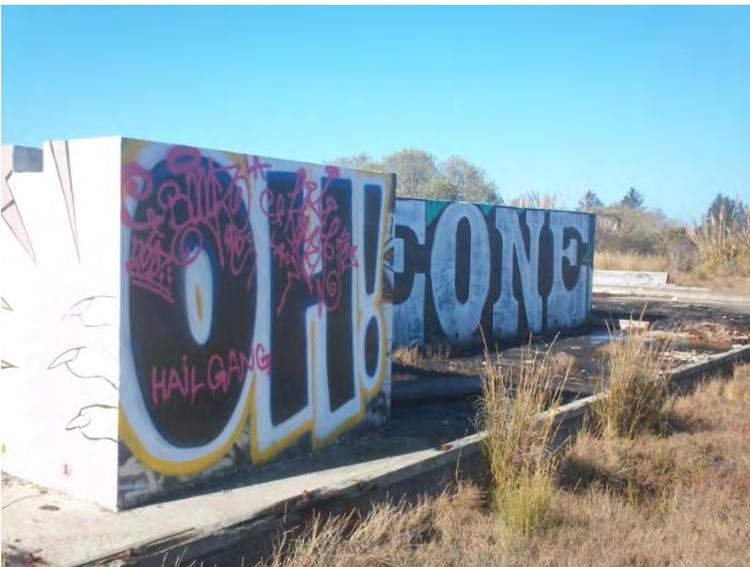
Photograph No. 38:

Several of the concrete cells of the pump house as viewed from the southeast corner of the structure. Black coloration of the concrete floor is remains of the structures tar and gravel roof.

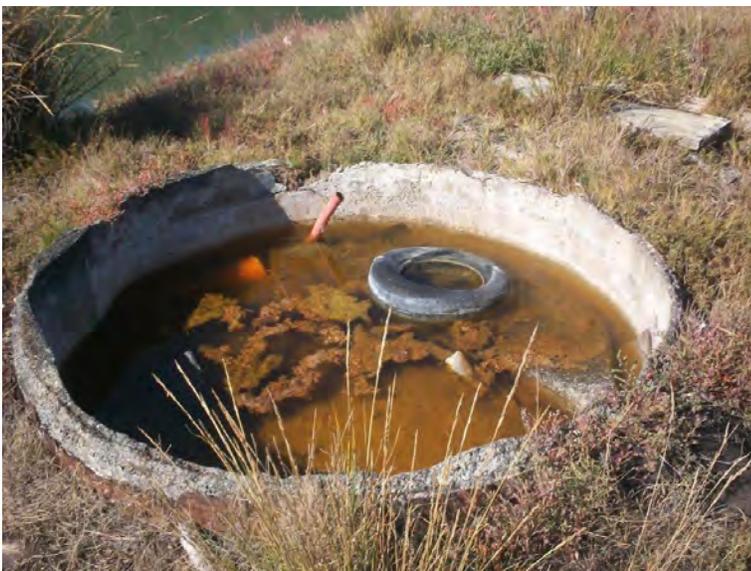
No stained soil, or stressed vegetation was observed during the site inspection. SHN did not observe any surface evidence (vent pipes, fill ports, dispenser islands, and so on) associated with underground storage tanks anywhere on the subject property; no aboveground tank features unassociated with water processing for the aquarium were observed. SHN did not observe any features consistent with the presence of a septic tank or leachfield, though no obvious connections to a municipal sewer system were observed either; the lack of features consistent with sewer lateral tie-ins to a municipal system on King Salmon Avenue suggests that a septic system was present onsite. Multiple conduits and pipes are present in the remaining concrete floors of both the aquarium structure, as well as the pump house; the function of the conduits/pipes was not readily discernible during the field inspection. Three debris and water-filled sumps were observed surrounding the pump house.

Photograph No. 40:
Debris and water filled sump located between the pump house and a submerged portion of the site adjacent to the armored levy. Pipes that appear in Photograph 41 connect the water body to the sump.

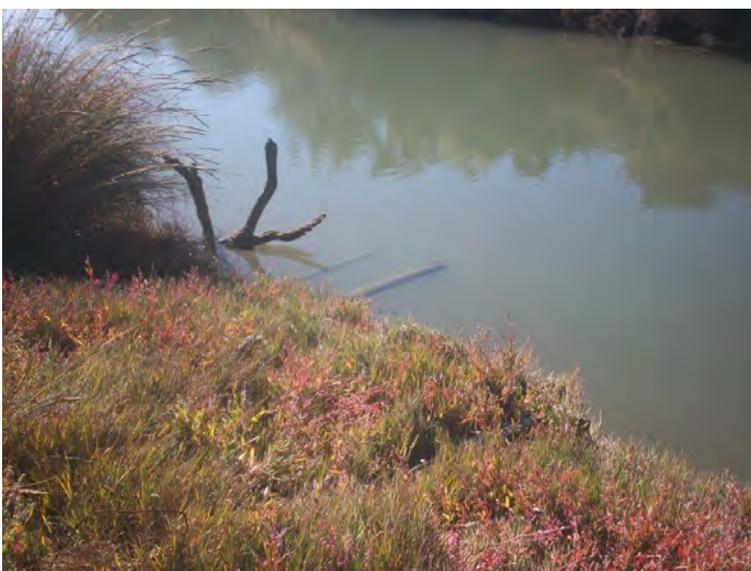
Photograph No. 41:
Pipes extending into water from the sump in Photograph 40. A portion of the western levy is visible in the upper right hand corner of the image.

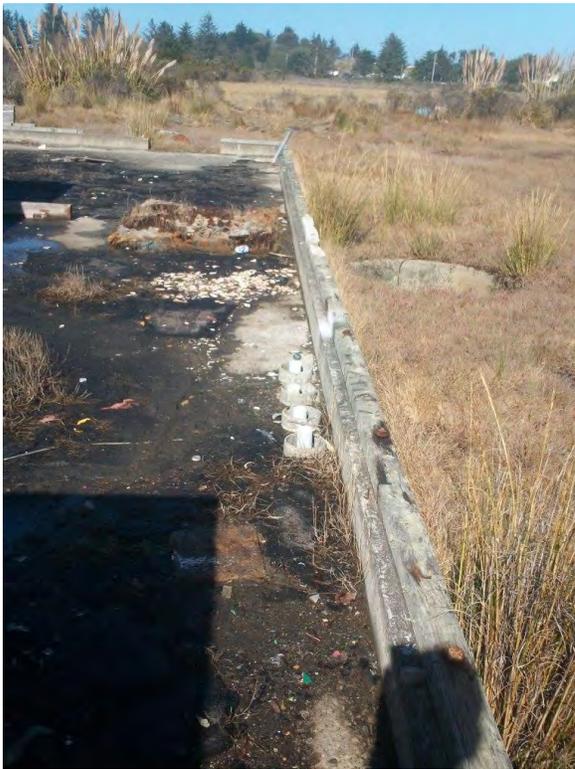
Photograph No. 43:
A third sump located off of the eastern side of the pump house. Conduits/piping is visible emanating from the floor in the midground and background of the image. Black coloration of the concrete floor is from tar and gravel roofing of the structure.

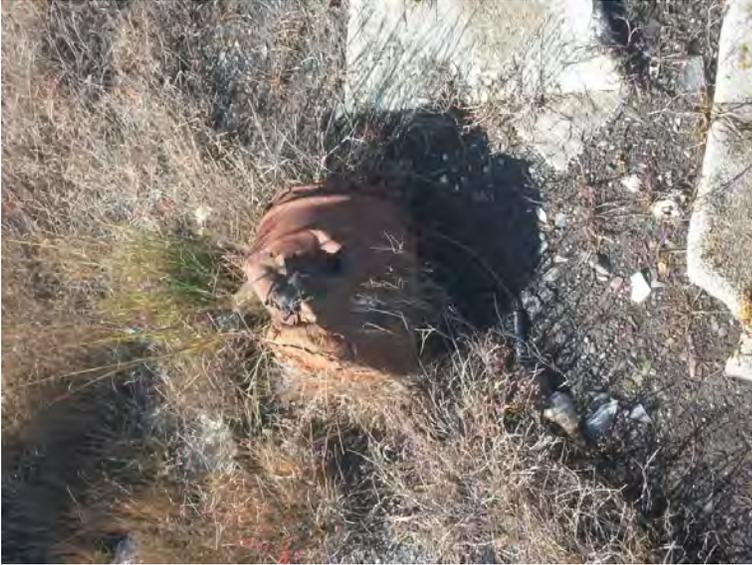
Photograph No. 47:
Carpet debris and a tar bucket observed on the ground near the pump house.

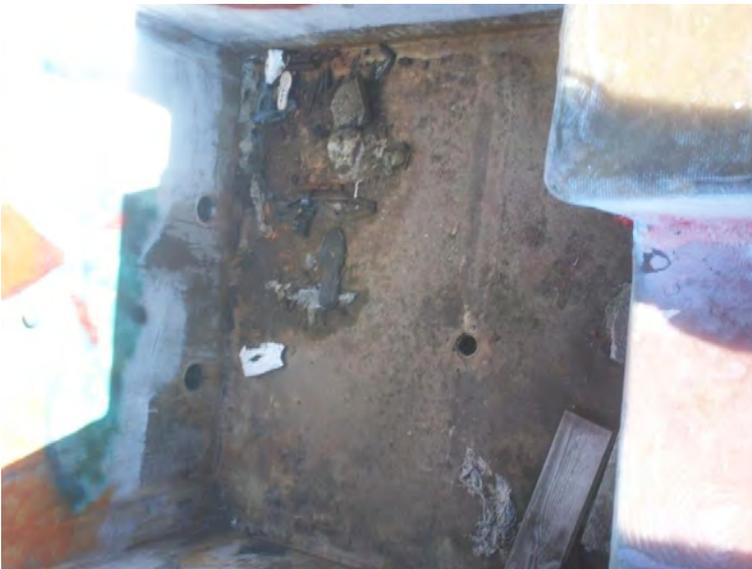
Photograph No. 49:
Garbage and drains visible in one of the pump house concrete cells.

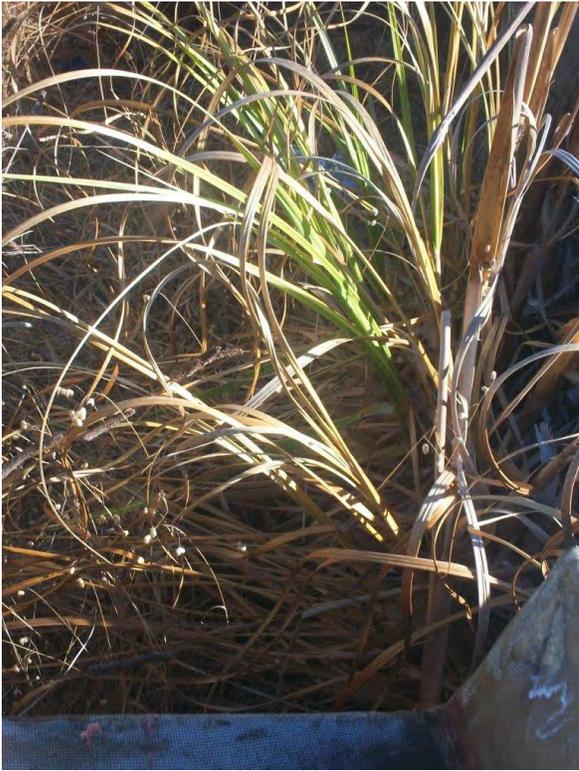
Photograph No. 50:
Vegetation growing inside one of the concrete cells of the pump house.

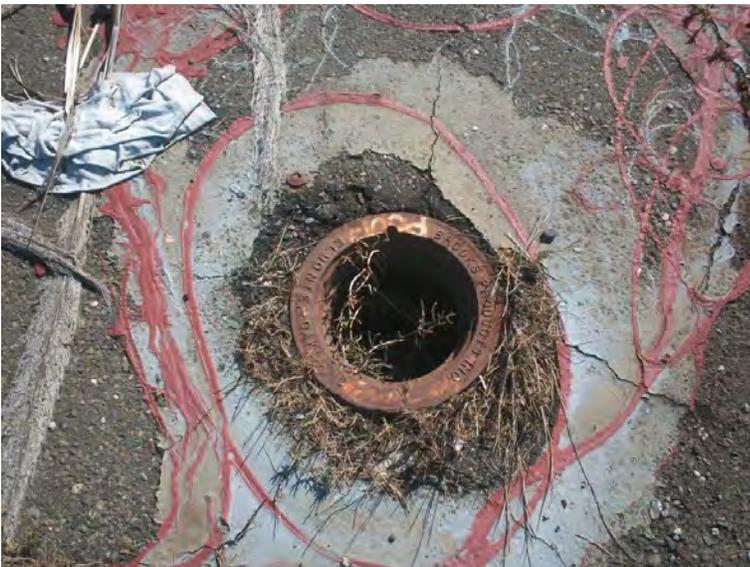
Photograph No. 59:

diameter valve box (water service?) was observed in the asphalt apron, the box was empty, and the bottom was not encountered when probed with a metal rod. Debris, comprising ceramic shards and miscellaneous household items, coats most of the concrete and asphalt of the former aquarium, and vandalism has resulted in paint being used to illustrate the concrete and asphalt surfaces. The concrete seal pool has a variety of household waste within it, and a hole was created in the center of the concrete bridge spanning the central portion of the pool, into which a large-diameter tractor tire was deposited.

A valve box. Probing of the box found no bottom down to approximately 2.5 feet below ground surface. Garbage and vandalism are apparent.

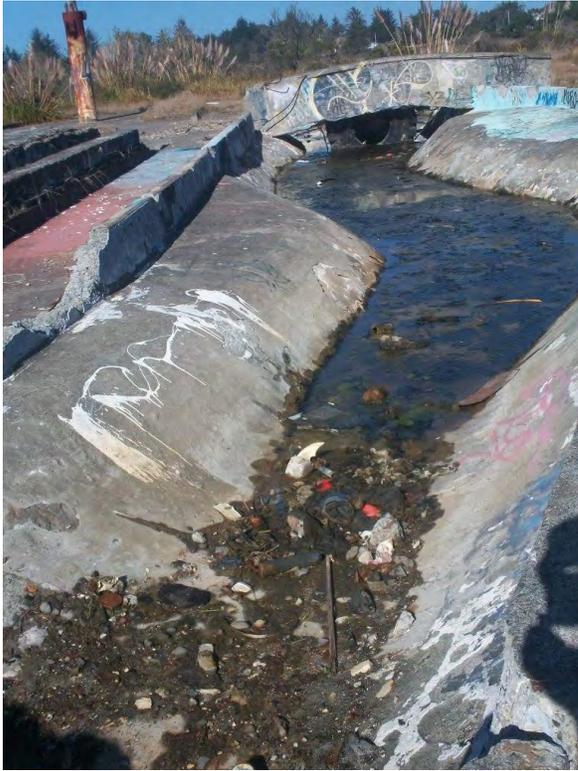
Photograph No. 60:
A portion of the seal pool on the eastern side of the former Ship Wreck structure. Garbage, a tractor tire and vandalism are apparent. Image taken facing north.

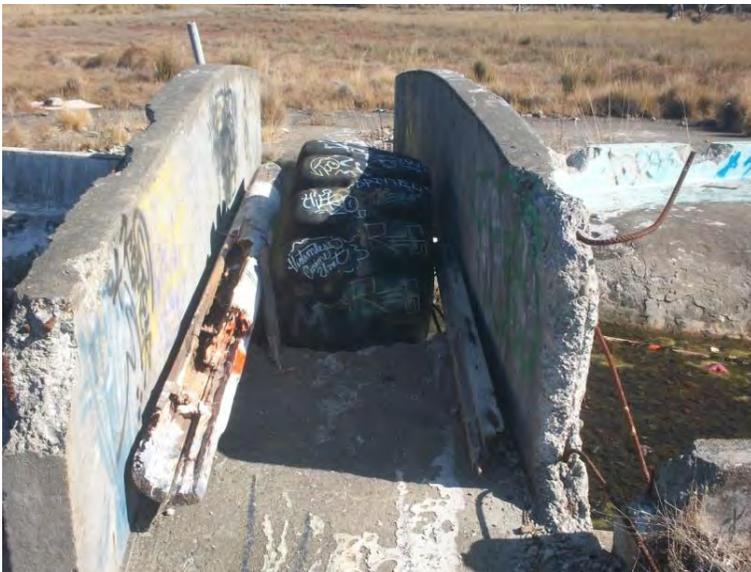
Photograph No. 61:
The seal pool bridge. The central portion of the bridge has been demolished and filled with a tractor tire.

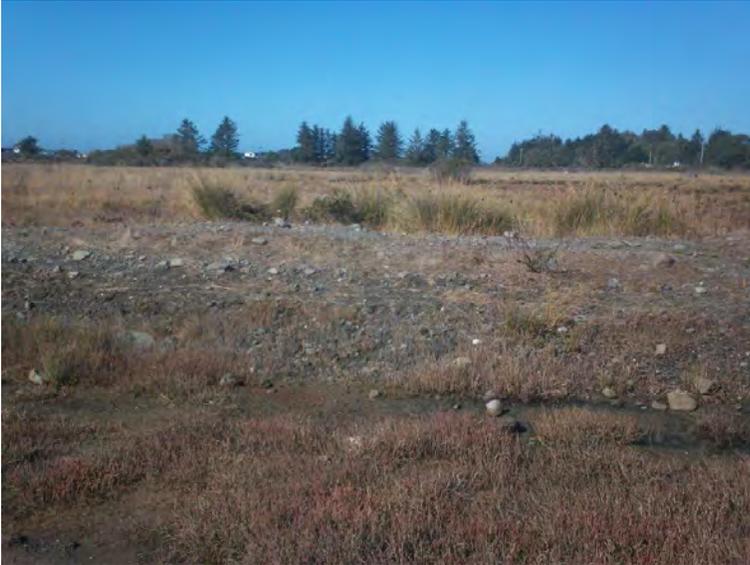
Photograph No. 65:
The gravel fill prism above the asphalt driveway. Pickleweed in foreground occupies the former parking area and provides evidence of frequent sea water inundation. Adjoining property to the north is visible in the background. Image taken facing north.
