Draft Analysis of Brownfields Cleanup Alternatives

Redwood Marine Terminal II Debris Cleanup Project

Humboldt Bay Harbor, Recreation and Conservation District

December 2016

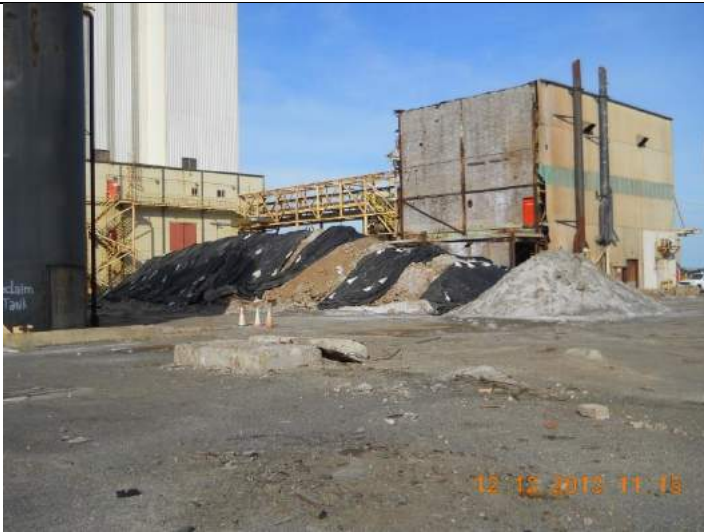
AOI 1: Pile 1 (left) and Pile 2 (right)

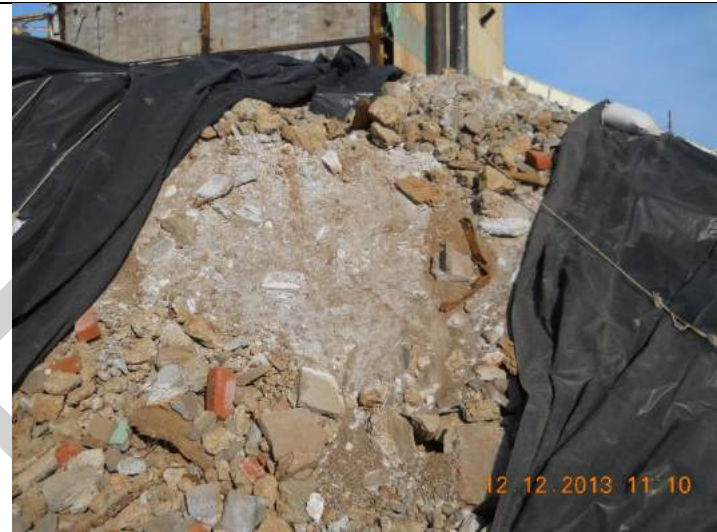
AOI 1: Close-up of Pile 1

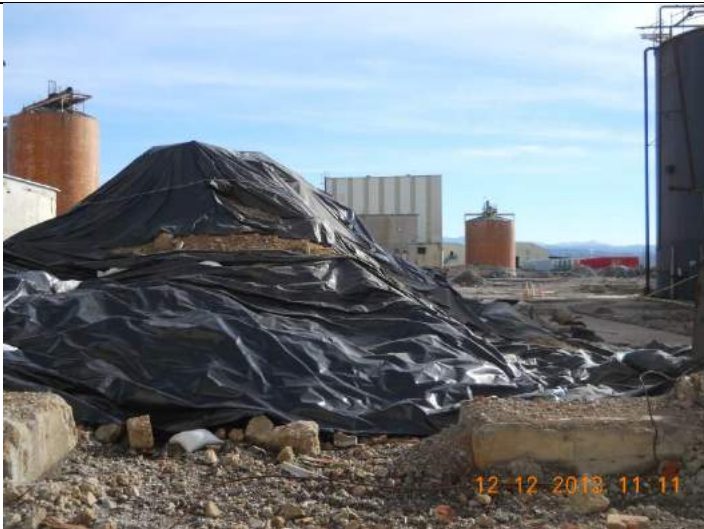
AOI 1: Pile 1 currently partially covered

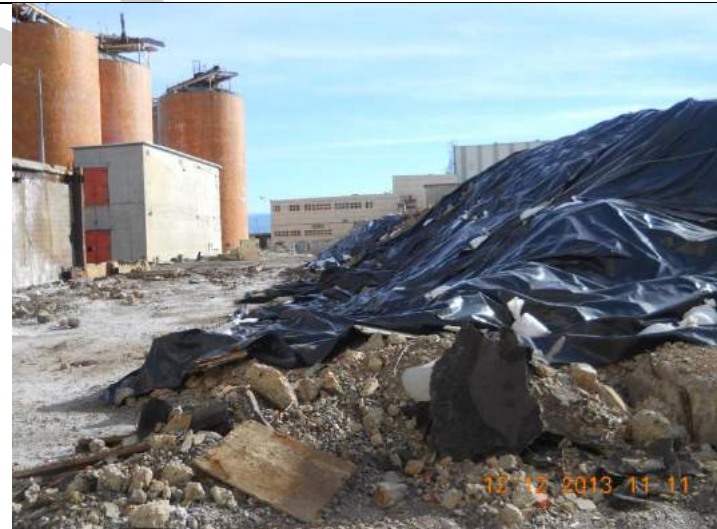
AOI 1: Pile 1 currently partially covered

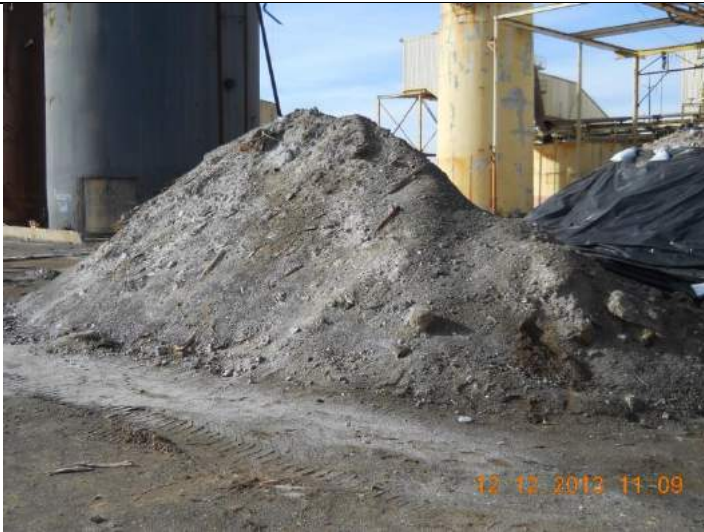
AOI 1: Pile 2

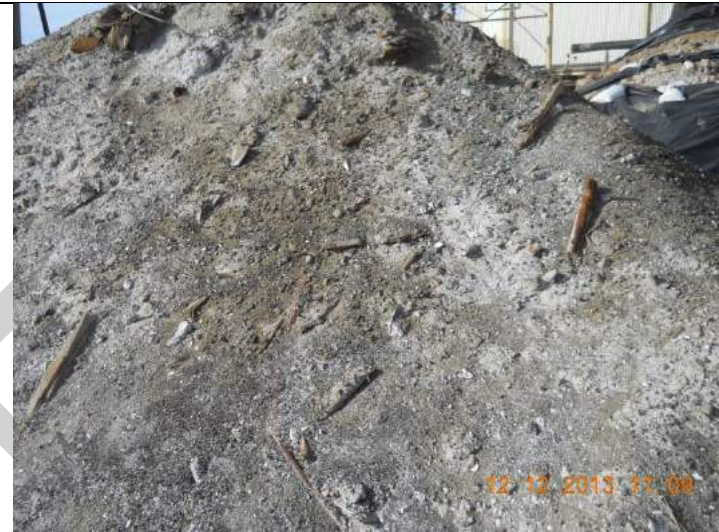
AOI 1: Close-up of Pile 2

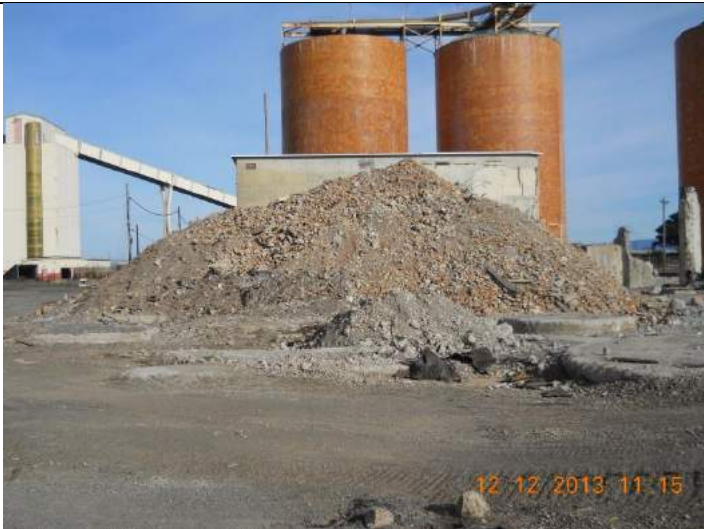
AOI 2: Pile 1

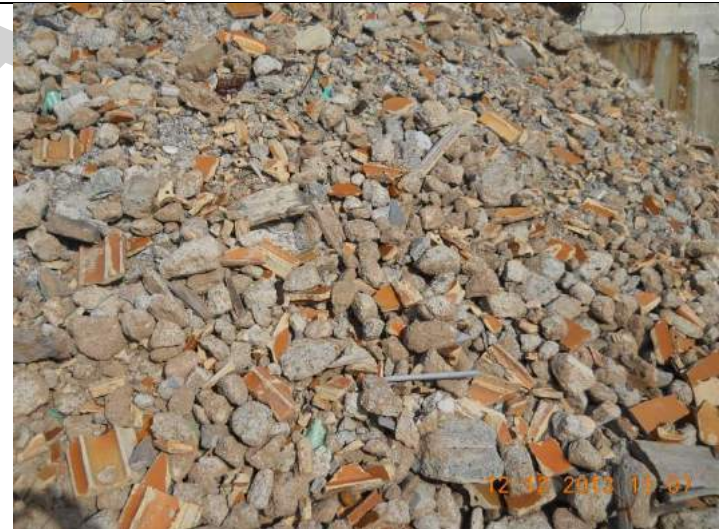
AOI 2: Close-up of Pile 1
