# Eelgrass Survey Report

Samoa Boat Launch Project  
Eureka, California

City of Eureka

September 2020

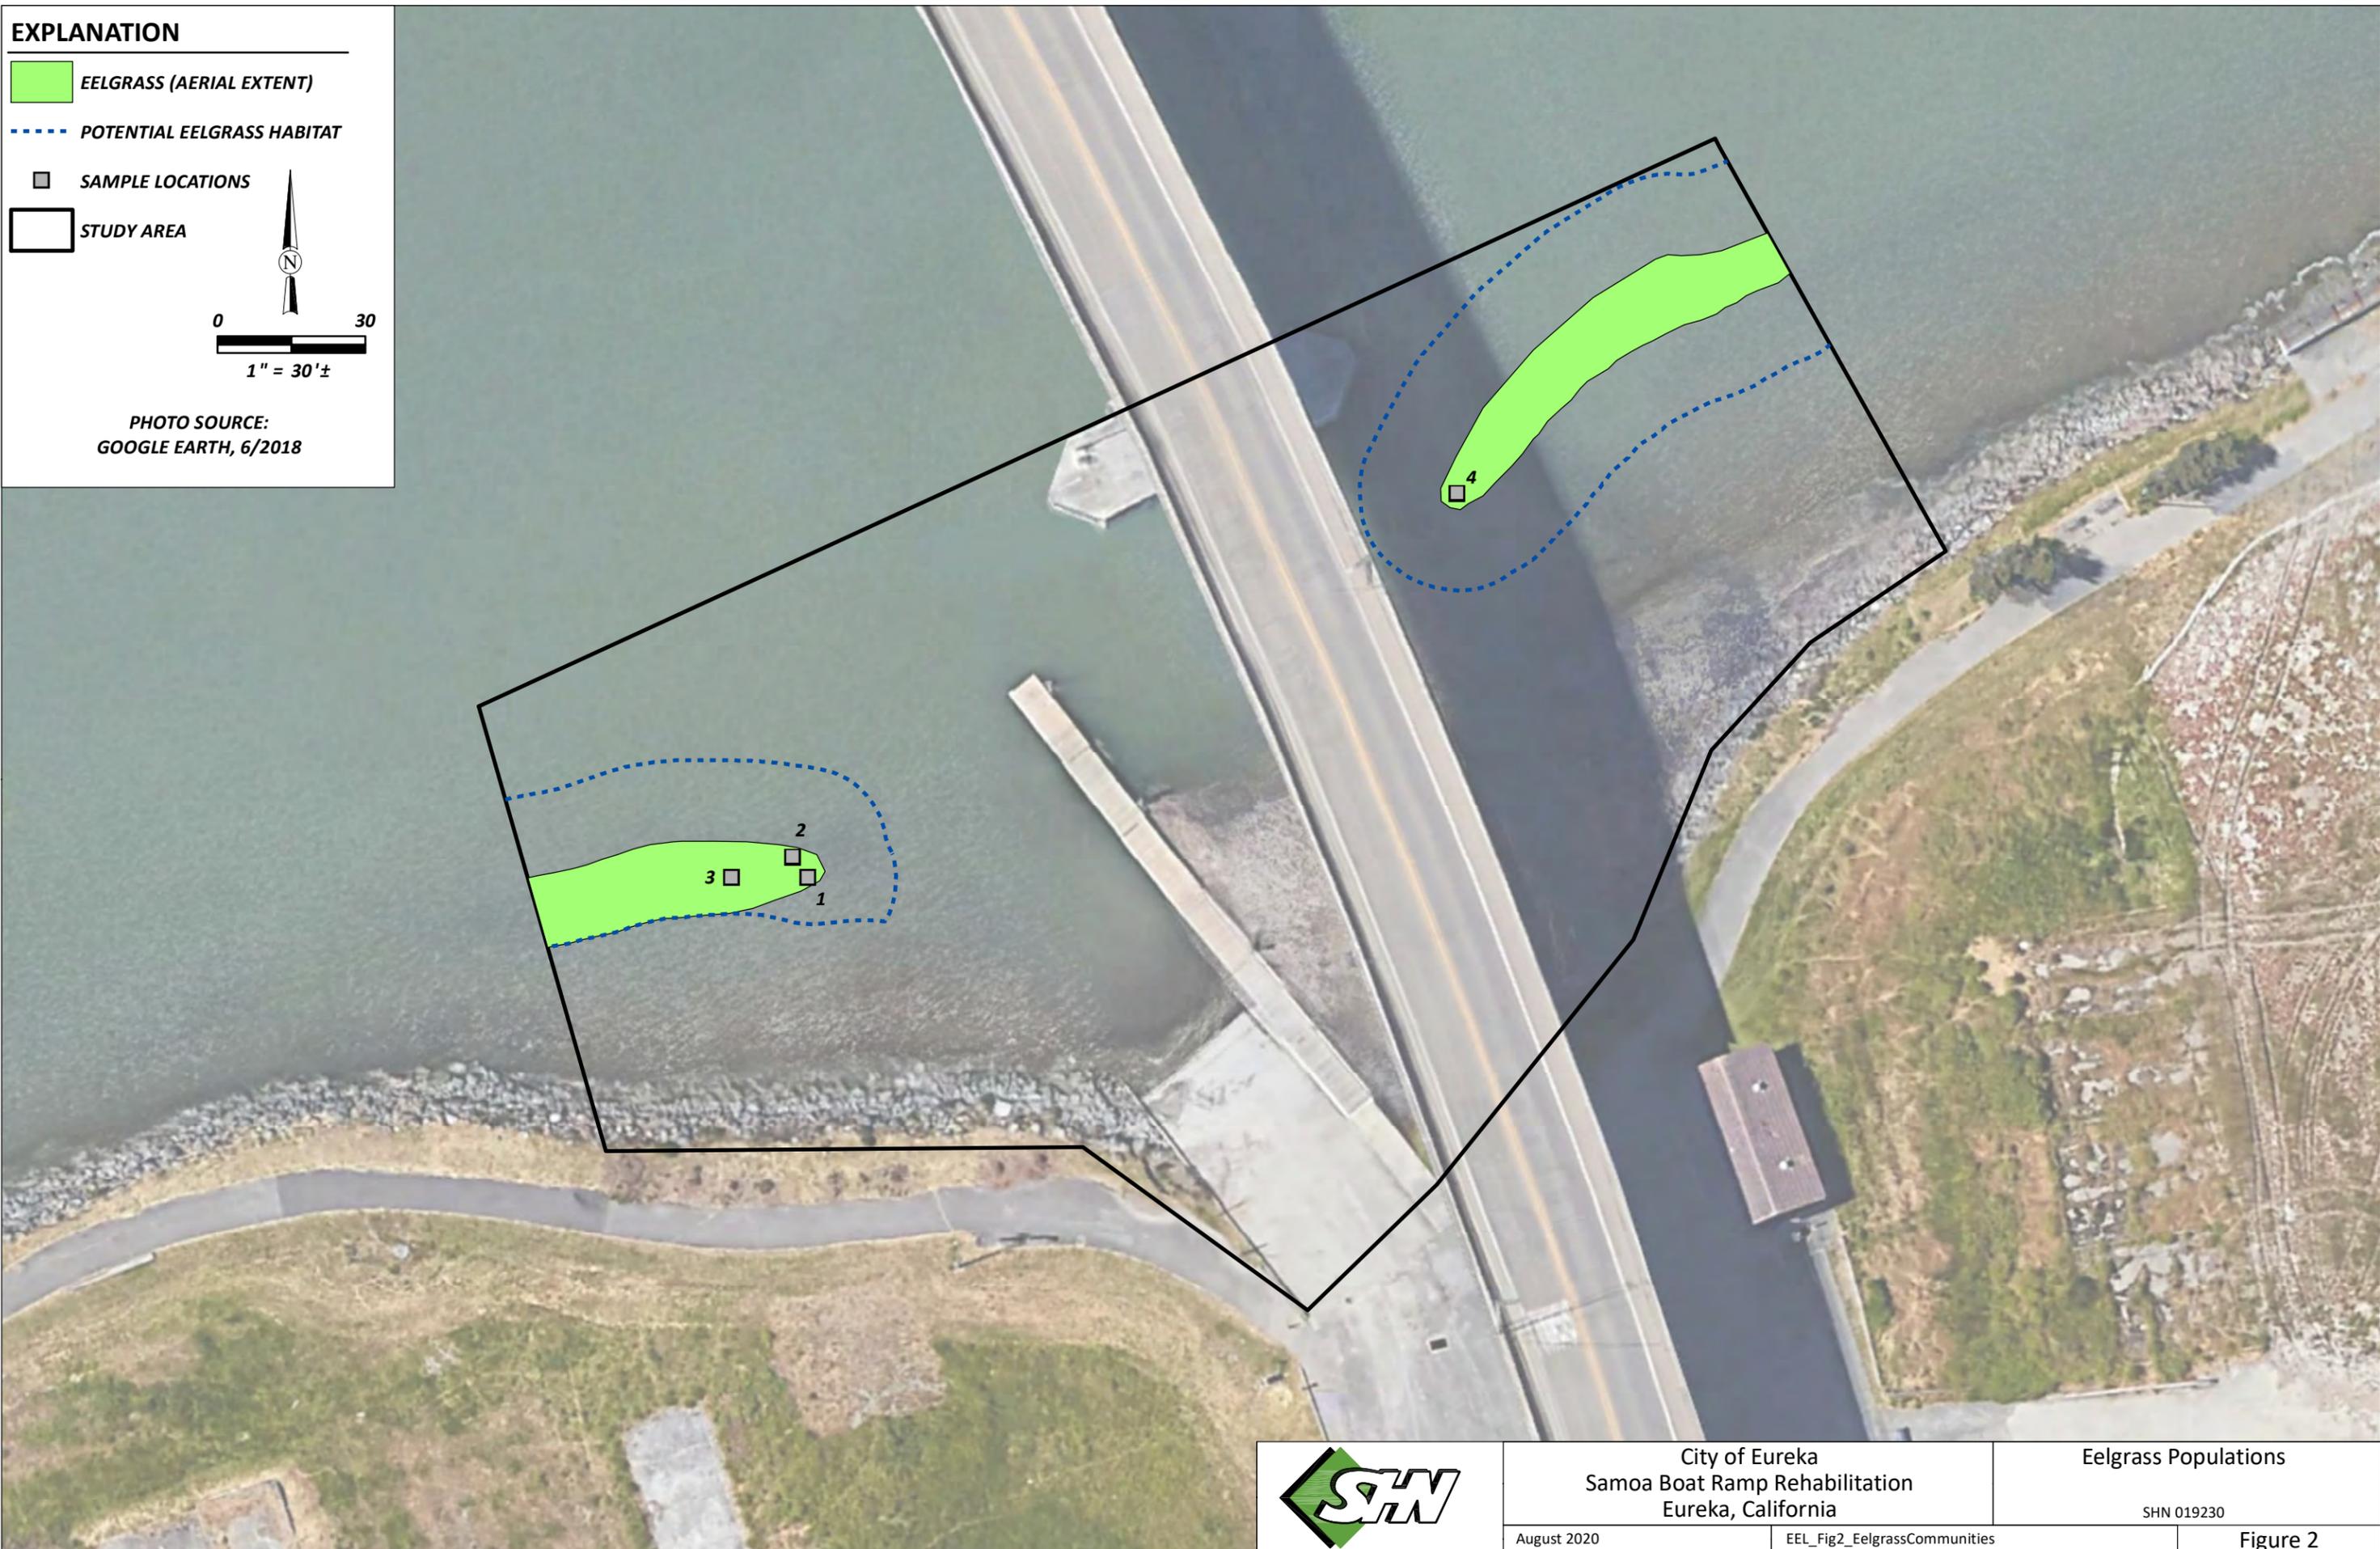
Eelgrass Populations  
SHN 019230  
Figure 2

Two distinct eelgrass populations were observed within the vicinity of the project area, one immediately west of the project area (Population 1) and the other over 120 feet northeast of the project area (Population 2; Figure 2). The populations, including spatial distribution, extent, percent vegetated cover, and turion density are described below and in Figure 2.

Population 1 exists to the west of the project area and is confined within an elevation band from 0.21 meters to 0.97 m below mean sea level (Figure 2, Appendix 1, Photos 1-6). The population extends southwest of the project area for an undetermined distance; however, the aerial extent is estimated to be 73.7 square meters (m<sup>2</sup>) within the study area. Total suitable eelgrass habitat including unoccupied distances less than 5 m from occupied habitat was 211.5 m<sup>2</sup> within the study area (Figure 2). The area studied for this report represents the northeastern-most extent of this population. Three sample points were taken to characterize the population (Figure 2).

Sampling Point 1 was taken at the eastern-most point of the population, approximately 2.4 meters from the main body of Population 1 (see Figure 2 and Appendix 1, Photos 3 and 4). This Sample Point represented an isolated subset of Population 1 with 12 turions present over an area of 0.5 m<sup>2</sup> for a turion density of 24 turions/m<sup>2</sup>. Vegetative cover was found to be approximately 10 percent within the square meter sampled. Because this small subset of eelgrass was within 10 m of the main body of Population 1, it is considered an extension of the population, and not a separate population.

Sampling Point 2 was taken at the northern most portion of the population, approximately 2 m northwest of Sampling Point 1, and 3 meters northeast of the main body of Population 1 (Figure 2). This Sample Point represented an isolated subset of Population 1 with 6 turions present over an area of 2 m<sup>2</sup> for a turion density of 3 turions/ m<sup>2</sup>. Vegetative cover was found to be approximately 3 percent of the area sampled. This subset of eelgrass was within 5 meters of the main body of Population 1 and is therefore considered an extension of the population, and not a separate population.

Sampling Point 3 was taken within the main body of Population 1, approximately 4 m south west of Sampling Points 1 and 2 (see Figure 2 and Appendix 1, Photo 5). Eelgrass was much denser with greater vegetative cover than the two subset populations sampled at Sampling Points 1 and 2. Turion density was found to be 47 turions/m<sup>2</sup> and vegetative cover was found to be between 40 and 50 percent.

Eelgrass populations occur within the vicinity of the proposed project. It appears that the project as proposed will not directly impact adjacent eelgrass populations and care should be taken to avoid eelgrass populations during construction. Project plans should indicate eelgrass population and habitat locations, and should indicate avoidance of these areas.

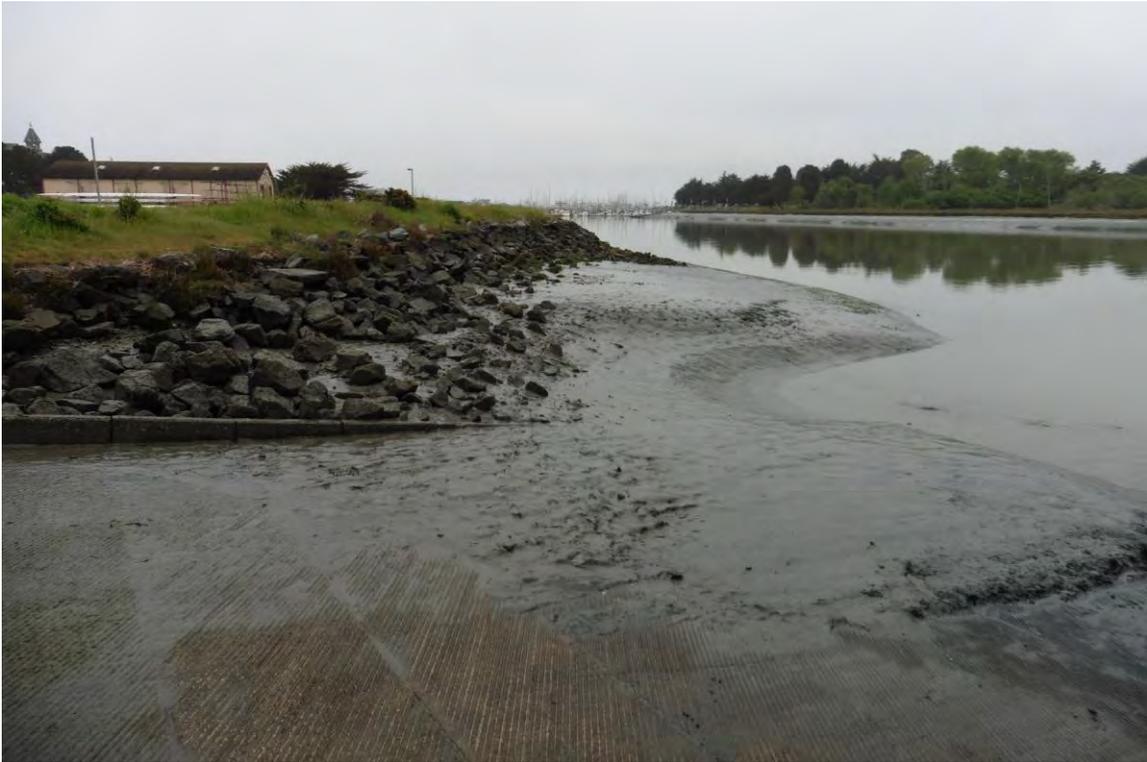
**Photo 1: Looking west across the existing boat launch toward the eastern edge of Population 1. Note how elevations become unsuitable for eelgrass adjacent to the boat launch. Photo taken May 8, 2020.**

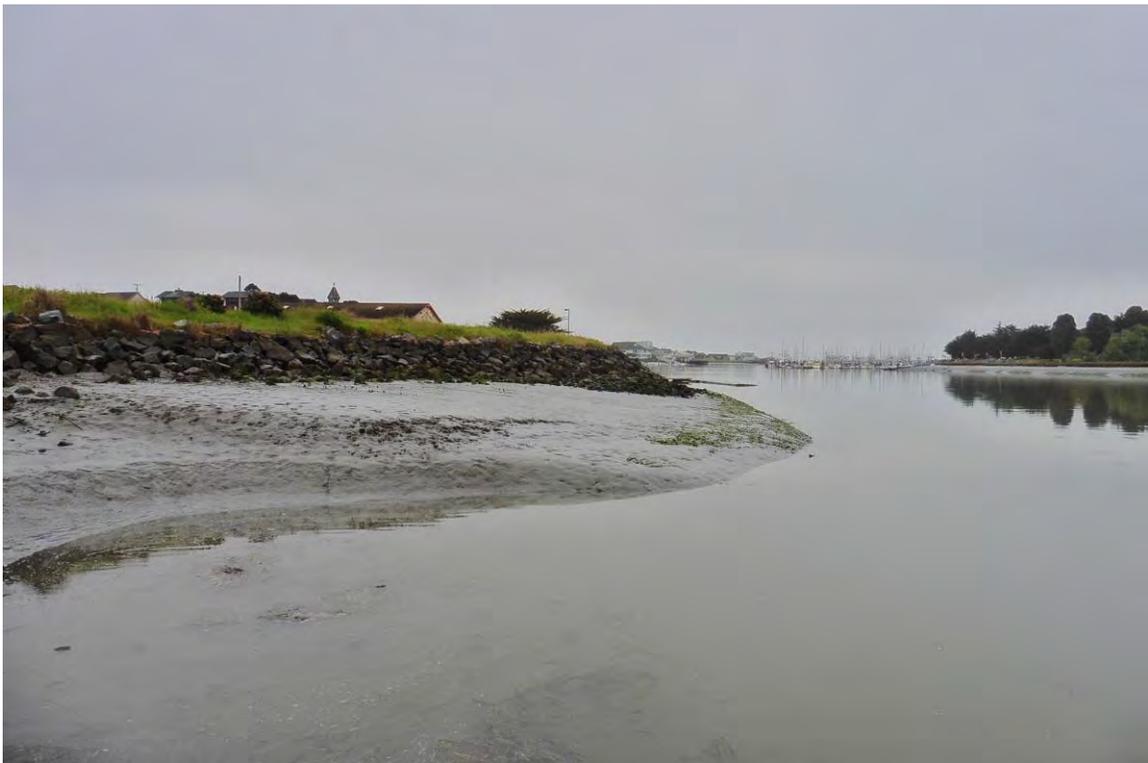
**Photo 2: Looking southwest toward the eastern edge of Population 1. Note steep mud flats that restrict eelgrass to a narrow band. Photo taken May 8, 2020.**

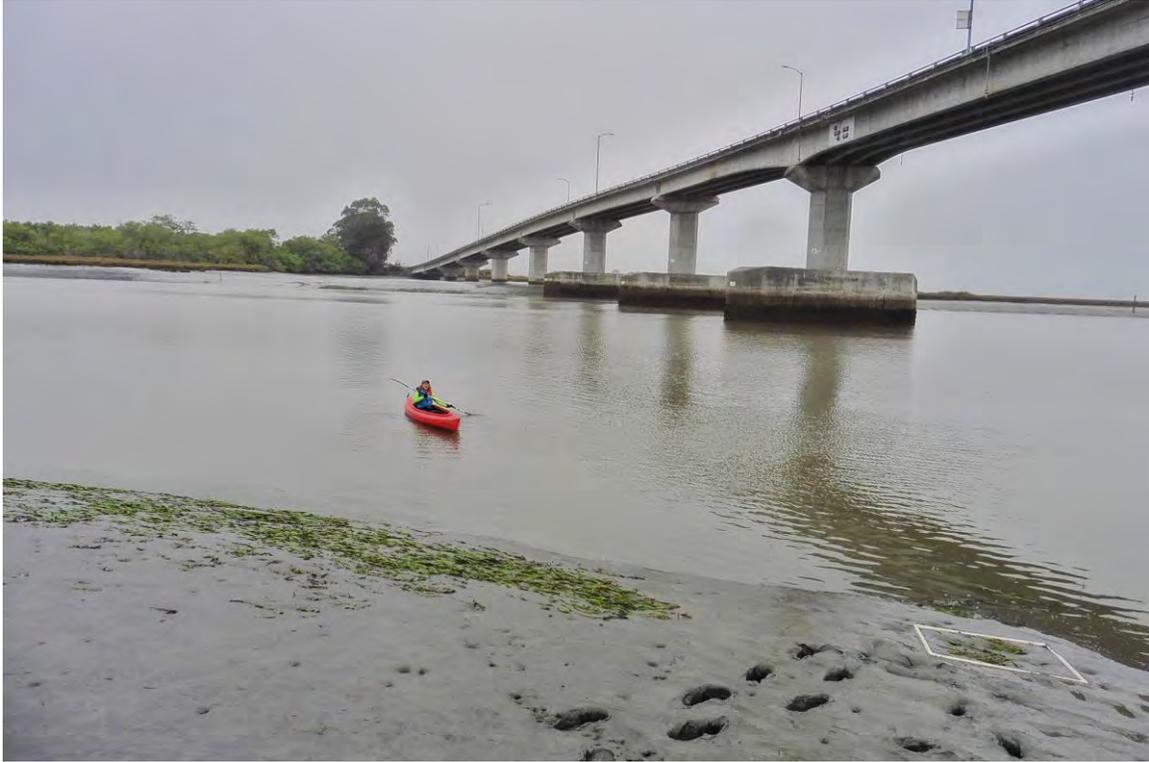
**Photo 3: Looking north across the eastern edge of Population 1. Note the 1x1 meter quadrat that is placed over the eastern most eelgrass within Population 1 representing Sampling Point 1. Photo taken May 8, 2020.**

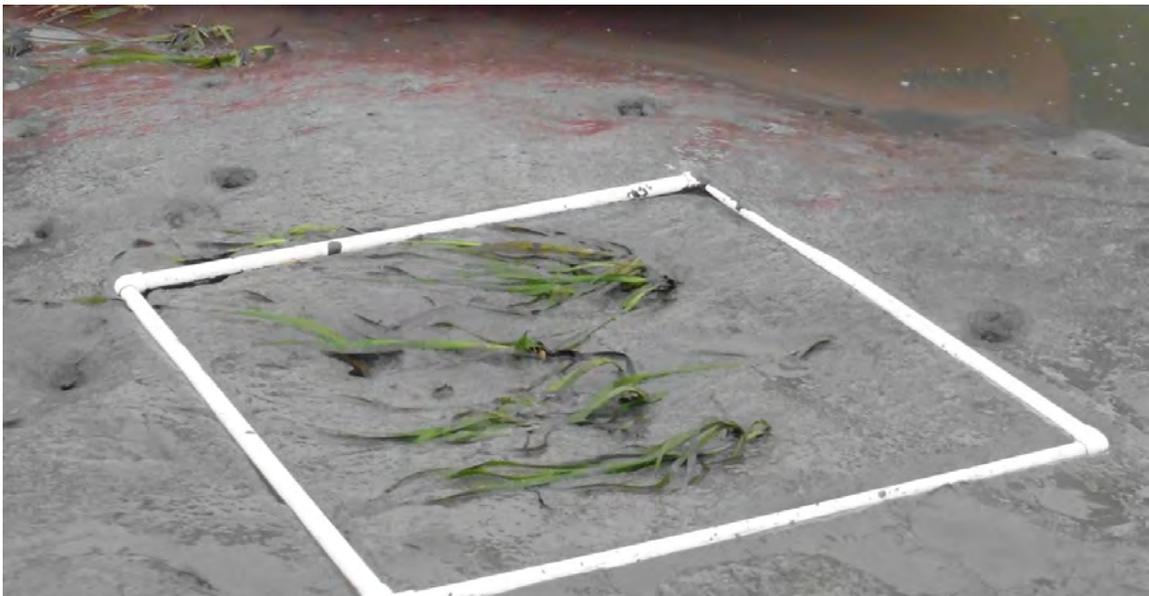
**Photo 4: Sampling Point 1 showing 12 turions and an estimated 10% vegetative cover. Photo taken May 8, 2020.**

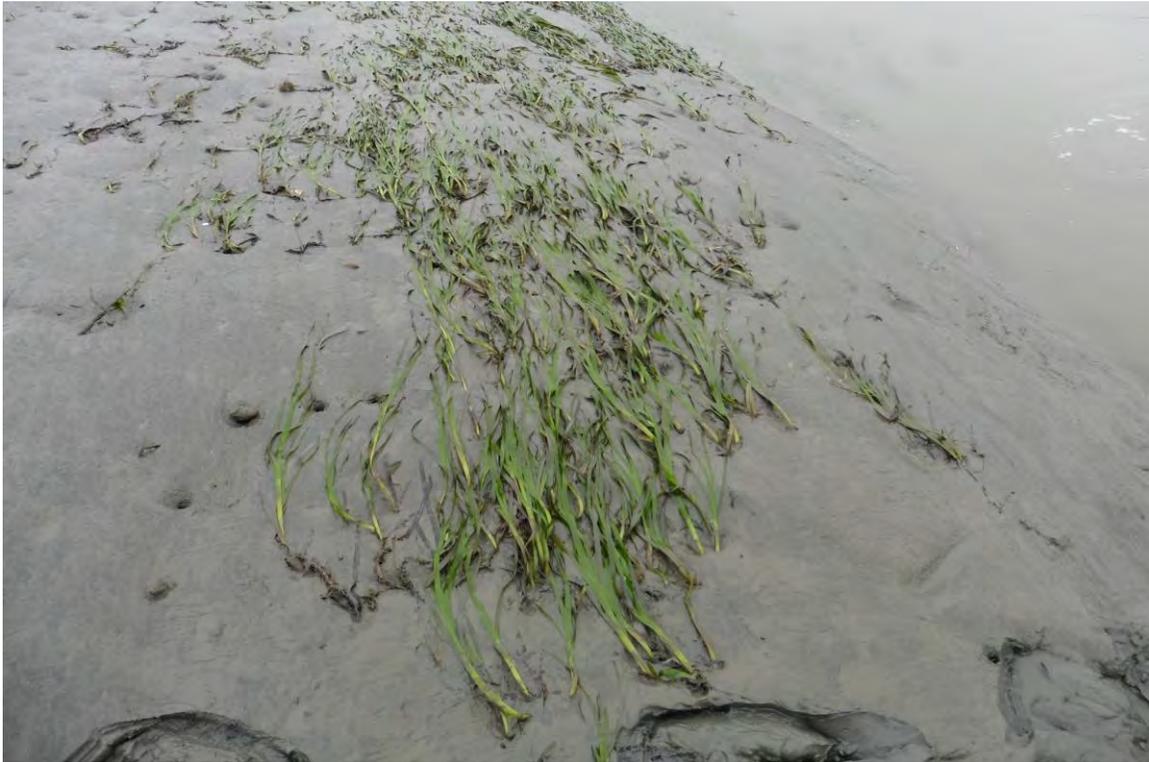
**Photo 5: Main body of Population 1 looking west represented by Sampling Point 3. Within the occupied habitat turion density averaged 47 turions/m<sup>2</sup> and vegetated cover was between 40 and 50%. Photo taken May 8, 2020.**

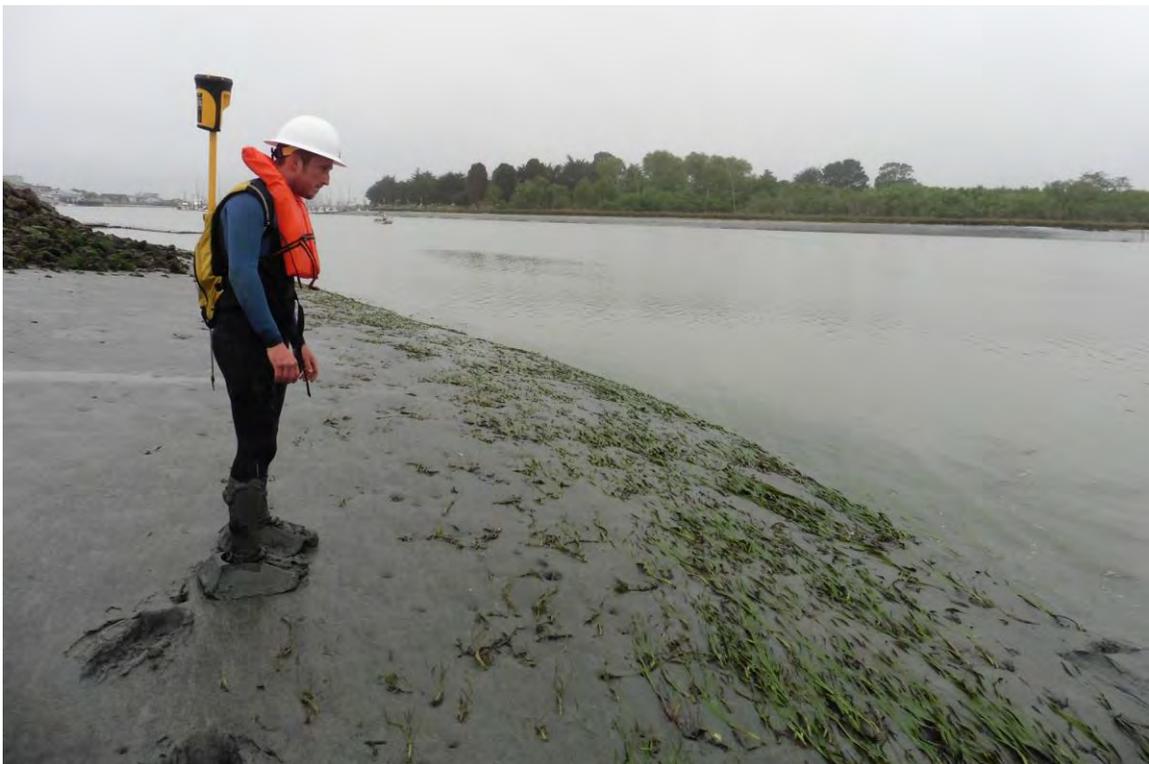
**Photo 6: Population 1 looking west. Photo taken May 8, 2020.**

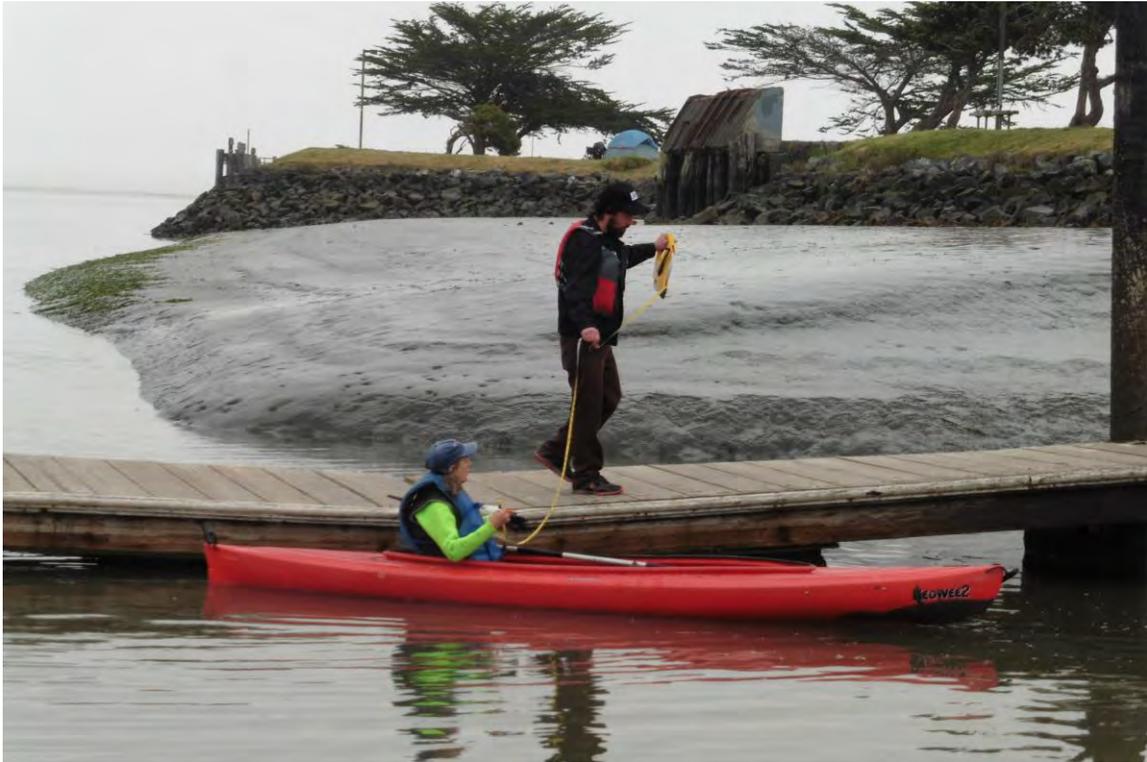
Population 2 exists to the northeast of the project area and is confined within an elevation band from 0.21 meters to 0.97 meters below mean sea level (Figure 2 and Appendix 1, Photos 7-9). The southwestern extent of Population 2 is approximately 120 feet from the project area at its closest point. Density and cover of eelgrass is very similar to what was observed within the main body of Population 1. Turion density was found to be 40 turions/m<sup>2</sup> with an average vegetative cover between 40 and 50 percent. The area studied for this report represents the southeastern extent of this population and the population extends northeast of the project area for an undetermined distance; however, the occupied aerial extent is estimated to be 94 m<sup>2</sup> within the study area. Total suitable eelgrass habitat including unoccupied distances less than 5 meters from occupied habitat was 406.2 m<sup>2</sup> within the study area (see Figure 2 and Appendix 1, Photos 3 and 4). One sample point was taken within Population 2 to characterize the population and can be used as a reference point following completion of construction, as this location is unlikely to be impacted by construction activities and is very similar to Population 1.

**Photo 7: Eelgrass Population 2 approximately 120 feet east of the project at its nearest point. Note mud flat and narrow elevation band of occurrence. Photo taken May 8, 2020.**

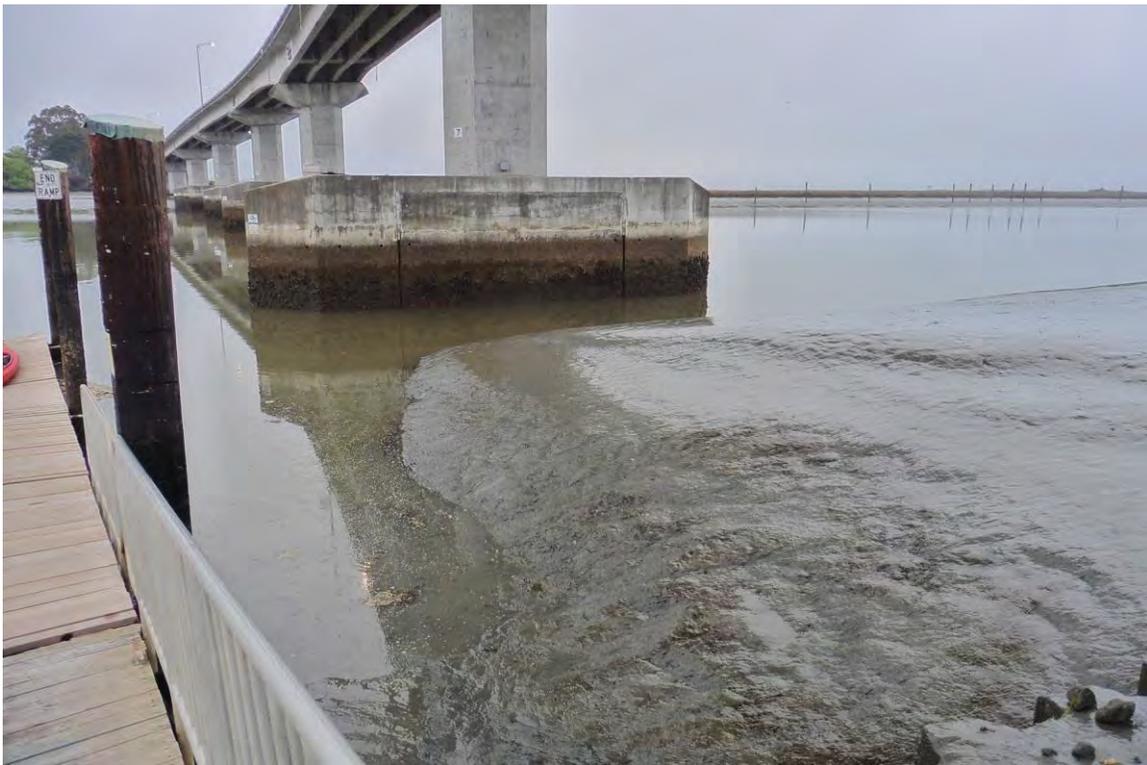
**Photo 8: Mud flat and conditions east of the project looking north. Note bridge infrastructure. Photo taken May 8, 2020.**

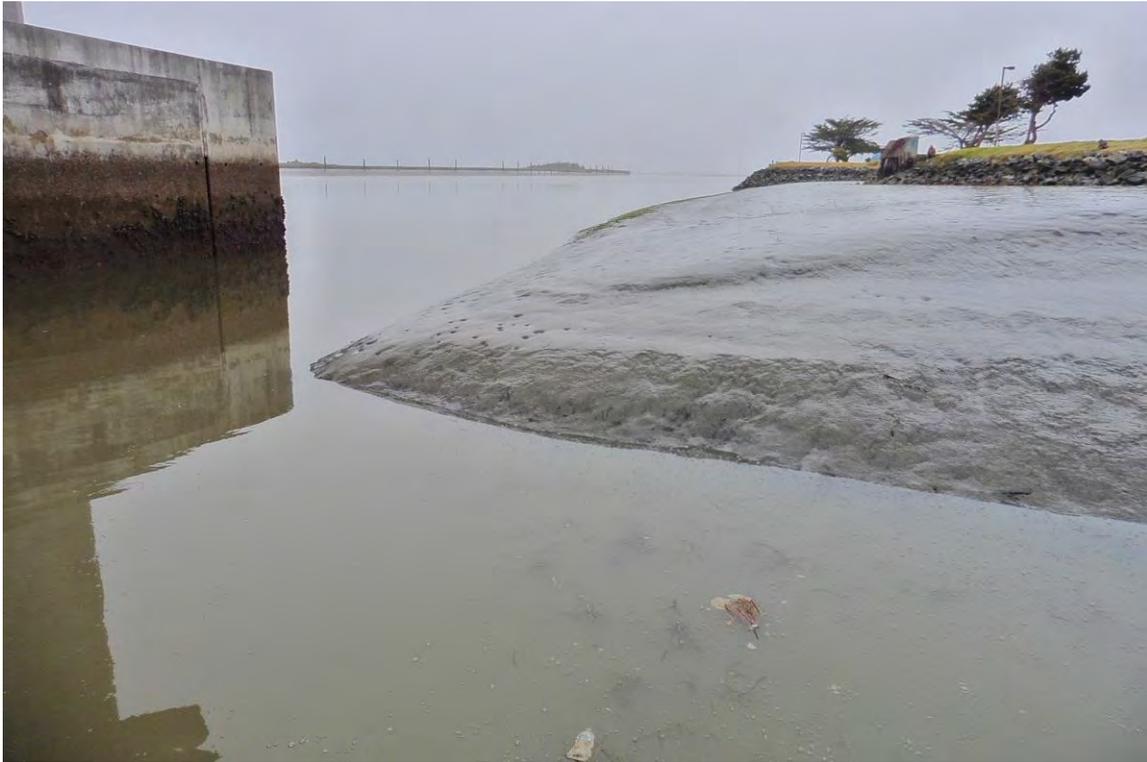
**Photo 9: Looking north toward eelgrass Population 2 from the existing dock. Elevations and shading from the bridge likely prevent growth of eelgrass closer to the dock. Photo taken May 8, 2020.**

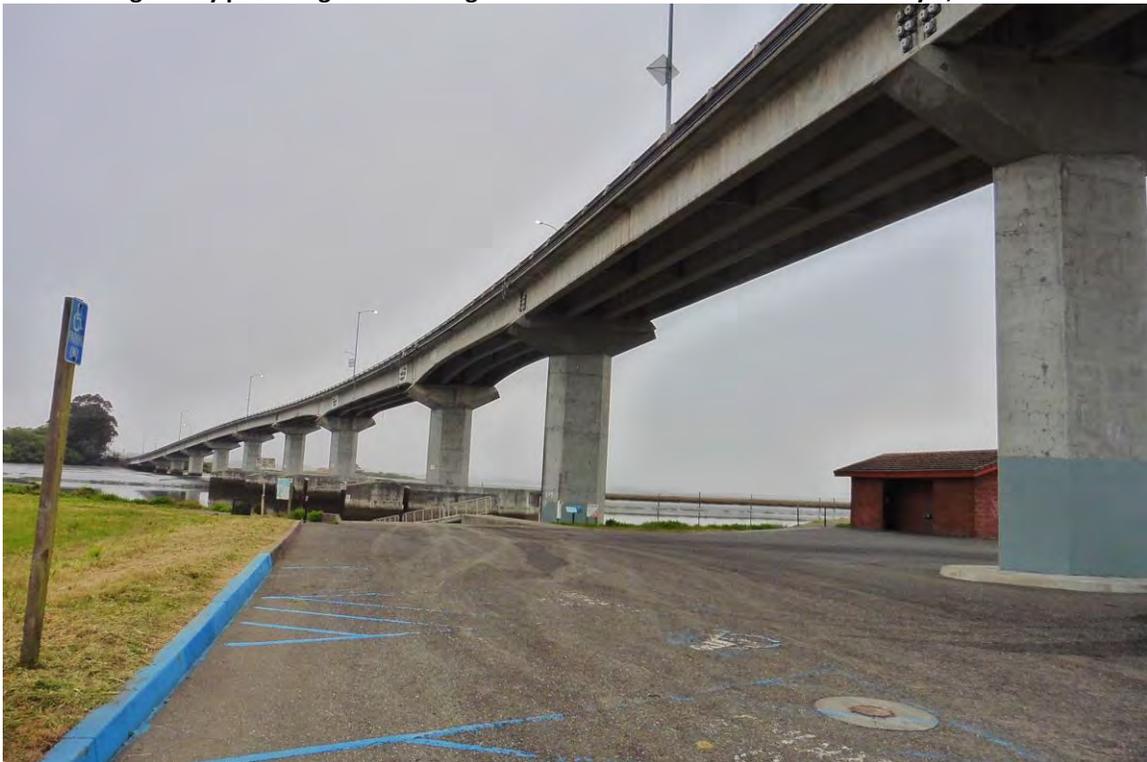
The work site will be accessed from the existing parking lot (Appendix 1, Photo 10), which is accessed from Waterfront Drive. No separate access is proposed from Waterfront Drive. In order to minimize use conflicts with other waterfront activities, construction equipment and materials will be staged in the open area to the west of the parking lot in the upland area at least 100 feet away from the small coastal wetland that was delineated by SHN (SHN, 2020).

**Photo 10: Boat launch parking lot looking north toward the existing dock facilities. Photo taken May 8, 2020.**
