## Chevron Eureka Terminal 2024 Repairs: Eelgrass Mitigation and Monitoring Plan

Project # 3606-07

# CHEVRON EUREKA 2024 MAINTENANCE REPAIRS PHASE I

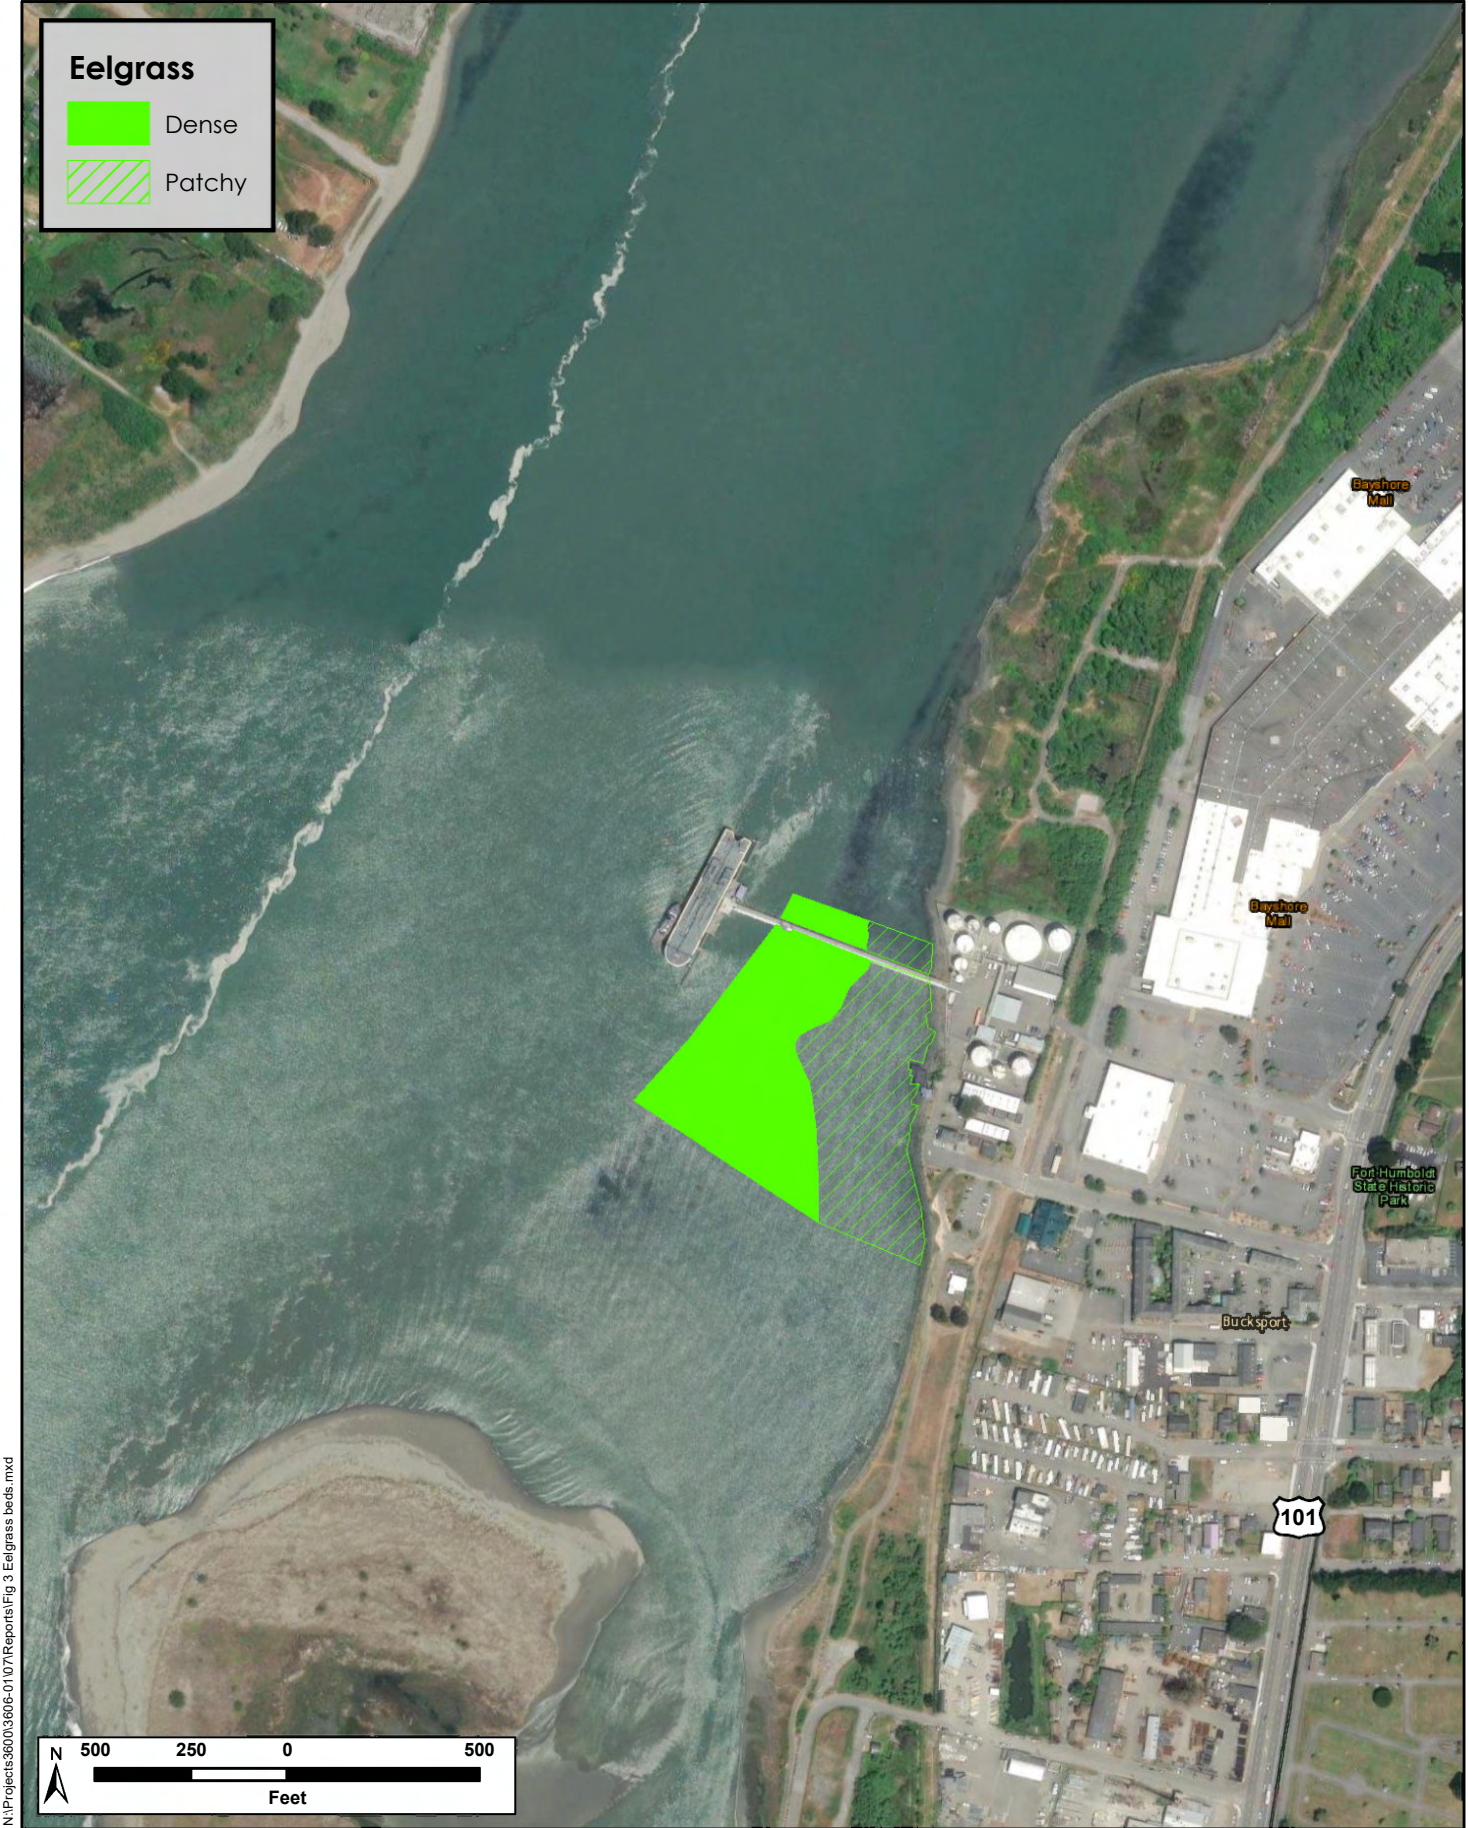
**Figure 3. Eelgrass Beds in the Vicinity of the Project Site**

Eelgrass is known to occur on mudflats at the project site on the north and south sides of the trestle, in both dense and patchy populations (see H. T. Harvey & Associates 2016, 2017, and 2018). Eelgrass has been observed growing immediately adjacent to piles on the south side of the trestle at suitable elevations, but little eelgrass was present close to piles on the north side of the trestle because of the shade provided by the trestle.

Eelgrass beds are found bordering the North Bay Channel, where the Chevron Eureka Terminal is located, approximately 365.8 meters north of the mouth of Elk River. The approximate distribution of dense and patchy eelgrass in the vicinity of the project site is shown in Figure 3, based on field mapping conducted at the site in 2015. We compared the NOAA (June 27, 2009) imagery, in true color and color infrared, with Google Earth imagery from 2003 through 2012, which is available for each growing season except 2007–2008, with the timing of the imagery ranging from May through August (NOAA 2009). Variability in eelgrass distribution at this location is evident from a review of the photographs, although low-imagery resolution and high-tide coverage at the time when the photographs were taken in some years limit the amount of information that can be derived. In general, eelgrass around the project site appears to exhibit greater seasonal variability in cover at higher elevations within the higher intertidal portion of its range closer to shore, with greater levels of cover observed in July and August. Closer to the channel where the shoal transitions from intertidal to shallow subtidal depths, eelgrass cover appears to be greater during the early portion of the growing season (May–June). The deep-water channel margin of the eelgrass bed appears to remain fairly constant. This pattern is consistent with field observations of the area.
