EUREKA SLOUGH BRIDGES GEOTECHNICAL INVESTIGATION

## NATURAL ENVIRONMENT STUDY

HUMBOLDT COUNTY, CA 01-HUM-101—POST MILES 79.50 / 80.20 EA 01-0F200 / EFIS 01-1500-0088

February 2023

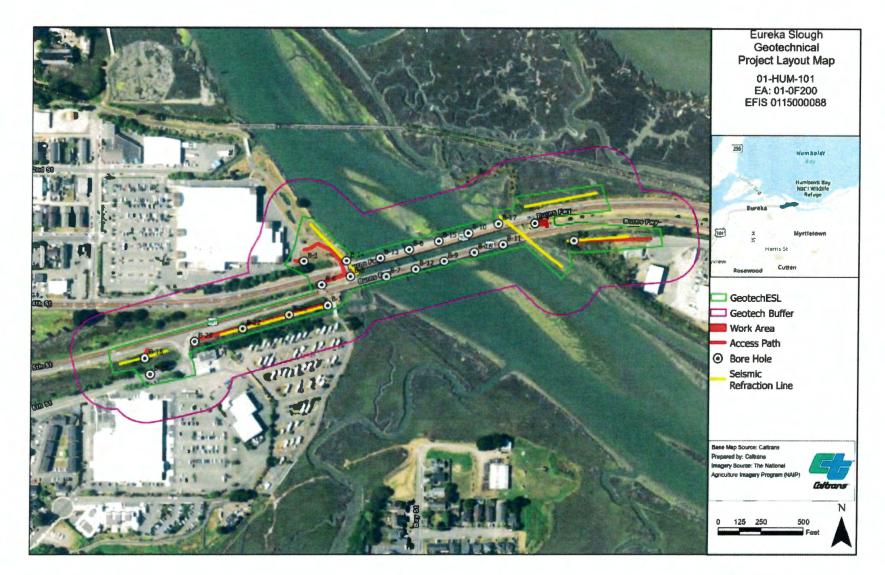
Figure 2. Environmental Study Limits and Biological Study Area

For the project, the ESL is the area encompassing the project footprint where there could be direct and indirect disturbance by geotechnical exploration (Figure 2). Within the ESL, project impacts are anticipated from geotechnical exploration, noise disturbance, equipment staging, and access routes. For the project, the BSA is the area where sound levels from geotechnical exploration would be expected to extend beyond the source and potentially impact terrestrial and aquatic species (Figure 2). In addition, the project is within the Coastal Zone, requiring a minimum of a 100-foot buffer. The BSA consists of a 165-foot (50 meter) buffer around the ESL.

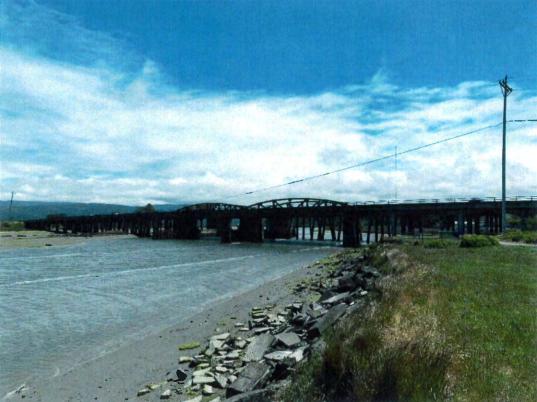
This preliminary site investigation plan outlines the procedures to obtain the subsurface information at the proposed replacement bridge locations. Drilling will be performed on the proposed bridge alignments at or near the proposed foundation locations. The exact number and locations of the borings will be determined once the General and Foundation Plans are received from Structure Design, indicating the proposed foundation locations.
