# Elk River Estuary (Planning Area 1) Restoration Project: Harbor District Development Permit Application Package

# Elk River Estuary (Planning Area 1) Restoration Project: Project Description

### Biological Resources Evaluation for the Elk River Estuary (Planning Area 1) Restoration Project

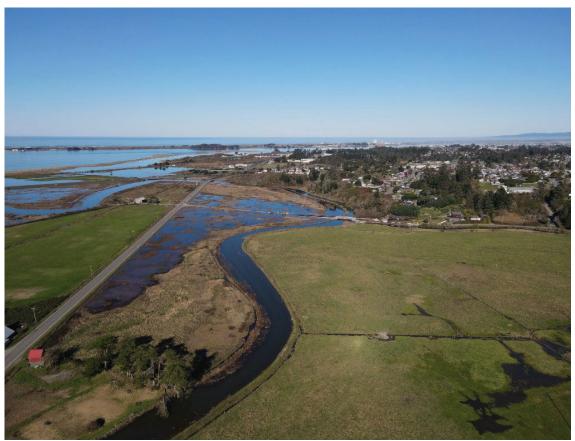
Image 1. Swains Slough at high tide.

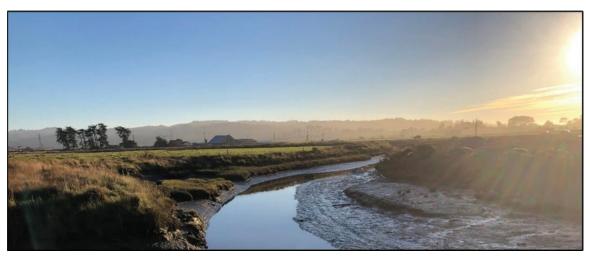
Image 2. Swains Slough channel.

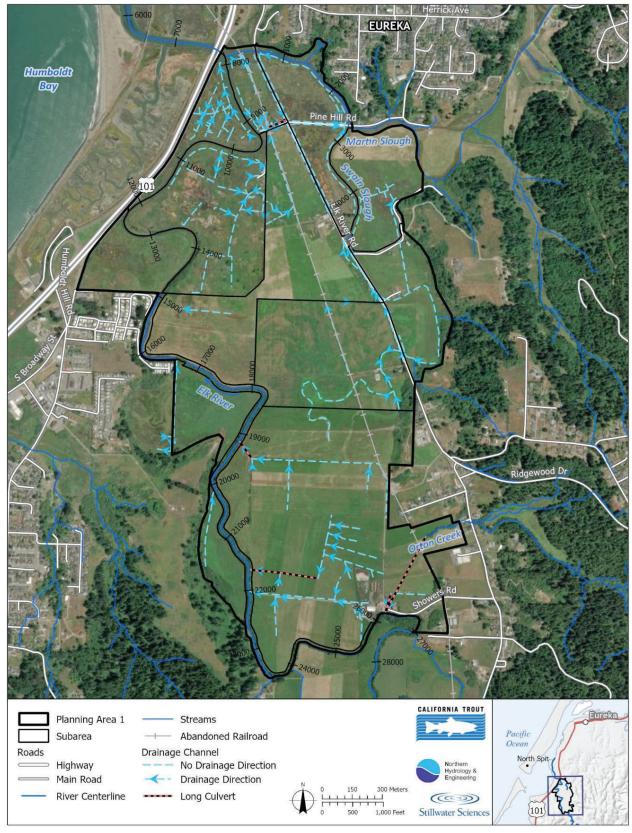
Figure 1-3. Map of Elk River PA1 showing existing drainage. River stationing represents the distance (ft) upstream from the Humboldt Bay confluence.

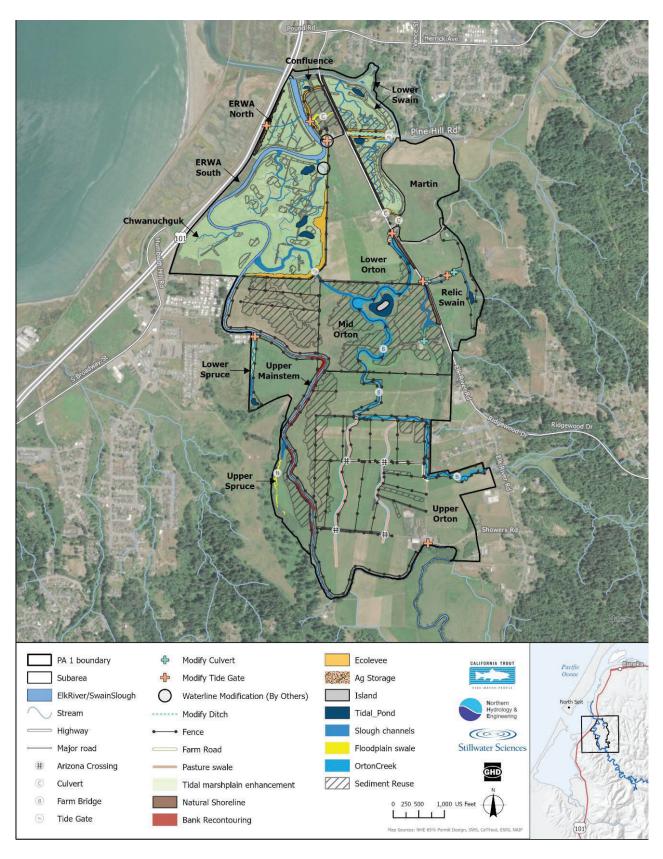
Figure 1-4. Overview of enhancement actions

Replacement or modification of infrastructure (Figure 1-4 and Figure 2-1) generally includes:

Following levee removal along the Elk River channel, agricultural fields will be protected by a new earthen eco-levee running along the southern and eastern property boundaries (Figure 1-4). This eco-levee will provide the same level of protection to adjacent agricultural lands as existing conditions but will incorporate design features that accommodate a natural transition from brackish marsh vegetation to riparian ecotone, and then to higher riparian and upland forest vegetation types. The eco-levee will appear as a slightly higher feature on the landscape, reaching an elevation of only 10 ft NAVD. Slopes to the marsh plain are generally 10H:1V slope or flatter,

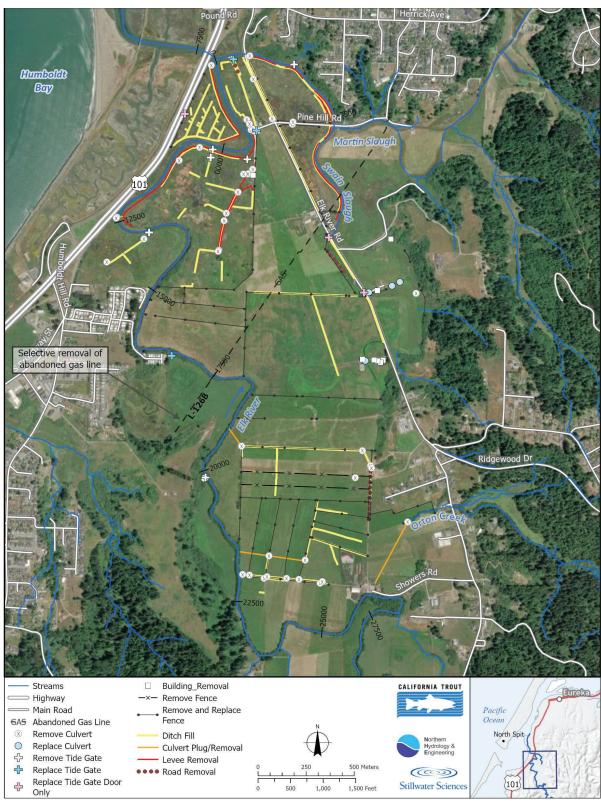
Figure 2-1. Infrastructure to be removed. These actions focus on routing overbank flow down valley, removing cross-valley drainage, retrofitting tide gates with fish friendly flap gates, and removing tide gates and levees at tidal march enhancement.

One tide gate will be replaced with a side-hinged double-barrel tide gates (Figure 2-1). The Humboldt Community Services District water line is located in the central portion of ERWA South. The water line will need to be modified to replace the tide gate and to accommodate a wider slough channel. The restoration design accommodates access to the water line for emergencies and maintenance.

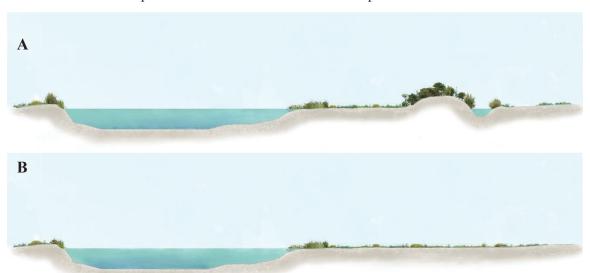
Figure 2-3. Elk River salt and brackish marshes. Existing conditions – with a narrow strip of marsh plain disconnected from larger tidal wetlands by existing levees (A). Proposed conditions resulting from removing and modifying levees to reconnect Elk River to extensive salt and brackish marsh plains during high tides, and from enhancing slough channel networks (B). Example is from ERWA- South in PA1.

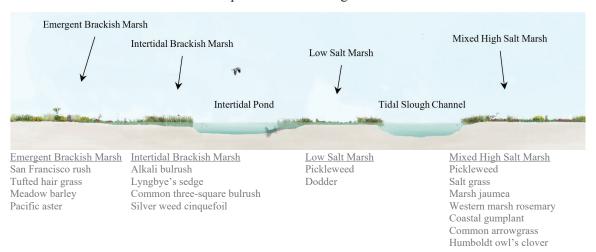
Figure 2-4. Conceptual cross section showing salt marsh enhancement including an enlarged slough channel network, intertidal pools, brackish vegetation along channel edges, and mixed high marsh. Water elevation shown is approximately MHHW. Example is from ERWA-Slough in PA1.

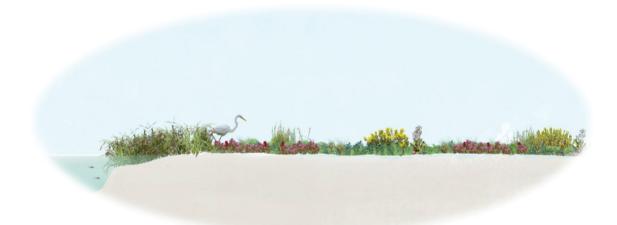
Figure 2-5. Conceptual illustration of mixed high salt marsh located at an elevation near MHHW.

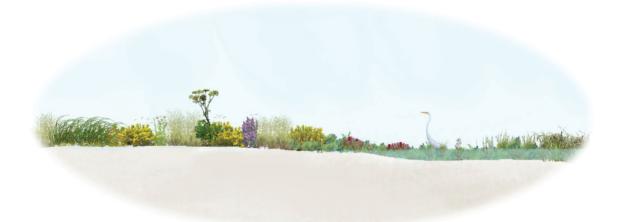
Figure 2-6. Conceptual illustration of emergent brackish marsh located at an elevation above MHHW.

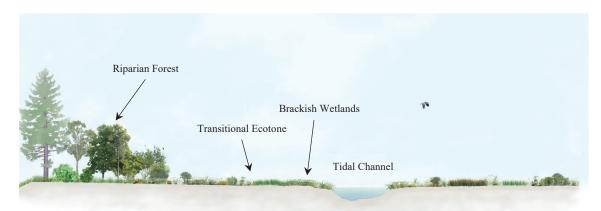
Figure 2-7. Conceptual cross section showing brackish wetlands enhancement including off-channel habitat with tidal channels fringed with brackish marsh vegetation. Brackish wetlands transition through a wetland-to-riparian ecotone, grading to riparian forest and uplands.

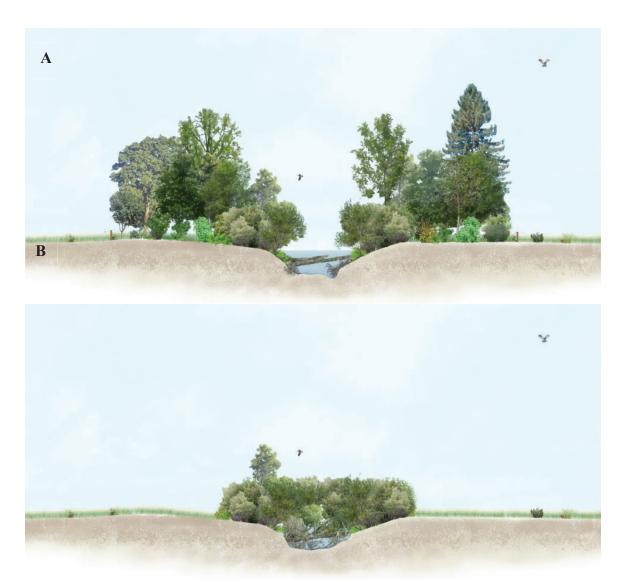
Figure 2-11. Current conditions along sections of Elk River that are dominated by fine stem clonal willow growth that cover the banks (A). Proposed conditions along the Elk River (ER-10 and ER-12) include thinning treatments, interplanting, and expanded width to enhance the riparian corridor in mainstem Elk River (B).

The entire Upper Mainstem riparian corridor along Elk River will be expanded and protected with cattle exclusion fencing (Figure 2-11). Beyond the graded bank treatments in the riparian management unit, thinning and/or removal of live wood in the Elk River channel will occur in reaches that have high in-channel encroachment of low to midstory shrubs and channel-spanning fallen live wood (Figure 2-12 and Figure 213). Individual trees contributing to overstory canopy will be preserved to the extent possible. The objective for riparian thinning is to reduce the existing small-diameter willow stem accumulation on the channel bed- and revegetate Elk River's upper banks and floodplain with a multi-tiered native riparian community that will promote growth and structure above Elk River's top of bank. Any gaps from thinning in intact riparian areas will be interplanted. Where clumps of willows will be removed, the bank will be recontoured and revegetated. Willow thinning treatments include: (1) the full removal of select individuals contributing to high fine stem accumulation within the lower channel bed and bank and (2) pruning and removal of fallen live channel-spanning willows rooted on the upper bank. The latter will involve a pruning cut at the base of selected incompletely-felled tree trunks and the subsequent removal of the trunk and its resprouted branch stems to considerably reduce stem density on the channel bed. Epicormic growth of treated willows will occur along the top of bank and will no longer contribute to fine stem accumulation on the channel bed. These willow thinning treatments include an additional 14% on the left bank (12% for full removal and 2% pruning) and 17% on the right bank (6% for full removal and 11% pruning). All thinned areas will be revegetated with a diverse riparian forest plant palette to promote fast recovery, stream cover, and expanded wildlife habitat. Subsequent vegetation management treatments may be warranted during the riparian plant establishment period to support the riparian plant community transition towards greater species and structural diversity.

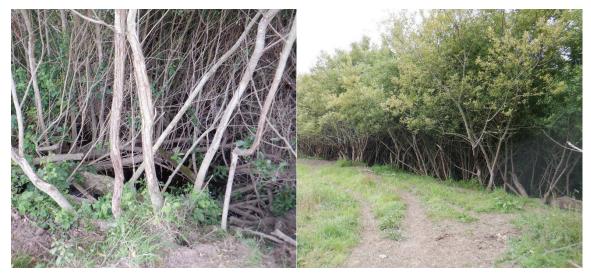
Figure 2-12. Example of high-density fine stem clonal willow growth in the channel.

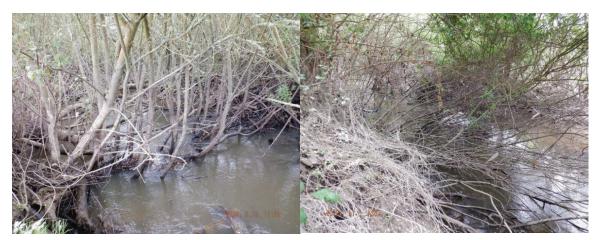
Figure 2-13. Existing conditions showing incompletely-felled live willows resprouting along channel bed that are targeted for removal.

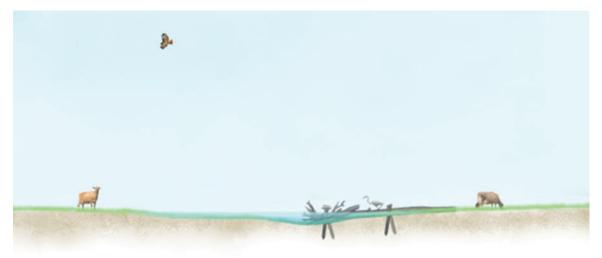
Figure 2-14. Floodplain channel through agricultural grasslands during flood flows in the Elk River. The low flow channel, set within a broad shallow floodplain channel, provides deeper flow paths with cover for fish to pass through agricultural grasslands to reach higher quality habitats as high water recedes. During dry periods, the floodplain channel is grazed.

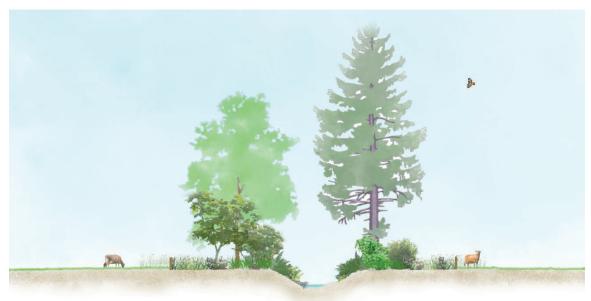
Figure 2-15. Conceptual cross section. Orton Creek restoration will include daylighting Orton Creek riparian creation and enhancement, and improving channel complexity with wood, alcoves, inset benches, and exclusion fencing.

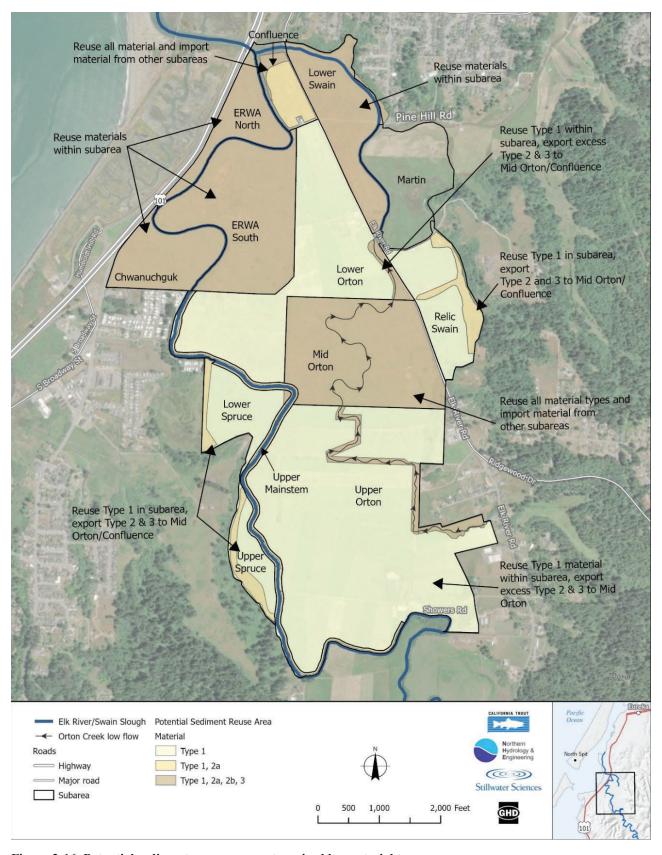
Figure 2-16. Potential sediment reuse areas categorized by material type.

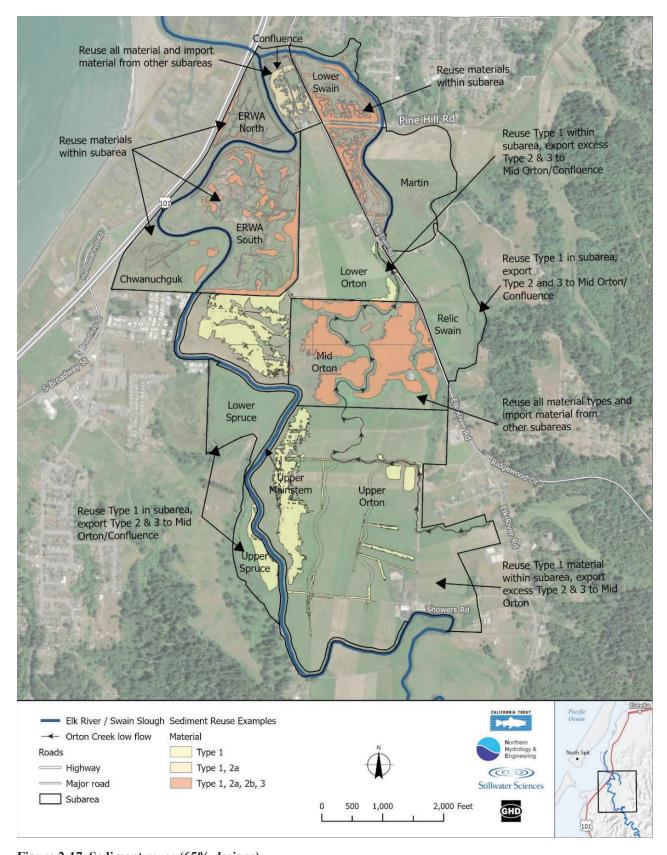
Figure 2-17. Sediment reuse (65% designs).

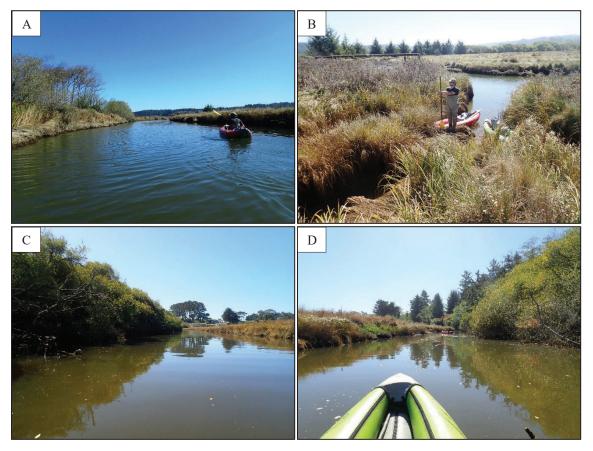
Figure C-3. Photos from September 2021 showing representative main-channel summer fish habitat conditions in ER5 (A), an alcove habitat associated with a tide gate at ER5.1 (B), and examples of overhanging riparian cover in ER6 (C) and ER7 (D). Note: tidal stage was relatively high when these photos were taken.

In channel segments ER5–ER7, overall fish habitat quantity and quality continues to be limited by the simplified, straight channel bordered by relatively steep banks and limited off-channel habitat. Main-channel salmonid summer rearing habitat quality improves somewhat relative to ER1–ER4 due to long patches of continuous riparian trees with overhanging branches on the right bank of ER5 and ER6 and on the left bank of ER7. These branches provide both overhead and inchannel escape cover for juvenile fish (Figure C-3). Based on observations during the winter survey, which was conducted at a lower tidal stage than the summer survey, the area of suitable salmonid rearing habitat provided by these overhanging branches is expected to be greatest at higher tidal stages, when they and the few gradually sloping banks become more inundated. It was difficult to fully assess in-channel cover at the surveyed tide due to depth and turbidity, but other than several pieces of submerged large wood in ER7, most cover was associated with channel margins (branches from live trees and grasses).

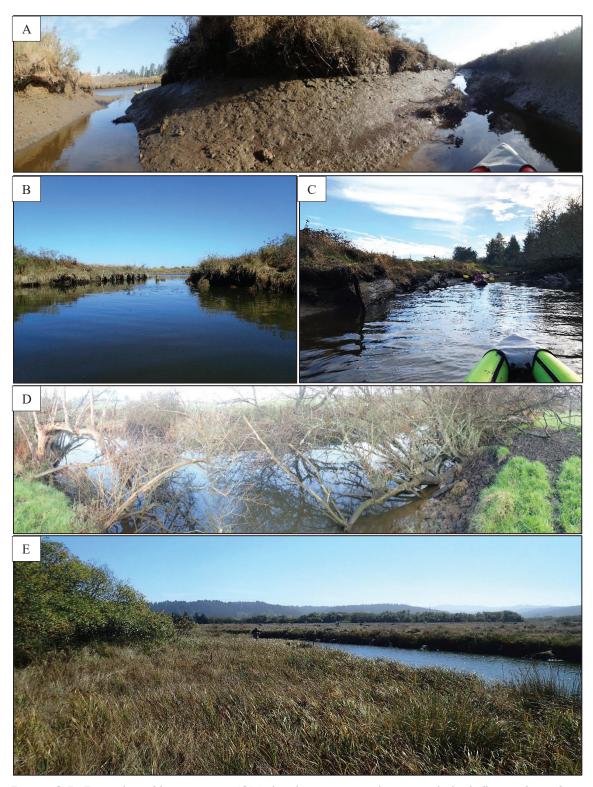
Figure C-5. Examples of locations in MSR1 that have potential to provide high flow refugia for fish in MSR1, including connected borrow ditch at ER1.1 (A), large alcove associated with ER2.2 (B), large wood along both channel margins in ER7 (C), relatively gradually sloped bank with in-channel willow branches in ER9 (D), and inset bench on right bank in ER5 (E).

The primary areas with potential to provide velocity refugia during higher stream flows include (1) the ER.1 ditch network, the alcove-like features present where drainage ditches enter the channel (e.g., ER2.1, ER2.2, ER3.1, ER4.1, ER5.1, and ER6.1 (2) small areas in ER6, ER7, ER8, and ER9 that have both relatively gradual slopes and complex, overhanging, in-channel riparian branches or large wood along the bank, and (3) the few pieces of in-channel large wood big enough to potentially provide small areas of low velocity habitat (Figure C-3). A series of 20–40 ft wide "inset benches" (bounded by levees) located along the right bank in ER3 and ER5 have gradual bank slopes (after an initial step up from the active channel). These sites may also provide velocity refugia when they are flooded during higher flows (Figure C-5).

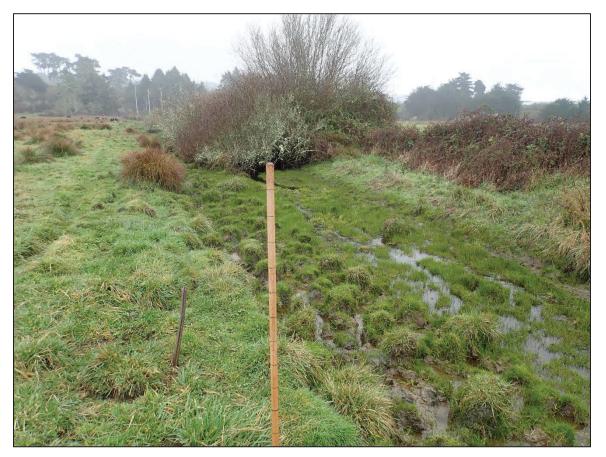
Figure C-6. Photo from January 2022 showing the lower portion of the drainage ditch at ER9.1.

The network of drainage ditches, relic slough channels, and depressions in the ERWA have potential to provide large areas of high-quality winter refugia and rearing habitat depending on flow and tidal stage, but the current habitat is generally in poor condition. Additionally, as described above, ER9.1 is not currently accessible to fish, but if restored, has potential to provide a large area of high-quality, off-channel salmonid winter rearing habitat. During the relatively dry winter period, a significant amount of fresh water was observed entering the ditch via the adjacent hillslope, which would help maintain water quality at the site if it were made accessible to fish (Figure C-6).

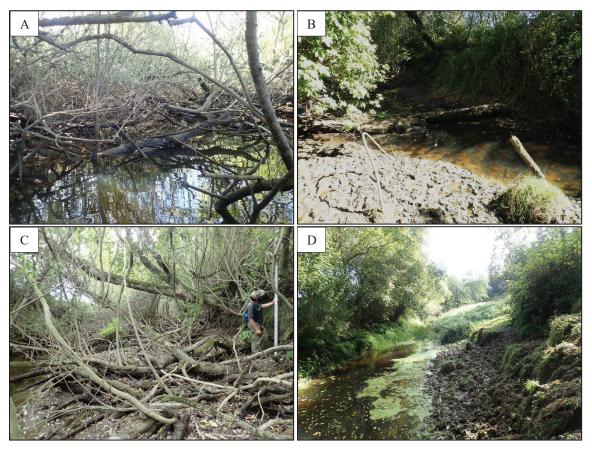
Figure C-7. Representative summer rearing habitat in MSR2. Dense willow branches and small woody debris covering much of the channel in ER10 (A), a more open section in ER11 with some functional large wood and cattle impacts in the channel (B), dense in-channel branches and entrenched channel in ER12 (C), and shallow, stagnant section of ER13 with in cattle impacts (D).

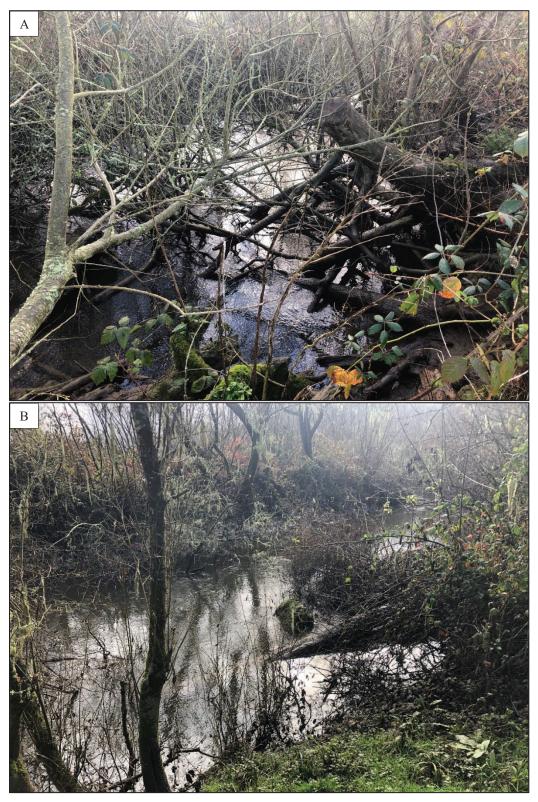
Figure C-8. Examples of low-velocity in-channel habitat in MSR2 observed during the January 2022 survey conducted at a moderate winter base flow. Dense in-channel branches and small wood pieces in ER10 (A) and a piece of large wood creating alcove-like habitat at the observed flow in ER11 (B).

Overall, quality of winter habitat in MSR2 is relatively poor, with minimal in-channel flow refugia due to low large wood densities, essentially no connected off-channel habitat features, and severely restricted connectivity with adjacent floodplains. During the winter habitat assessment conducted in January 2022 at a moderate winter baseflow, small areas of relatively low-velocity habitat (<1.0 ft per second) were observed along the channel margins in a few locations where banks were more gradually sloped and dense willow branches or large wood were present (Figure C-8). However, because of the entrenched channel and limited functional large wood, even moderate high-flow events are expected to produce water velocities that exceed values preferred by Coho Salmon for rearing (approximately 0.6 ft per second ft/s; Beecher et al. 2002) throughout much of the reach. In some locations, it is possible that the extremely dense in-channel willow trunks and instream branches create low-velocity refugia along the channel margins or slow upstream water velocities through backwatering. Several groups of large wood pieces that were observed also likely create some in-channel flow refugia at higher flows.

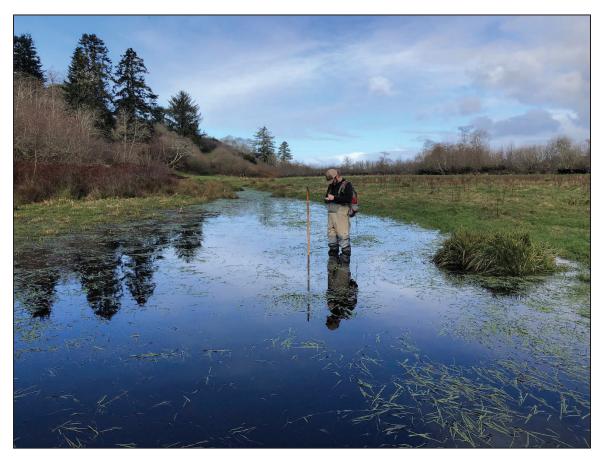
**Figure C-9.** Large area of existing off-channel habitat at ER12.1 that is inaccessible to fish due to a tide gate.

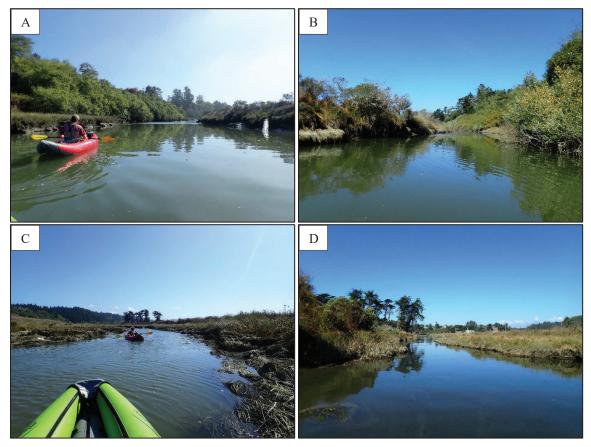
Figure C-10. Photos from September 2021 showing representative main-channel summer fish habitat conditions in Swain Slough. Looking upstream at straight channel in SS2 confined by a levees on the left bank and more gradual bank with riparian cover on the right bank (A), looking downstream at overhanging riparian cover along both banks in SS3 (B), looking upstream at flooded vegetation along the margins of SS5 during a relatively high tidal stage (C), and looking downstream from the tide gate at the end of SS6 (D).

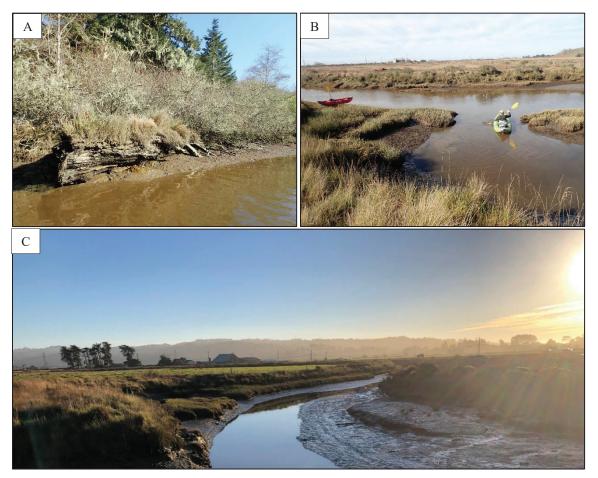
Figure C-11. Photos of from the January 2022 fish habitat assessment of Swain Slough.

Examples of potential high flow refugia habitat, including large wood located on the relatively gradually sloping right bank of SS3 (A) and an alcove at SS4.1 (B) and representative area with shallow water and low in-channel habitat complexity that occurs during lower tidal stages in SS4 (C).

During wetter periods of winter and spring with more freshwater influence, like MSR1, Swain Slough has potential to support rearing age-0 juvenile salmonids and other freshwater-dependent or brackish species (Table C-1). Winter habitat complexity and fish escape cover in the Swain Slough channel during moderate winter flows is similar to that described for summer habitat: relatively large areas of high-quality habitat are accessible along the channel margins during higher tidal stages and minimal in-channel habitat is available during lower tides (Figure C-10 and Figure C-11). During high winter flows, when significant freshwater enters Swain Slough via Martin Slough and upstream drainages, water velocities in much of the channel may become too high to support juvenile salmonid rearing. As described above, access to off-channel and floodplain habitats that provide velocity refugia is limited by the levees that run along much of Swain Slough. During high flow conditions, some high-flow refugia habitat appears to be present along the more natural bank margins that occur along the right bank of SS2 and SS3, which has sections with relatively gradual slopes (up to the base of the adjacent hillslope) with thick overhanging tree branches and some bankside large wood (Figure C-11). Fish may also find

velocity refugia where the levees have failed, and they can access the network of borrow ditches and adjacent lower elevation floodplains. However, fish stranding could be an issue when flows recede and the ditches become disconnected.

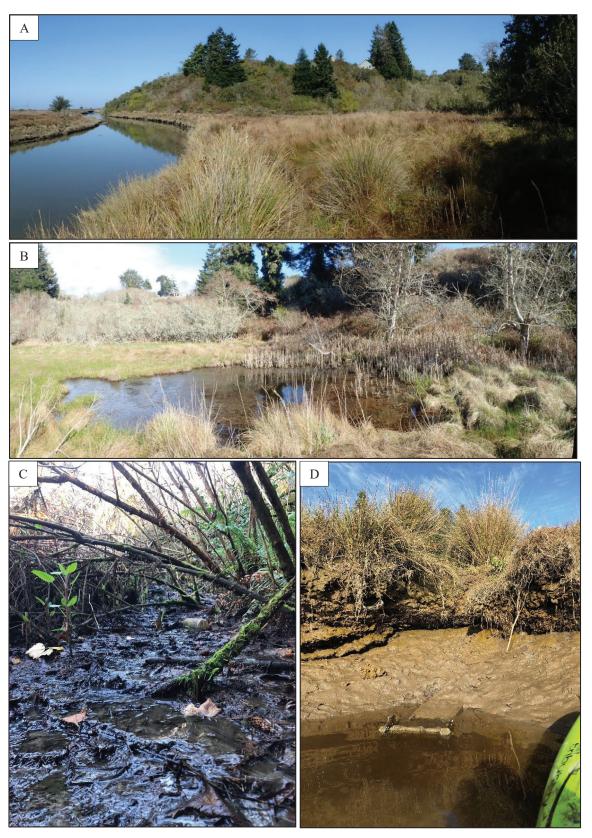
Figure C-12. Photos of disconnected off-channel salt marsh (A), associated pond (B), small tributary flowing into marsh (C), and old tide gate that enters Swain Slough (D).

The salt marsh that occurs east of the SS2/SS3 boundary (SS3.1), is currently largely disconnected; however, it has high potential to provide a large area of high-quality fish habitat adjacent to lower Swain Slough (Figure C-12). The approximately 1-ac marsh is fed by a small drainage originating in the adjacent wooded hillslopes that provide significant freshwater inputs to the site during the wet season. Most of this water appears to drain into a narrow (2 ft) and very entrenched (3–5 ft deep) drainage ditch that runs across the meadow before terminating in Swain Slough through a small tide gate at the base of a channel-side levee. An existing, small (40x40 ft) brackish pond is present on the eastern edge of the marsh. It does not have an obvious inlet or outlet channels but appears to be tidally connected at some tidal stages (was brackish during September site visit) and likely receives some freshwater from the adjacent hillslopes. The site appears to become inundated at the highest tidal stages that flood the berm that runs along this channel/marsh margin (Figure 2-1 of the *Elk River PA 1 10% Design Report*; CalTrout et al.

2023). However, field observations suggest the marsh is inaccessible to fish at most tidal stages. It is unclear how frequently the site floods during winter flow events but appears to be disconnected by the relatively high elevation berm at most flows. This site has significant potential for restoration of high quality and valuable fish habitat since it is an undeveloped low-elevation salt marsh habitat with an off-channel pond in the lower estuary that could be fed by significant freshwater. If restored, this site could provide high flow refugia habitat during flood events and persistent off-channel rearing habitat for salmonids and other fish during the winter and spring.

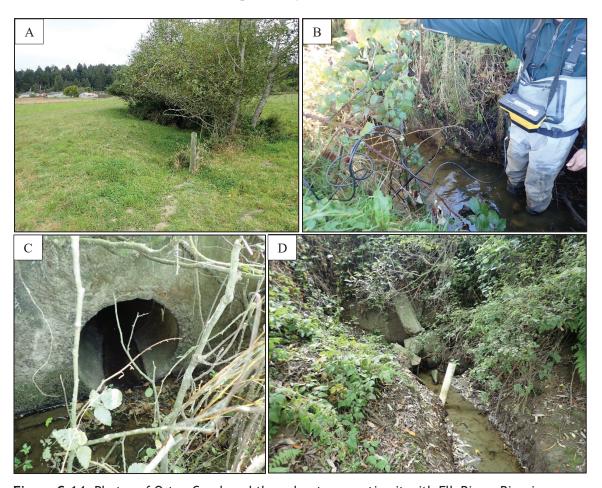
Figure C-14. Photos of Orton Creek and the culvert connecting it with Elk River. Riparian zone near culvert inlet (A), wetted channel during January 2022 flow measurement near culvert inlet (B) culvert inlet during August 2021 site visit (C) and culvert outlet and flow into Elk River during September 2021 habitat assessment.

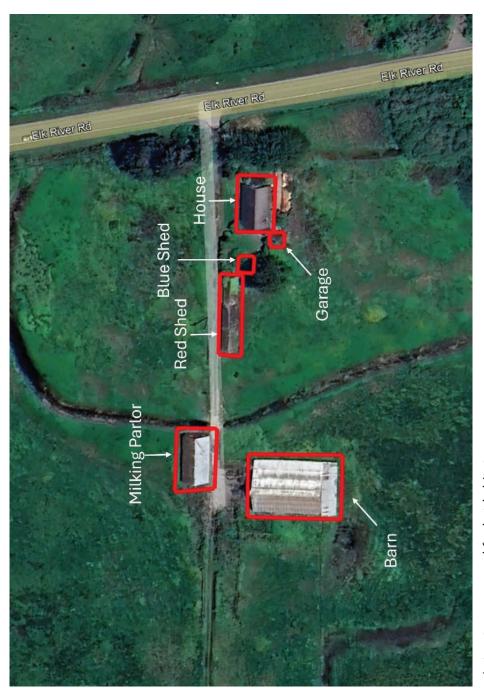
Figure D-2. Area 1 structures assessed for bat habitat.

The bat habitat assessment within Area 1 included the review of six structures (Figure D-2).

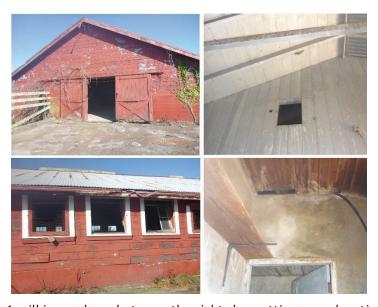
Figure D-3. Area 1 milking parlor; photos on the right show attic access locations.

The current Project design will remove the milking parlor. The structure consists of wood siding and a roof made of either corrugated metal or wood (the latter observed over the attic). It consists of one large room with a few smaller adjoining rooms; all with moderate deteriorated conditions (Figure D-3). The attic was not accessible during the survey.

There was no evidence of bats. About a dozen pre-existing barn swallow nests were observed. While the structure provides bat roosting habitat, there is a **low to moderate likelihood** for this structure (particularly the attic) to support a maternity roost due to the open nature of the building.

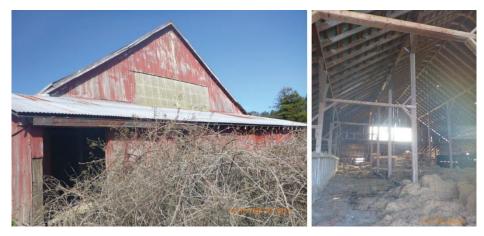
**Figure D-4.** View of Area 1 barn's southernly exposed exterior (left) and view of the barn interior (right).

The current design will retain the barn structure. The barn is comprised of wood siding and a corrugated metal roof (Figure D-4). The structure is a single open room. There was no evidence of bats, and limited maternity roosting opportunities. Several barn swallow nests from a prior season and one active rat nest were present. While the structure provides bat roosting habitat, there is a **low likelihood** for the barn to support a maternity roost due to the lack of crevices present.

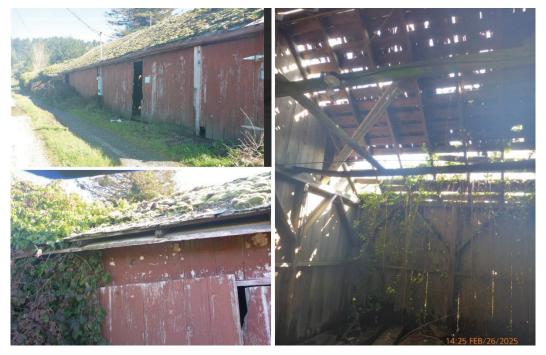
**Figure D-5.** Area 1 red shed exterior view (top left), view of the interior (right), and potential bat roosting habitat at the roof (bottom left).

The current design will remove the red shed. The red shed is composed of wood siding and a wooden and composite shingle roof (Figure D-5). While the inside of the red shed was not thoroughly inspected due to safety concerns, portions of the highly degraded structure allowed significant airflow which reduces the suitability of the structure to support maternity roosting habitat. Roosting habitat may be present in the gap between the roof, as shown in Figure D-5. Overall, there is a **moderate likelihood** for this shed to support a maternity roost due to the gap along the roof.

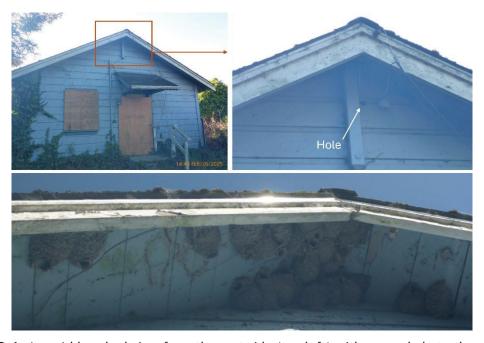
The current design will remove the blue shed. The blue shed is comprised of wood siding and a composite shingle and wooden roof (Figure D-6). This structure was fully boarded (doors and windows) and the interior was not accessible to survey. While the structure appeared well sealed from the outside, there was one hole on the east side of the attic which may provide access to the attic. There was no evidence of bats. Several barn swallow nests from a prior season were documented on the underside of the overhanging eves. While the blue shed provides access to the roof for roosting habitat, there is a **low likelihood** for this structure to support a maternity roost as the structure was well sealed.

Figure D-6. Area 1 blue shed view from the east side (top left) with access hole to the attic (top right) and prior years barn swallow nests (bottom).

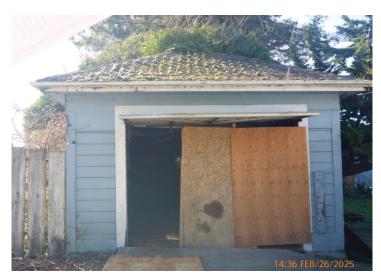
The current design will remove the garage. The garage is composed of wood siding and a wooden and composite shingle roof (Figure D-7). The interior and exterior of this structure were thoroughly inspected and there was no indication of bat use. Besides the garage door being open, the garage was well sealed on the outside. While the structure provides bat roosting habitat, there is a **low likelihood** for this structure to support a maternity roost due to the lack of crevices.

Figure D-7. Exterior view of the Area 1 garage structure.

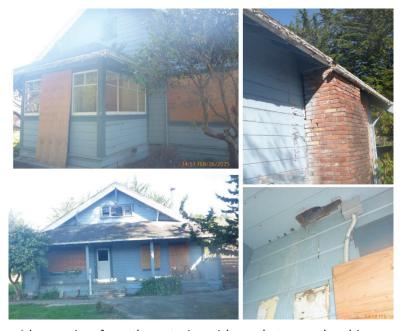
The current design will remove the house. The house is composed of wood siding, a brick chimney, and a wooden and composite shingle roof (Figure D-8). The interior of the house was not accessible. The exterior of the structure looked well sealed except for a hole on the back side of the house, where bird droppings were observed. There was also a gap between the chimney and the side of the house; however, there was no indication of guano. The structure may support roosting habitat, particularly in the attic and gap between chimney and wall, as shown in Figure D-8. Overall, there is a **moderate likelihood** for this structure to support a maternity roost due to the presence of crevices and attic openings.

**Figure D-8.** Area 1 house view from the exterior with gap between the chimney and the house (top right) and access to the attic (bottom right).

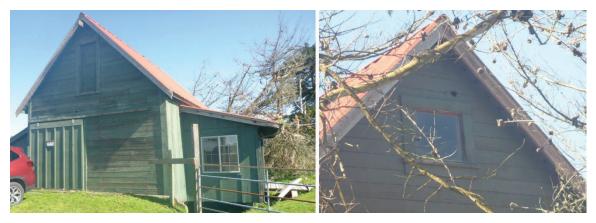
The current design will retain the barn. The barn is composed of wood siding and a corrugated metal roof that overlays a wooden roof (Figure D-12). The interior of the barn was not accessible. From the exterior, the structure appeared well sealed with one hole on the easterly facing second-story. There was no evidence of bats. The structure provides bat roosting habitat, particularly in gaps present along the wooden roof but there is a **low likelihood** for this structure to support a maternity roost

While this structure is in an ideal location to enhance bat roosting habitat as it is located within the zone of greatest morning sun between late May and early June, when bats are rearing their pups (Figure 1), the preferred second story easterly wall does not provide sufficient height (about 9 feet) above a roofline for bats to drop and take flight from a roost.

Figure D-12. Area 1 barn view from the outside and access hole (right)

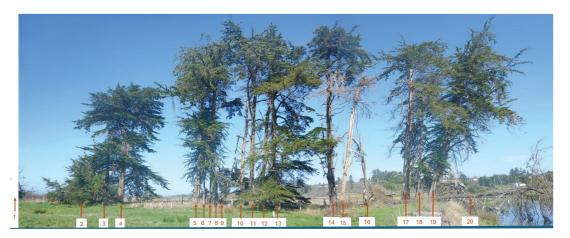
The Monterey cypress stand near Swain Slough consists of 20 trees and is within the zone of greatest morning sun between late May and early June, when bats are rearing their pups (Figure D-1). Thus, this location is an ideal area to incorporate bat habitat enhancements in intact trees to support roosting bats. Some of these trees have peeling bark, which is suitable for roosting bats. The trees support nesting habitat for birds and the broken tops and vertical limbs provide perch sites while foraging in adjacent grasslands and agricultural fields (Figure D-13). Although these features represent ideal habitat conditions for wildlife, they also represent a decline in tree health. An arborist may be able to assess disease susceptibility and existing lifespan of living trees planned for habitat enhancements.

Figure D-13. Area 4 Monterey cypress stand (Trees 1-20).

Results of the tree inventory assessment:

- Tree 1 (down snag, adjacent to barn): Low habitat suitability for nesting birds/roosting bats as existing crevices are shallow and peeled bark is on the underside and would collect water forming undesirable conditions for bats.

- Tree 2 (snag): Moderate habitat suitability for perching birds on a horizontal limb.
- Tree 3 (decadent tree with broken top): Low habitat suitability as this tree has active decay and insect damage and is leaning towards the south-east side of the property, creating shade.

- Trees 11 and 12 (living): Moderate habitat suitability and potential for enhancement by adding bat crevices.
- Tree 13 (decadent tree): Low habitat suitability due to active decay and broken lower limbs, which are shading adjacent planting area.
- Tree 14 (decadent tree): Low habitat suitability with a potential for enhancement by adding bat crevices.
- Tree 15 (snag): Moderate habitat suitability due to peeling bark on easterly-side, which may provide natural bat roosting habitat.
- Tree 16 (snag): Moderate habitat suitability for perching birds on limbs.
- Trees 17 through 19 (living): Moderate habitat suitability for bird nesting.
- 20 (down snag): Low habitat suitability.
