Reference: 022054.400

**Subject: Preliminary Geotechnical Data Report, Redwood Multipurpose Marine Terminal, Samoa, California**

Redwood Marine Multipurpose Terminal  
Preliminary Geotechnical Investigation  
Samoa, California

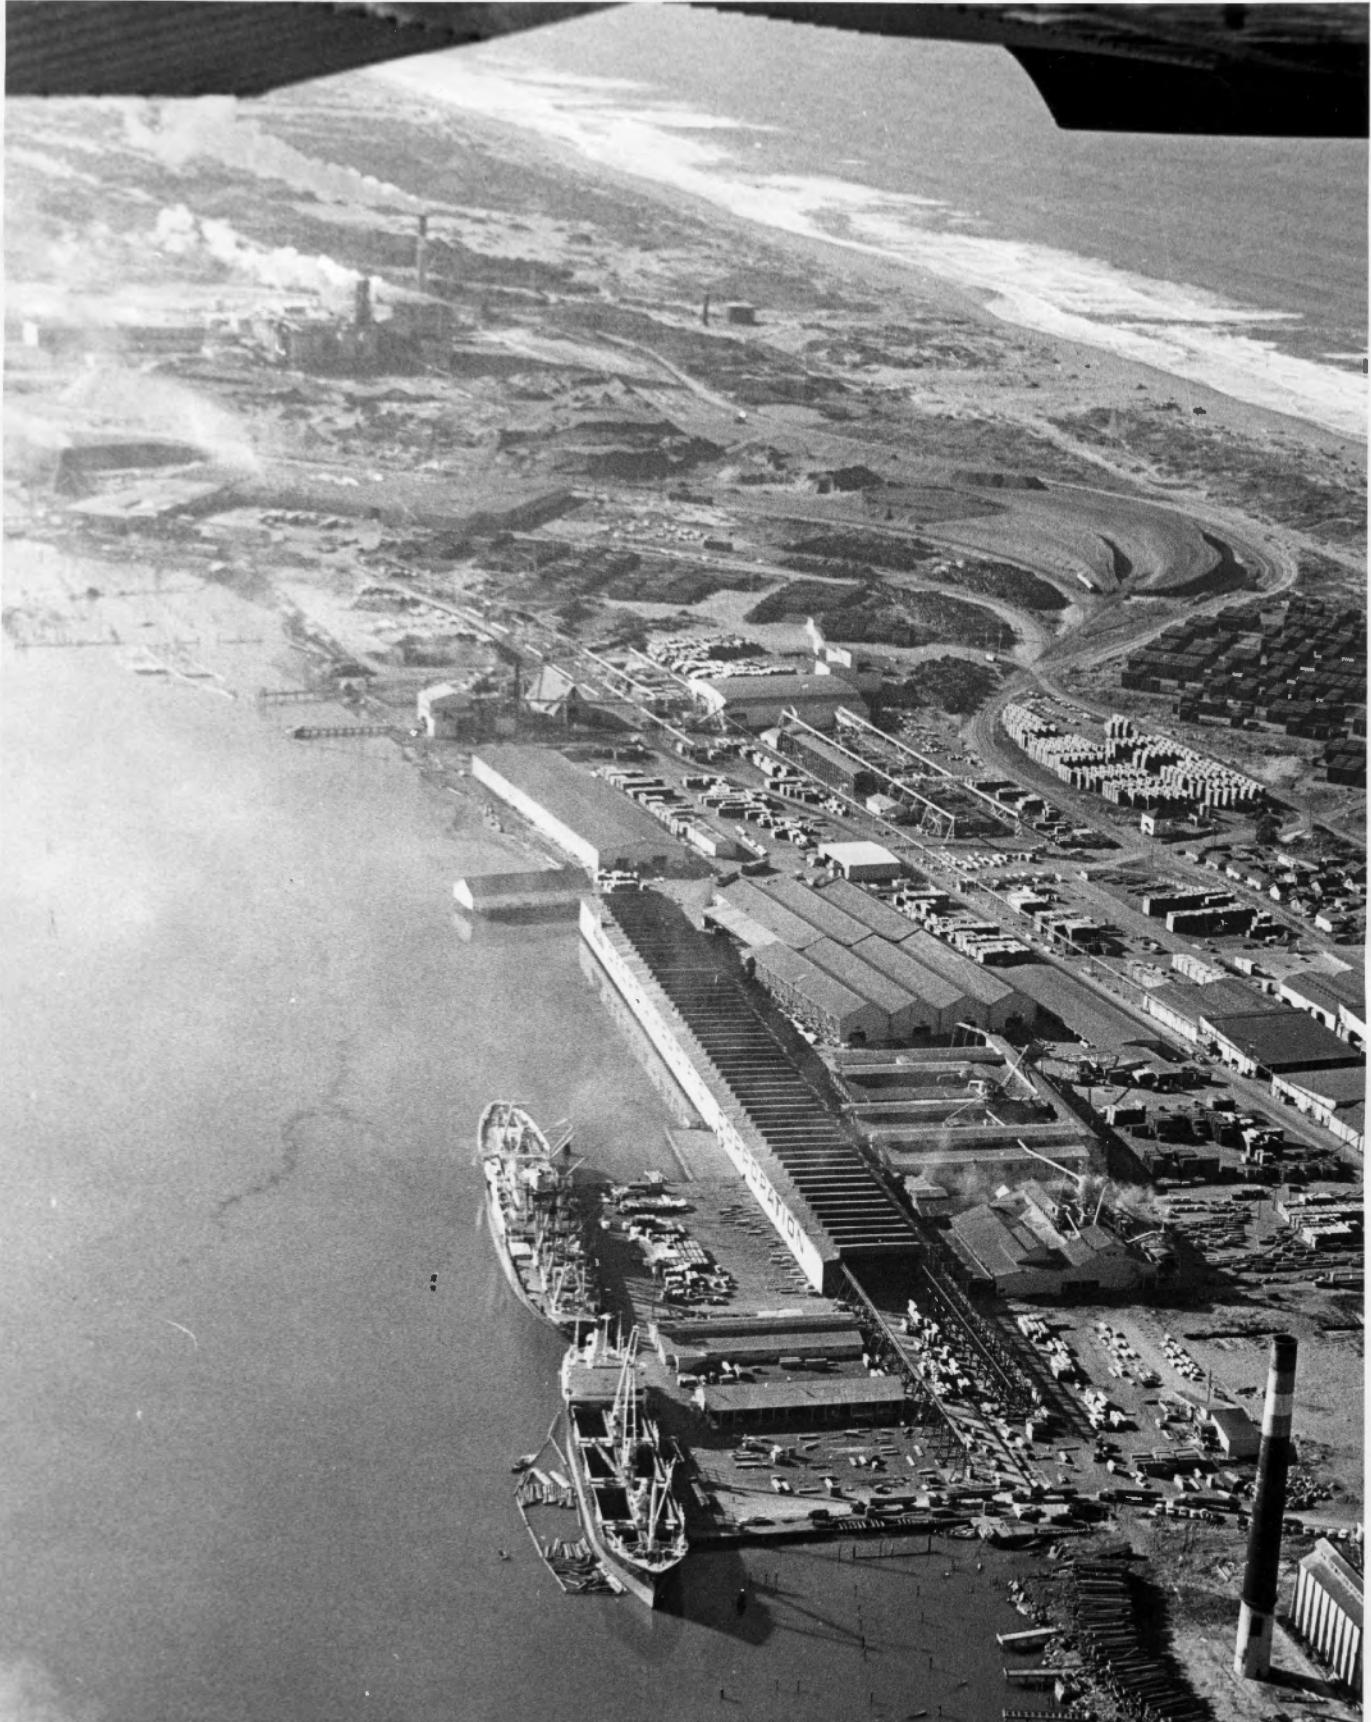
**Figure**  
**3**

**Historic Oblique Aerial Image, Circa late 1950's-1960's**  
**View to South, Source Unknown**  
August 2022 - 022054.400

The RMMT site is located on the Samoa Peninsula, a narrow peninsula that separates Humboldt Bay from the Pacific Ocean (Figure 1). Where undisturbed, the Samoa Peninsula is a dune-covered surface; subsurface investigation in upland areas of the Peninsula in the site vicinity indicate 15 to 20 feet of loose, modern dune sand overlying older (Holocene and Pleistocene age) sediments. The subject site, however, has a long industrial history of timber production that has resulted in significant grading, infilling, and expansion over previous intertidal lands along the Humboldt Bay shoreline. Figure 2 shows an 1894 Humboldt Bay survey and depicts the historic encroachment over pre-existing intertidal lands. Figure 3 is a late 1950's- or early 1960's-era aerial photograph of industrial development on the Samoa Peninsula.

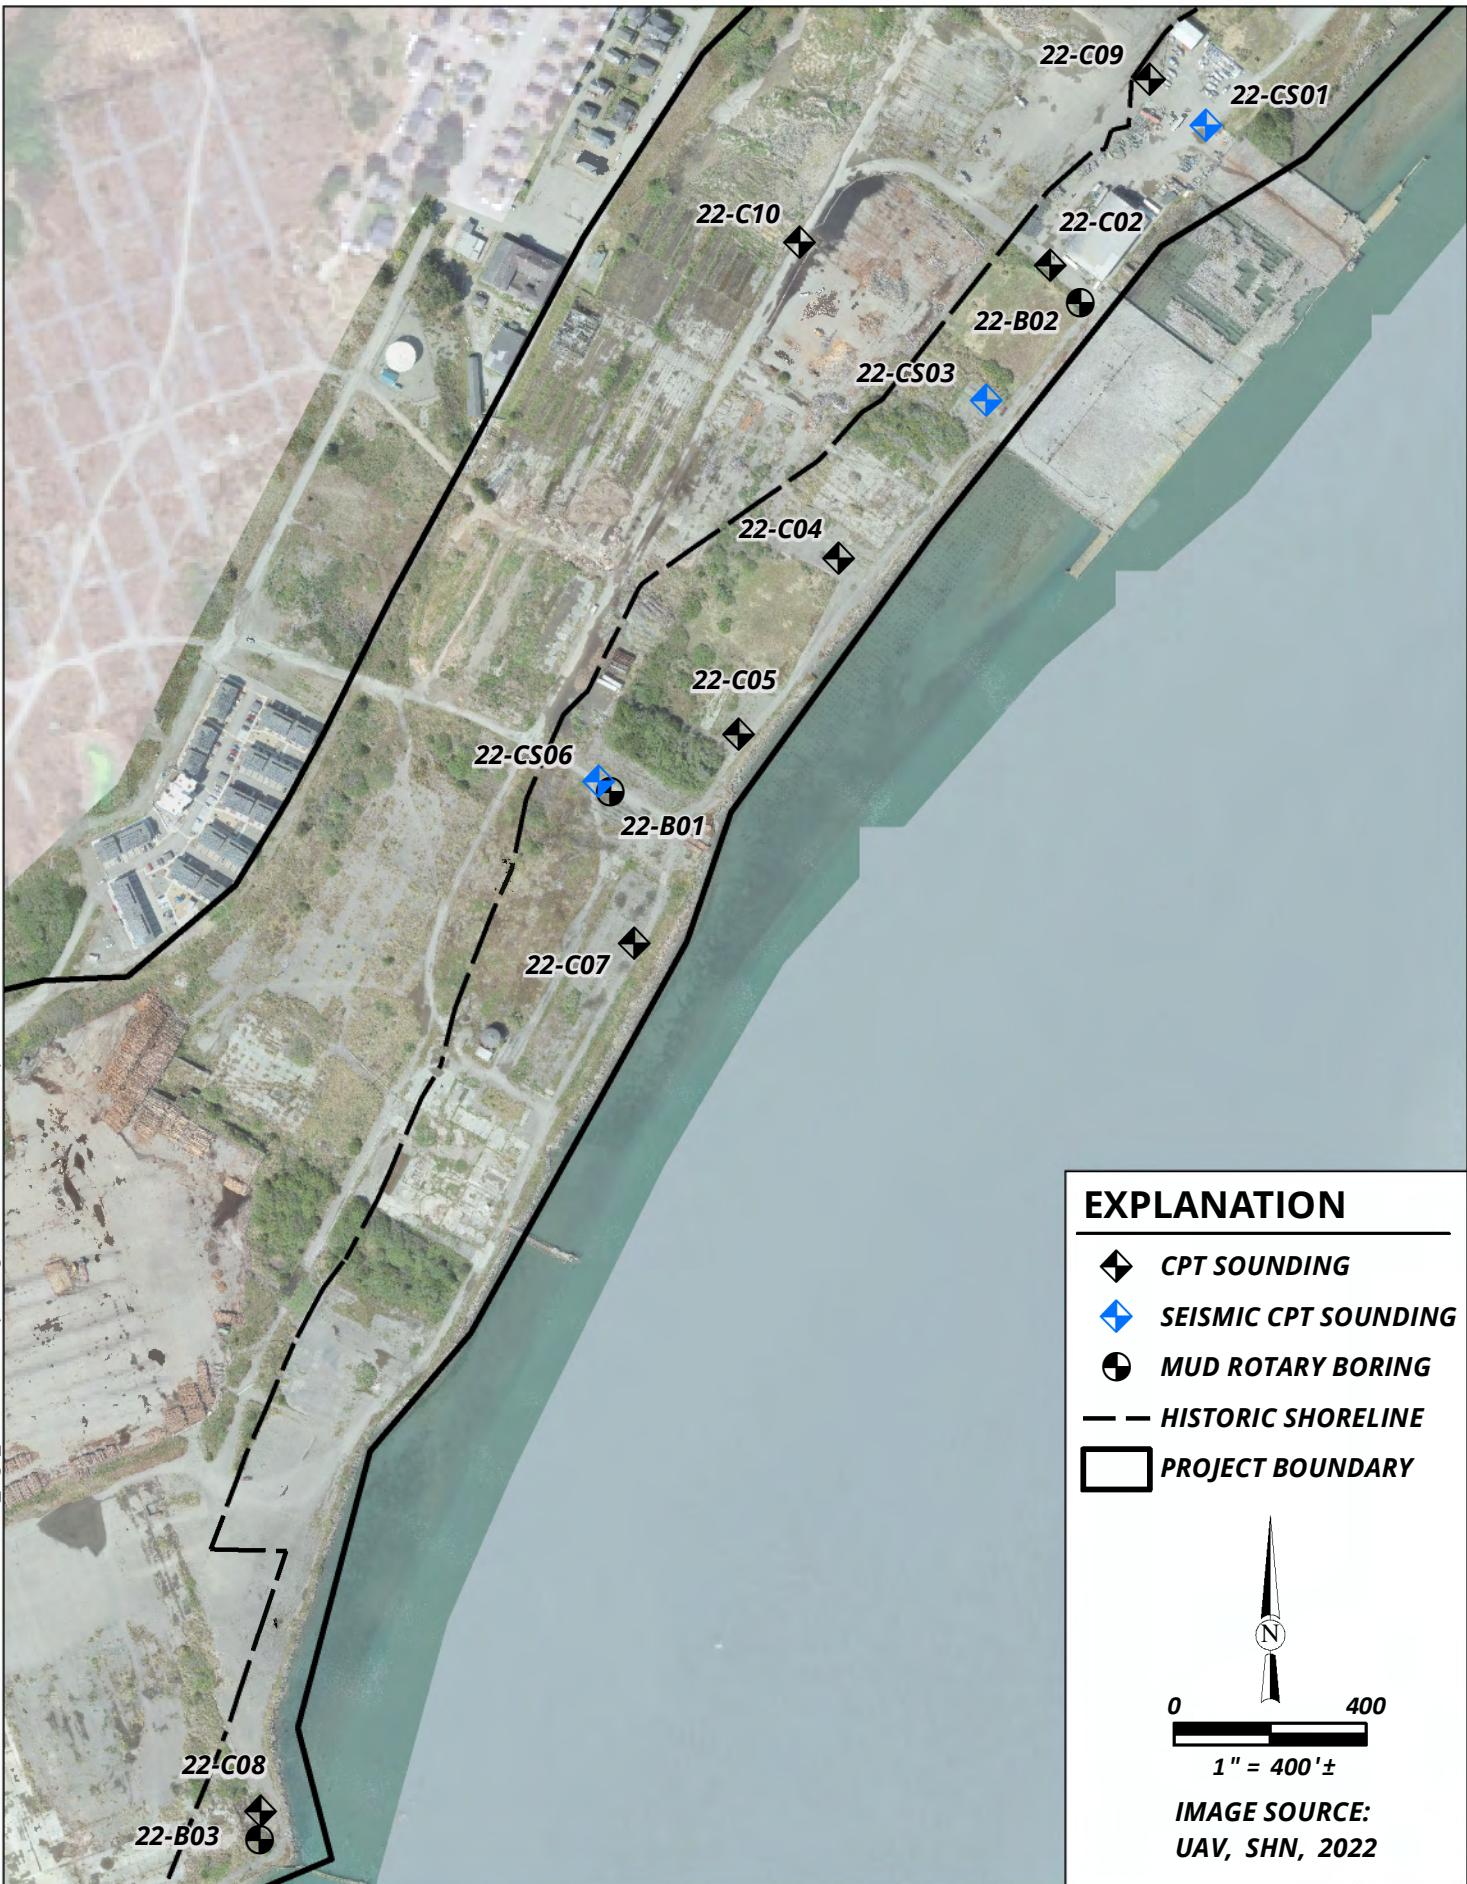
CPT and Mud Rotary Boring Locations

The preliminary geotechnical field investigation consisted of 10 cone penetration tests (CPTs) and three machine borings. The investigation sites are shown on Figure 4; they are also shown on Figure 2 to show their location relative to the historic shoreline (note that all but CPT 22-C10 occurred within filled areas bay-ward of the historic shoreline). The CPTs were completed first, between April 19 and 22, 2022, followed by the machine borings, which occurred between May 31 and June 3, 2022. Based on conceptual development plans, the preliminary geotechnical field exploration was focused in the central and northern parts of the site; a single exploration site occurs at the southern end of the site. Exploration locations were developed collaboratively with the RMMT geotechnical team and staffed in the field by SHN geologists.

In general, the results of the CPTs and machine borings were consistent, such that where borings were advanced adjacent to a previous CPT probe site, the observed soil type was consistent with the interpreted soil behavior type. Soil penetration resistance was typically low in the upper few tens of feet, becoming increasingly dense with depth, which is consistent with the geologic interpretation of the distribution and ages of subsurface materials.
