State Aquatic Resources Delineation

Humboldt Bay Offshore Wind Heavy Lift
Marine Terminal

New Navy Base Road
Eureka, California

January 2024

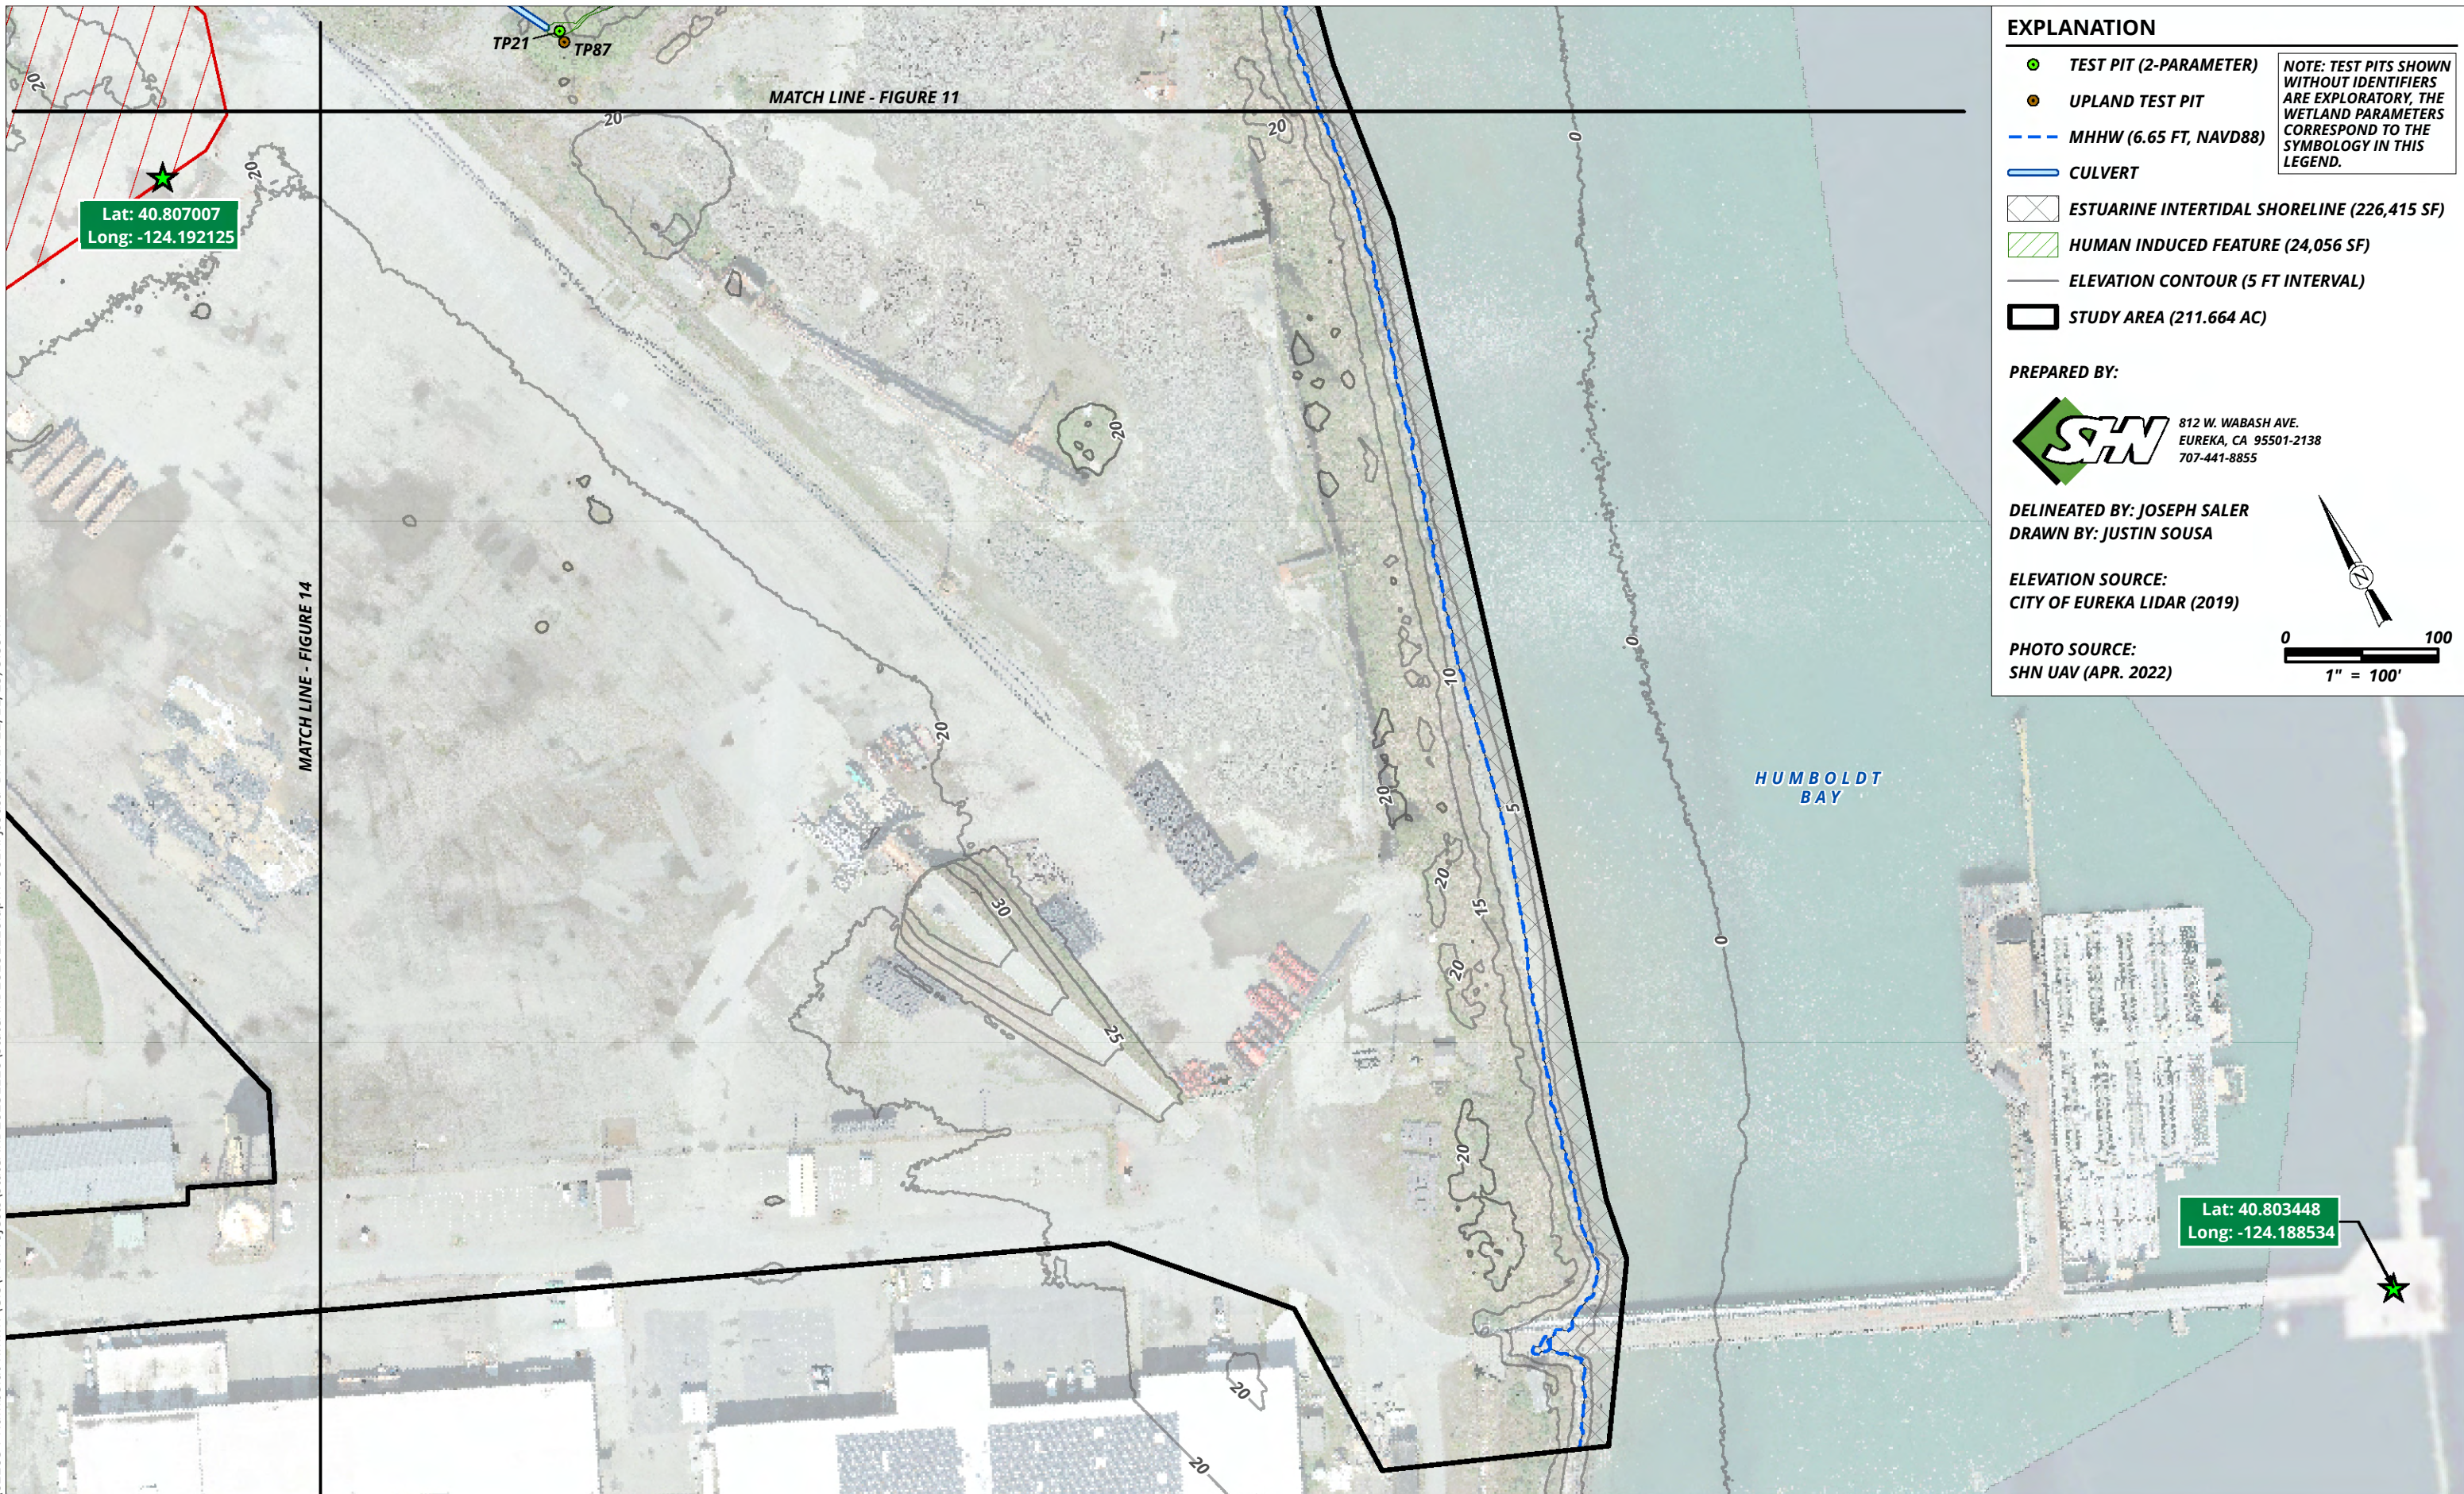
Figure
12

- TEST PIT (2-PARAMETER)
- UPLAND TEST PIT
- MHHW (6.65 FT, NAVD88)
- CULVERT
- ESTUARINE INTERTIDAL SHORELINE (226,415 SF)
- HUMAN INDUCED FEATURE (24,056 SF)
- ELEVATION CONTOUR (5 FT INTERVAL)
- STUDY AREA (211.664 AC)

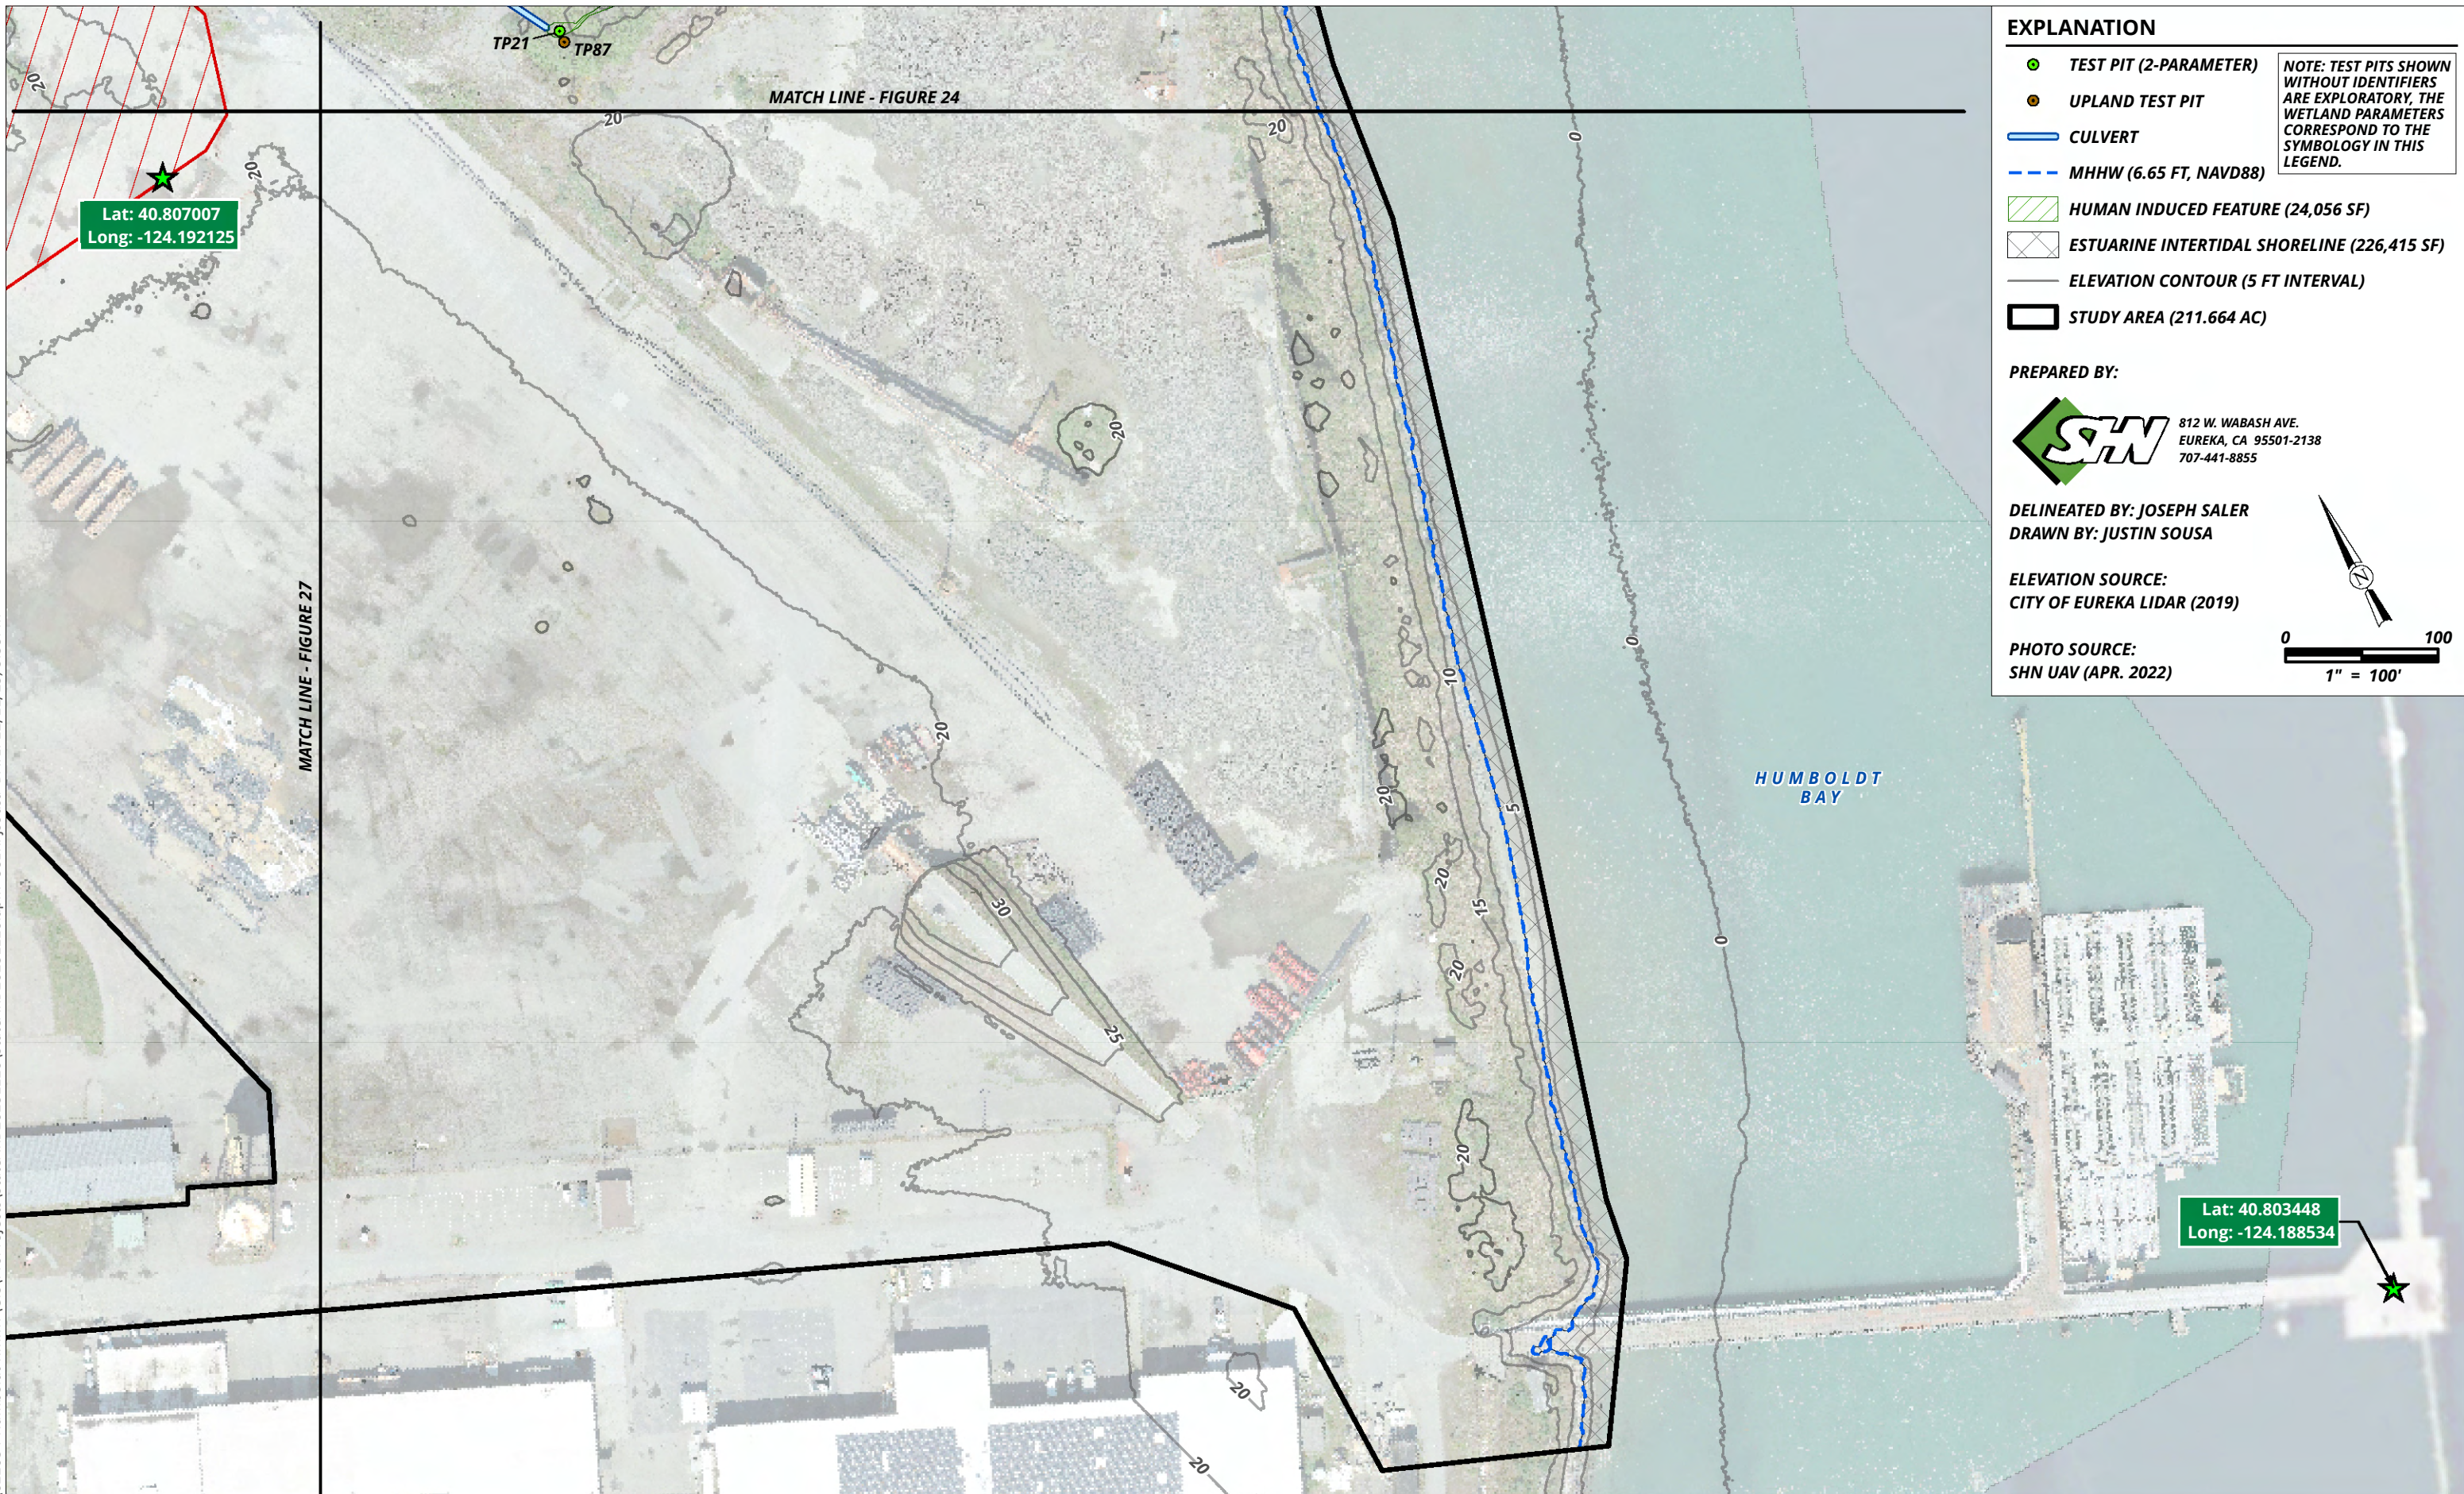
- TEST PIT (2-PARAMETER)
- UPLAND TEST PIT
- CULVERT
- MHHW (6.65 FT, NAVD88)
- HUMAN INDUCED FEATURE (24,056 SF)
- ESTUARINE INTERTIDAL SHORELINE (226,415 SF)
- ELEVATION CONTOUR (5 FT INTERVAL)
- STUDY AREA (211.664 AC)

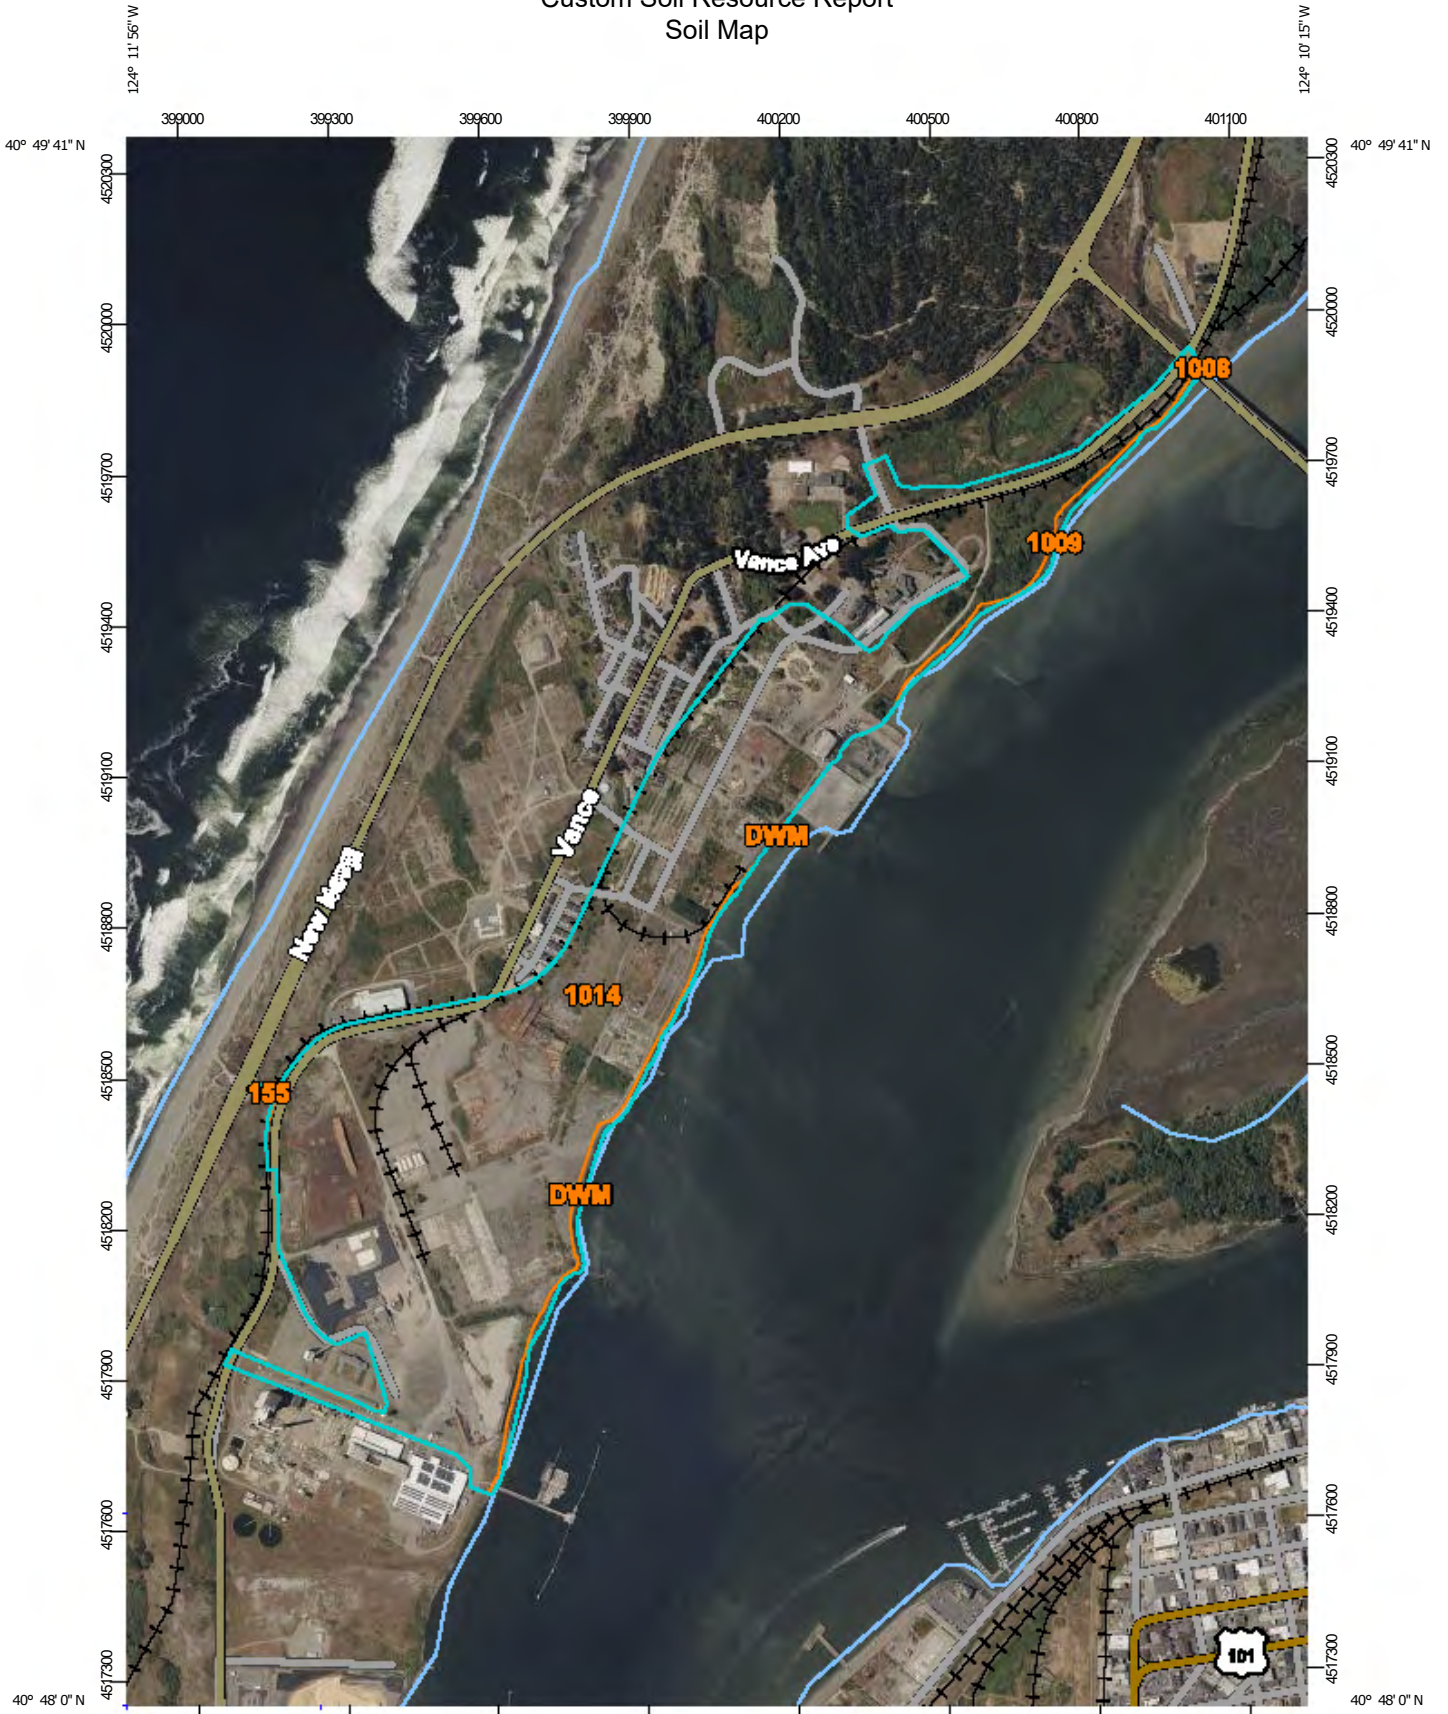
Custom Soil Resource Report Soil Map

The soil map section includes the soil map for the defined area of interest, a list of soil map units on the map and extent of each map unit, and cartographic symbols displayed on the map. Also presented are various metadata about data used to produce the map, and a description of each soil map unit.

Map Scale: 1:15,200 if printed on A portrait (8.5" x 11") sheet.

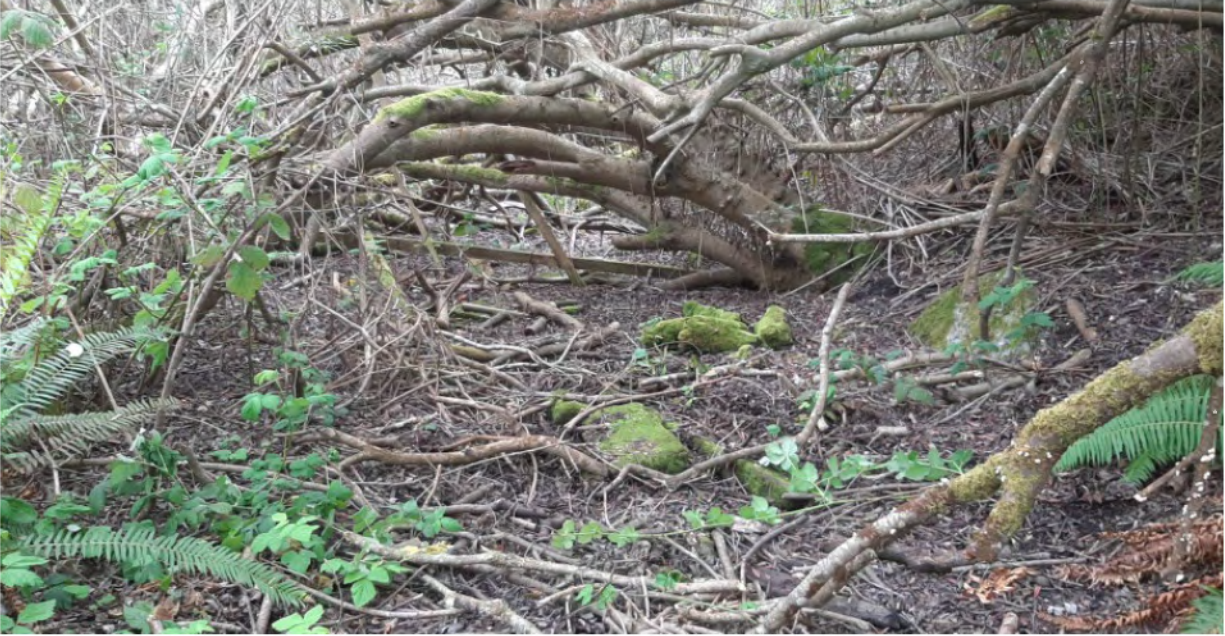
Photograph 1: An example of a Palustrine Forested Wetland- Wetland 05, located near TP31. Photograph taken on May 5, 2022.

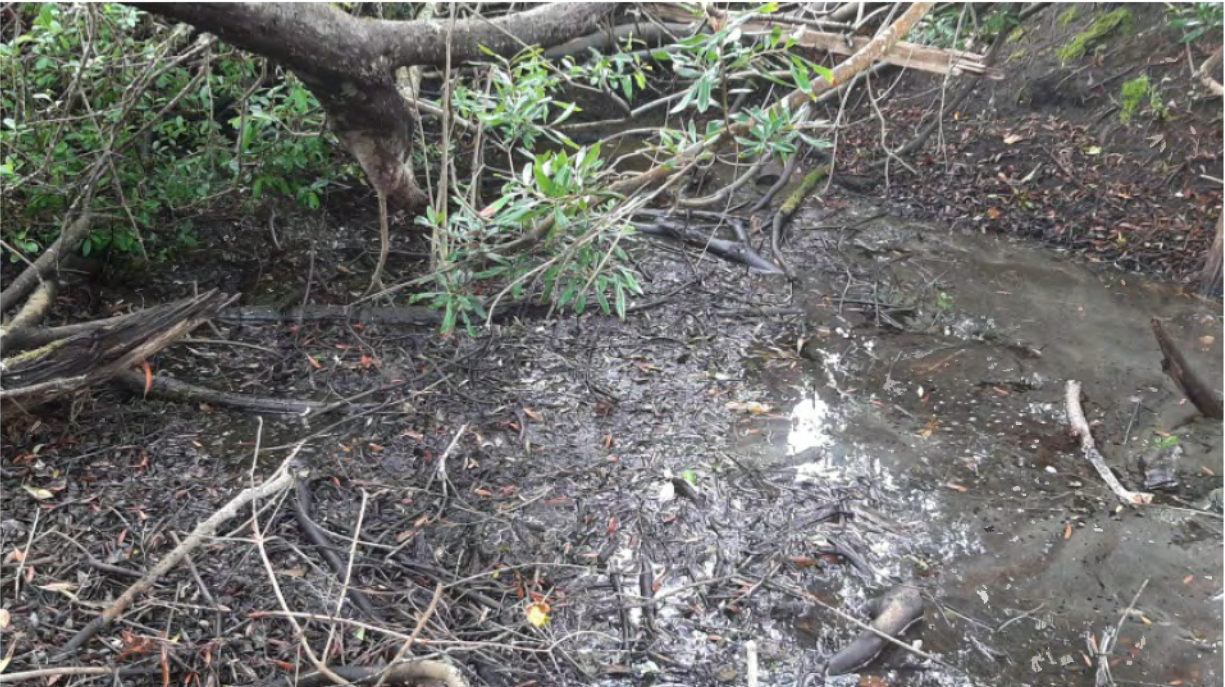
Photograph 2: An example of a Palustrine Forested Wetland- Wetland 06, located near TP37. Photograph taken on May 5, 2022.

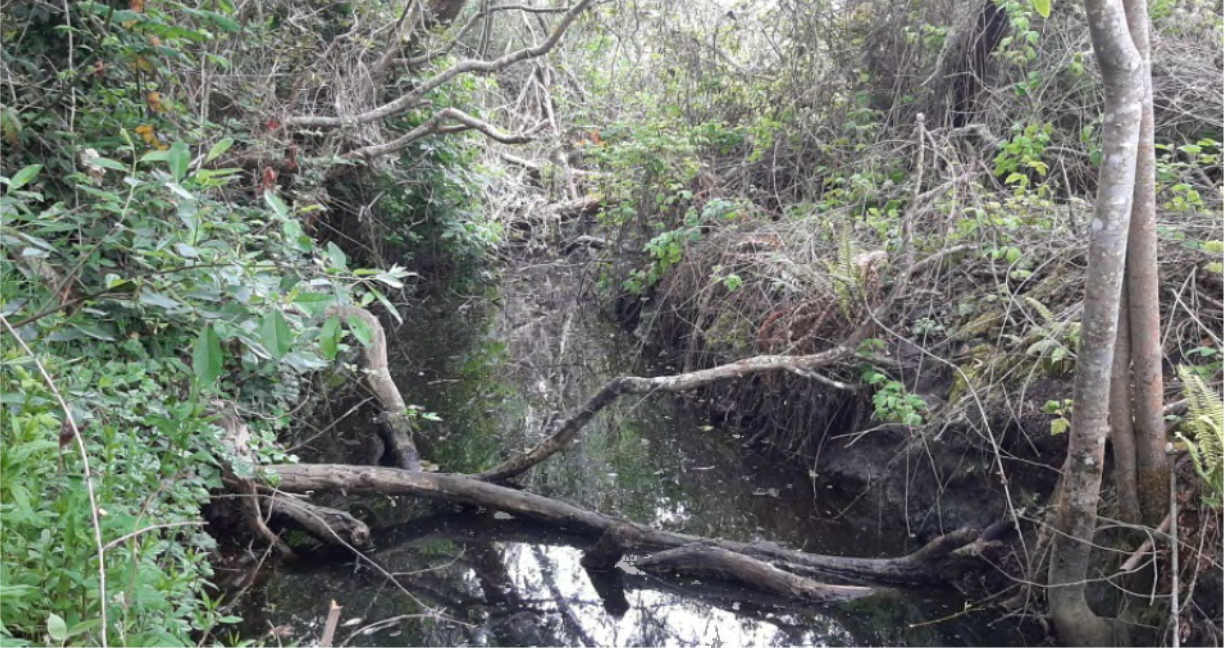
Photograph 3: An example of a Palustrine Forested Wetland- Wetland 09, located near TP43. Photograph taken on May 12, 2022.

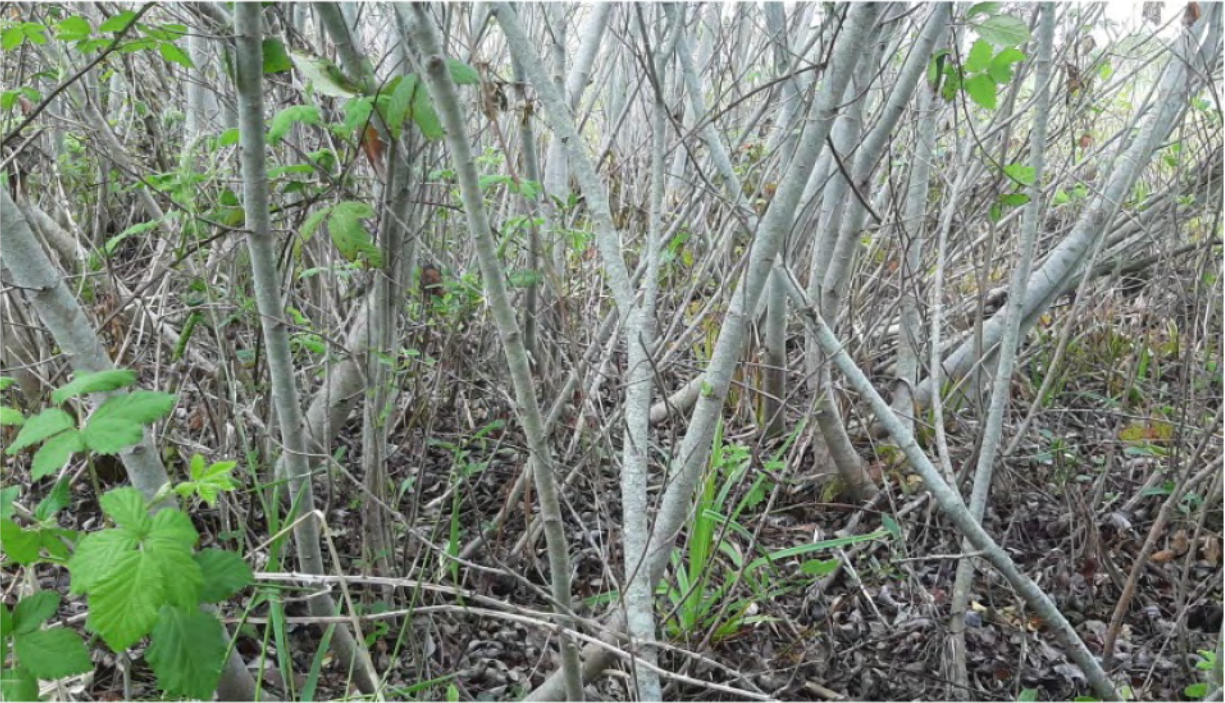
Photograph 4: An example of a Palustrine Scrub-Shrub Wetland- Wetland 07, located near TP39. Photograph taken May 5, 2022.

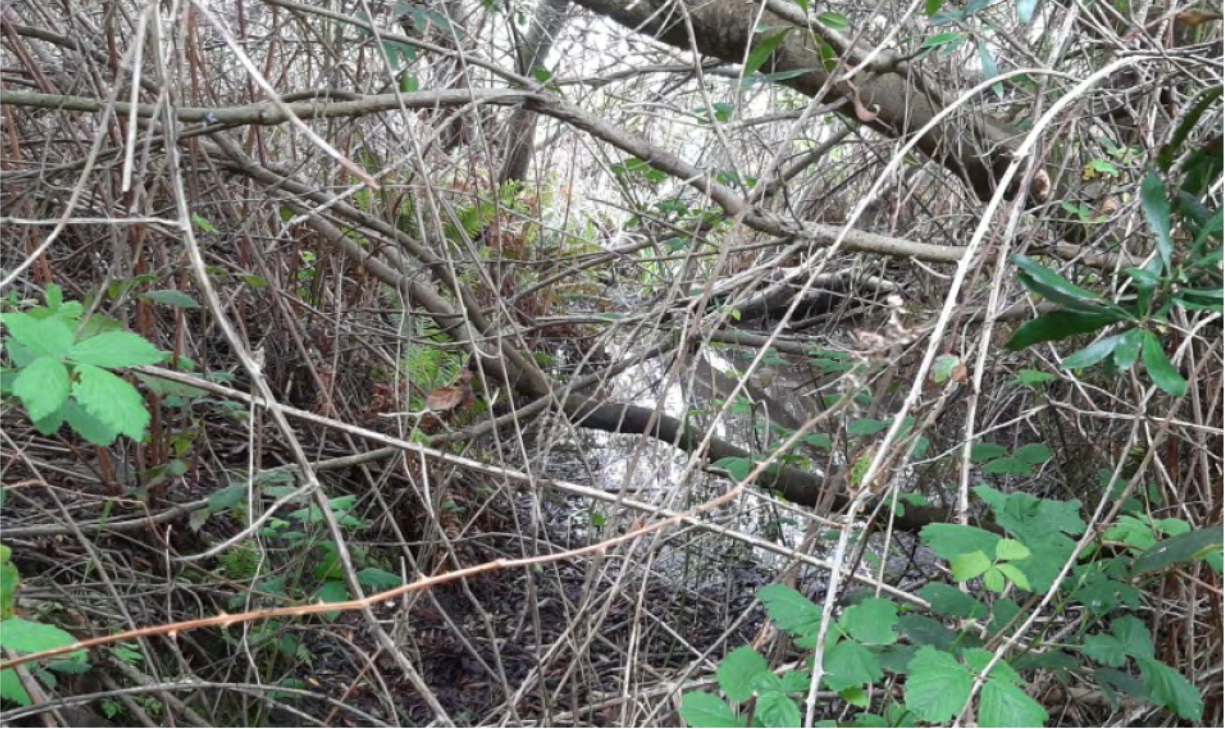
Photograph 5: An example of a Palustrine Scrub-Shrub Wetland- Wetland 08, located near TP41. Photograph taken May 5, 2022.

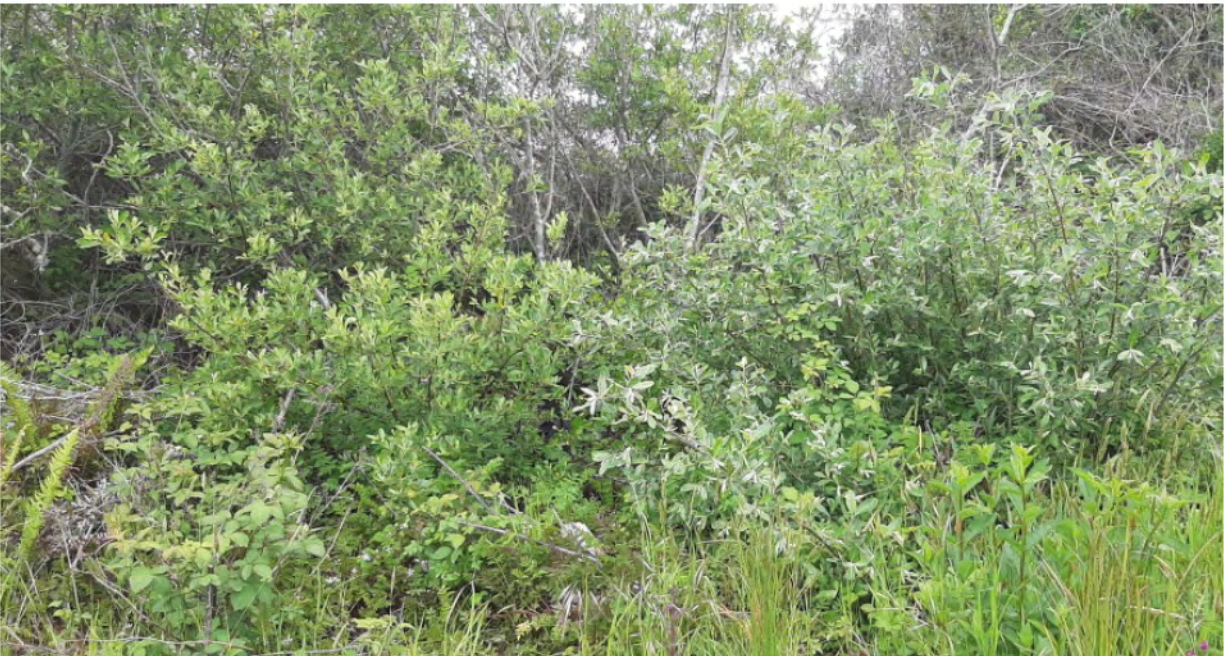
Photograph 6: An example of a Palustrine Scrub-Shrub Wetland- Wetland 11, located near TP45. Photograph taken May 12, 2022.

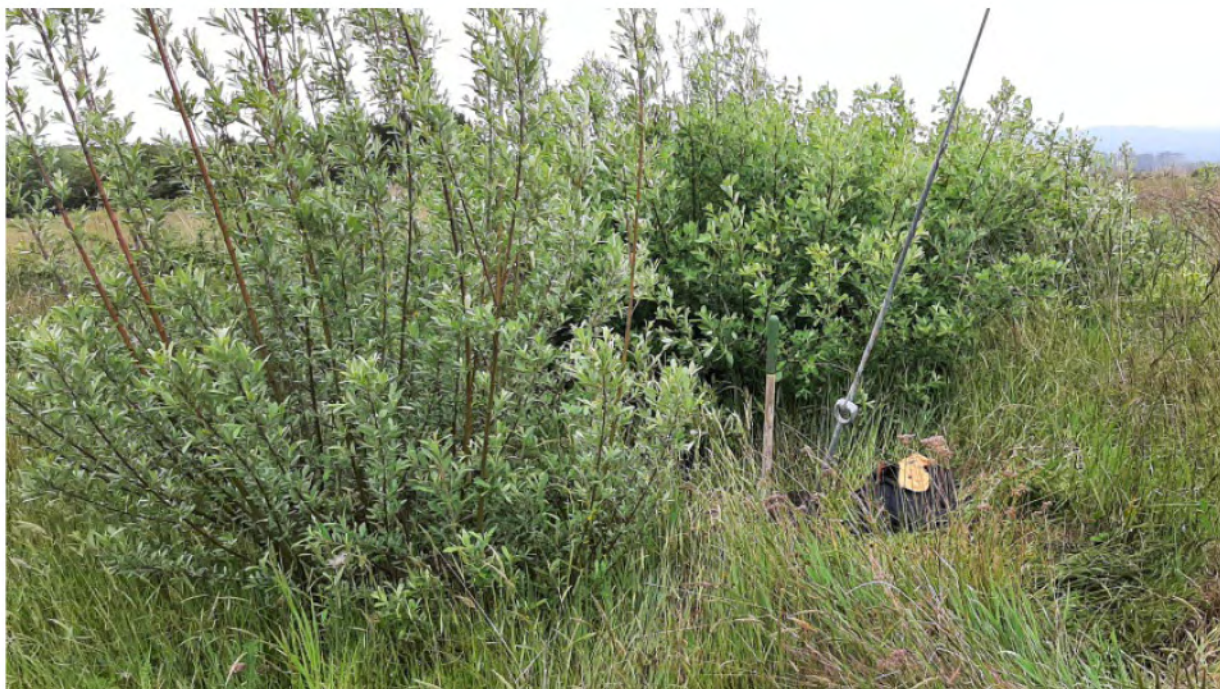
Photograph 7: An example of a Palustrine Scrub-Shrub Wetland- Wetland 14, located near TP53. Photograph taken May 12, 2022.

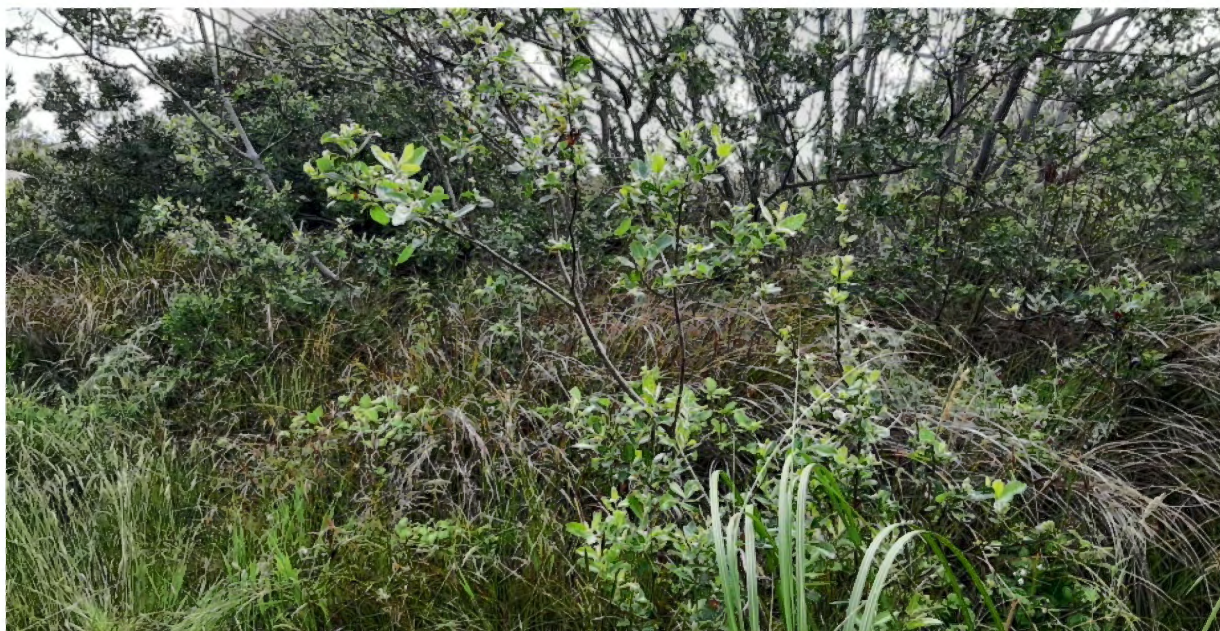
Photograph 8: An example of a Palustrine Scrub-Shrub Wetland- Wetland 21, located near TP78. Photograph taken May 19, 2022.

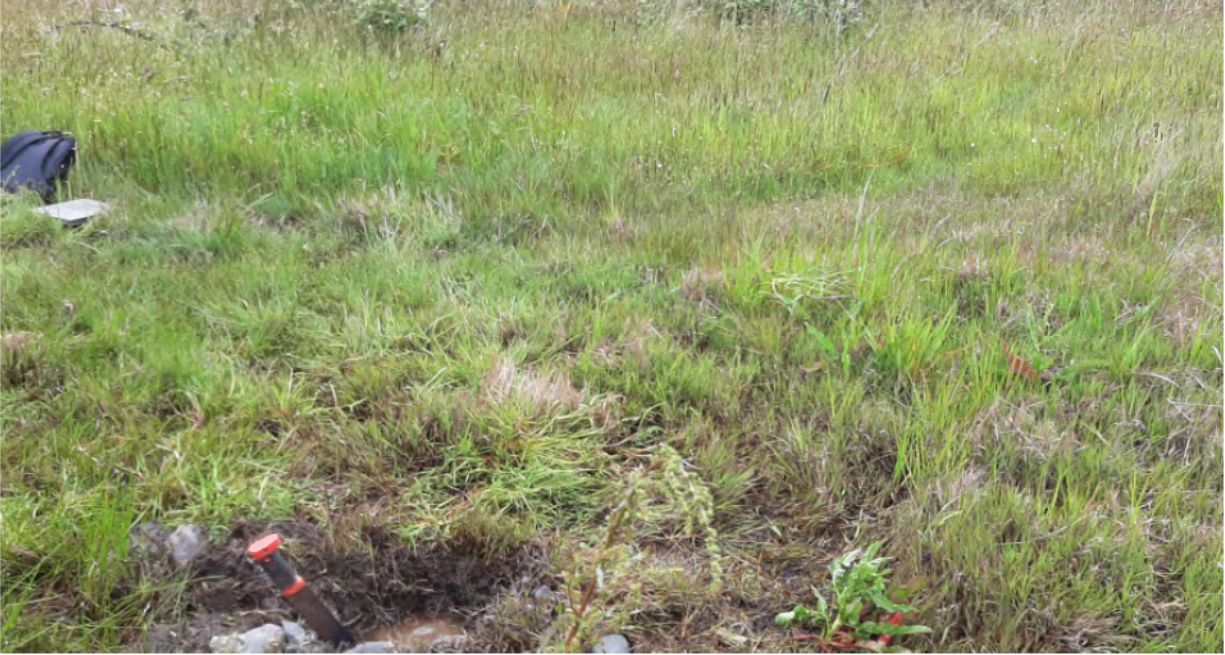
Photograph 9: An example of a Palustrine Emergent Wetland- Wetland 12, located near TP57. Photograph taken May 13, 2022.

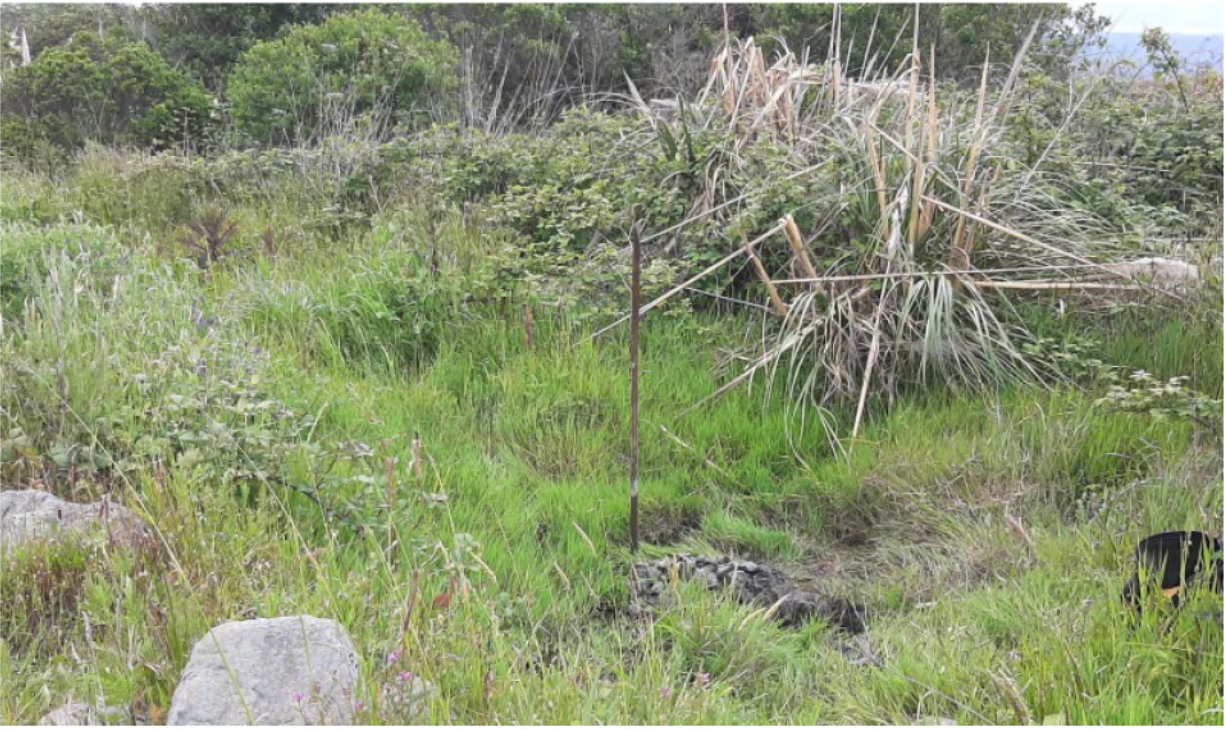
Photograph 10: An example of a Palustrine Emergent Wetland- Wetland 13, located near TP47. Photograph taken May 12, 2022.

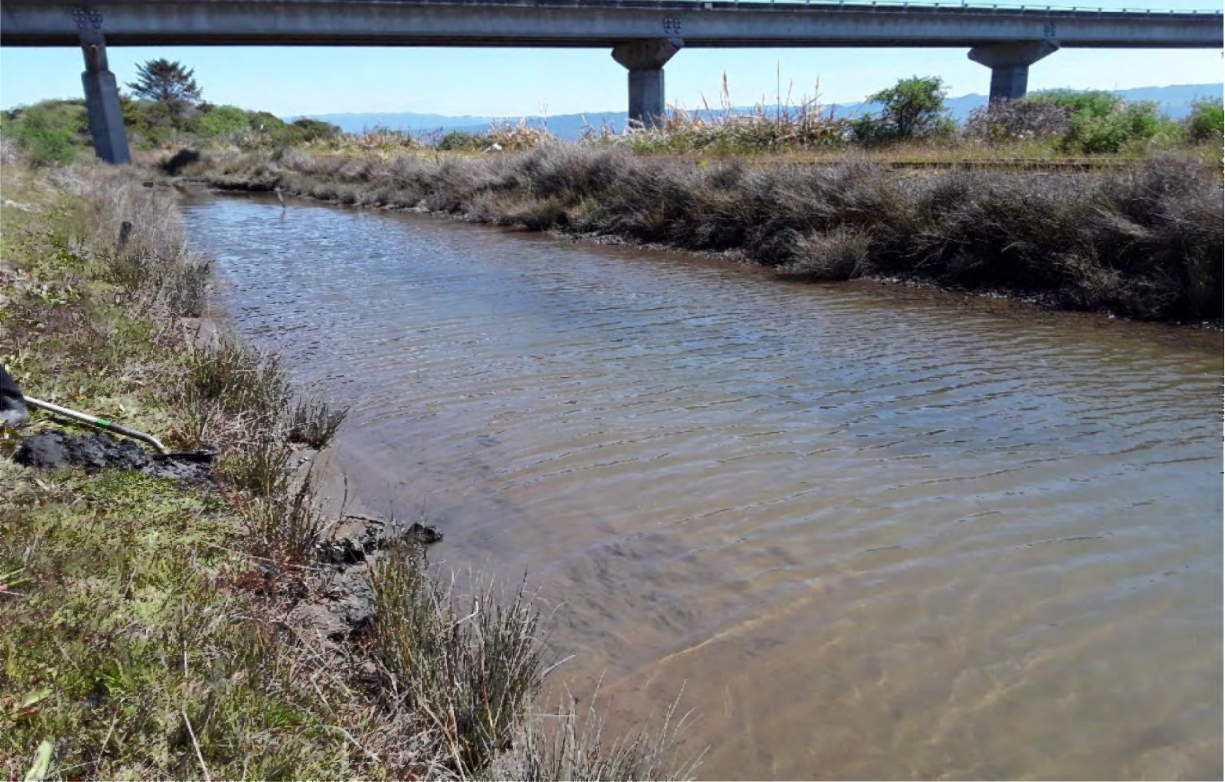
Photograph 11: An example of an Estuarine Wetland- Wetland 03, located near TP23. Photograph taken April 29, 2022.

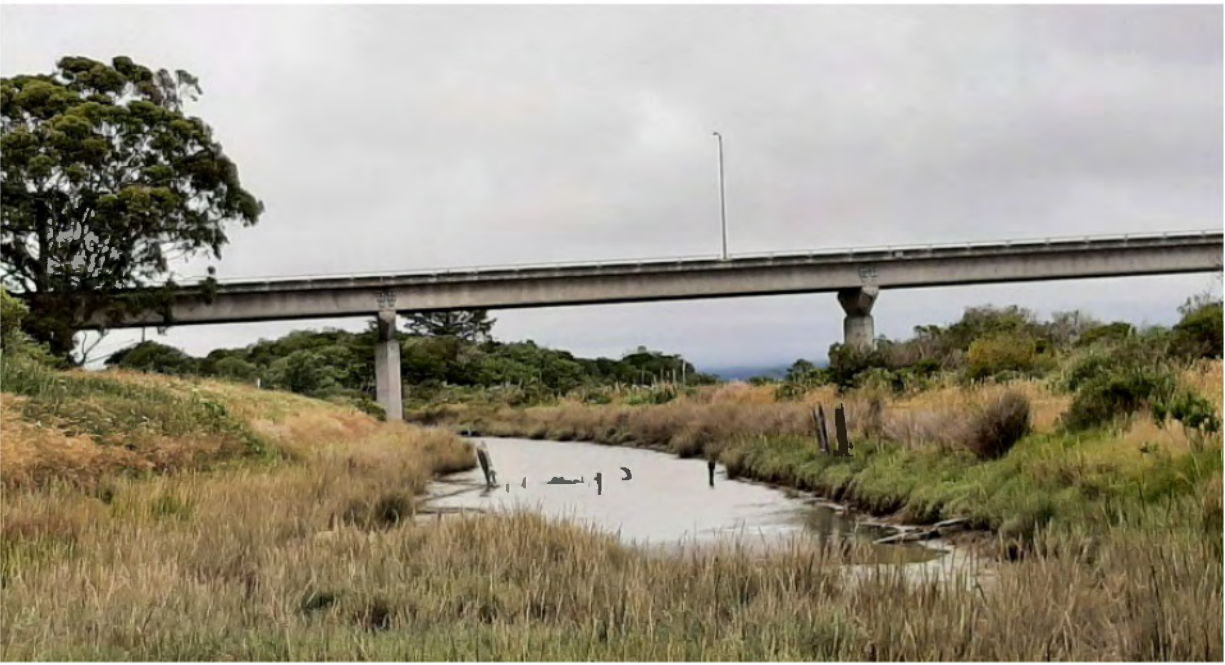
Photograph 12: An example of an Estuarine Wetland- Wetland 03, located near TP23. Photograph taken July 6, 2022.

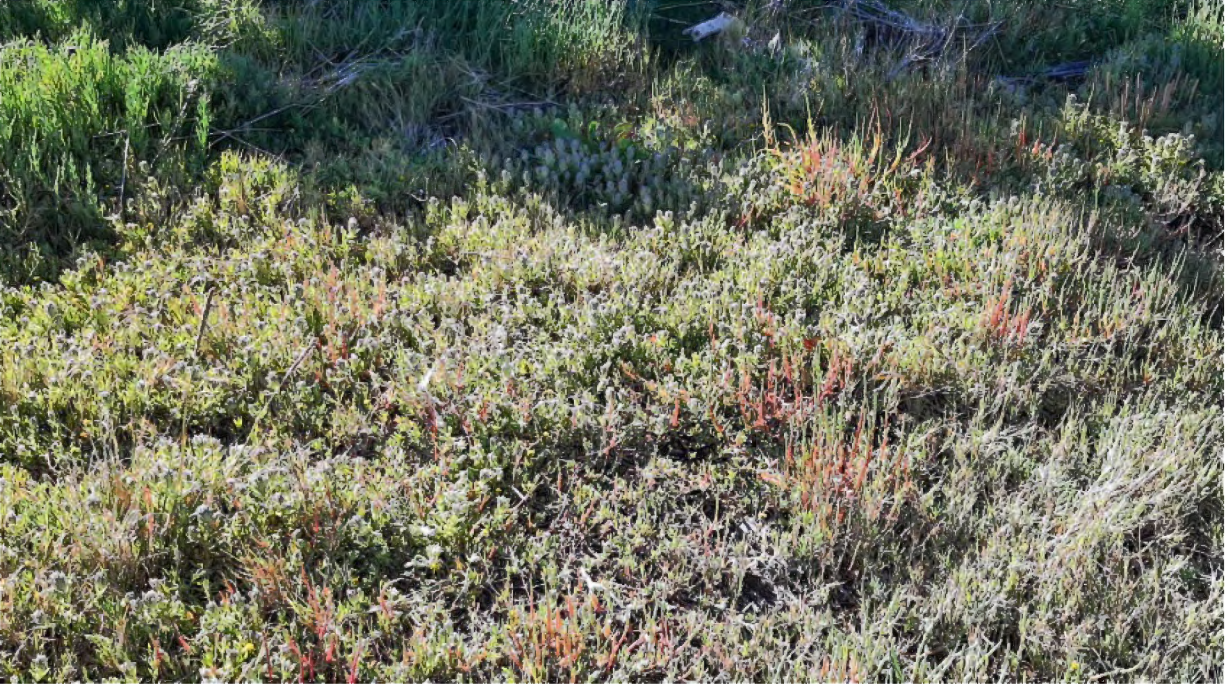
Photograph 13: An example of an Estuarine Wetland- Wetland 01, with Pt. Reyes Bird's Beak in the foreground. Photograph taken July 7, 2022.

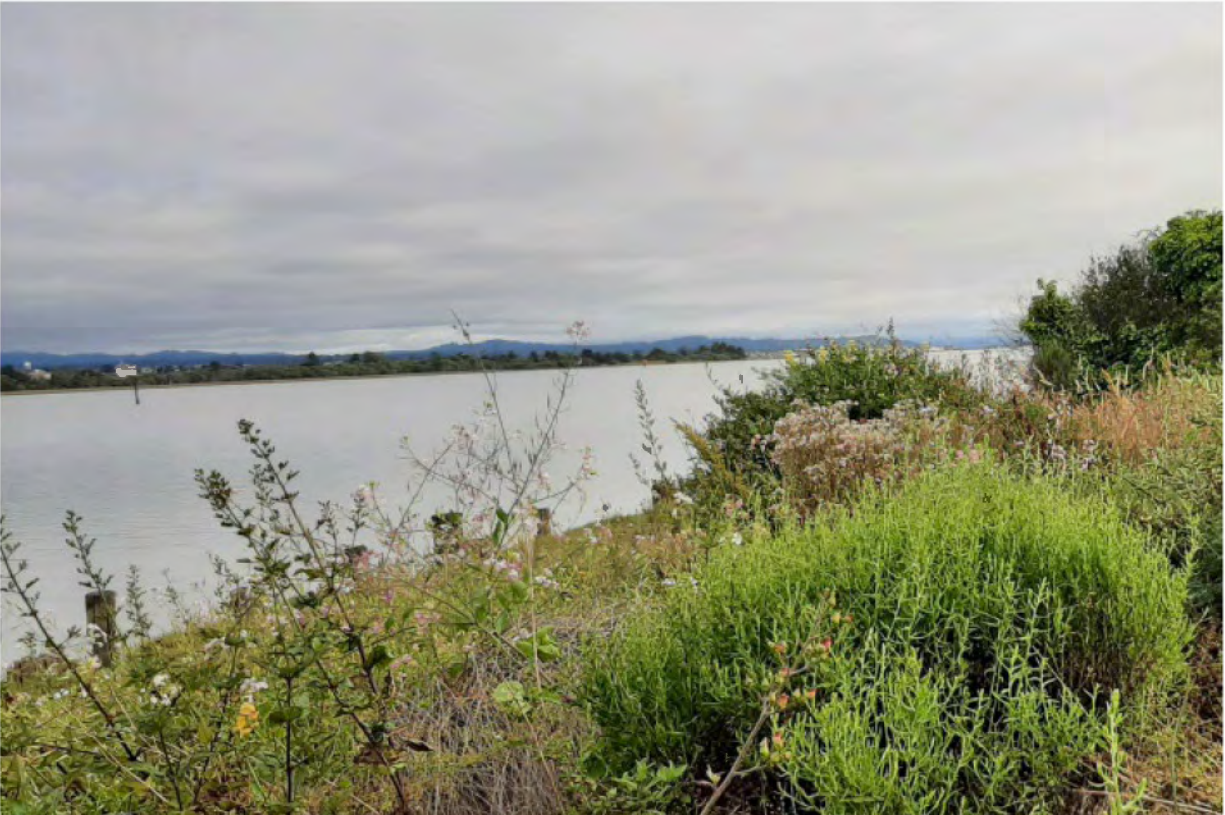
Photograph 14: An example of an Estuarine Wetland- Wetland 01, located above the MHHW in the northern portion of the study area. Photograph taken July 6, 2022.
