State Aquatic Resources Delineation

Humboldt Bay Offshore Wind Heavy Lift
Marine Terminal

New Navy Base Road
Eureka, California

January 2024

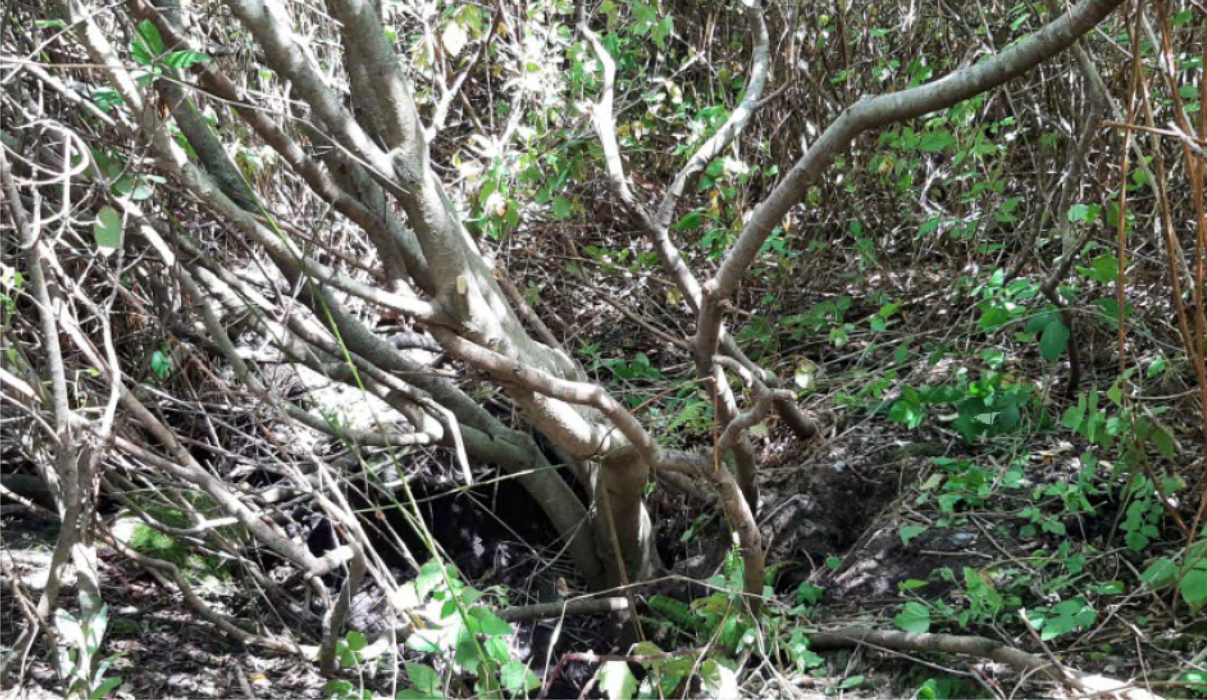
Photograph 15: An example of an Estuarine Wetland- Wetland 23, located near TP81. Photograph taken May 19, 2022.

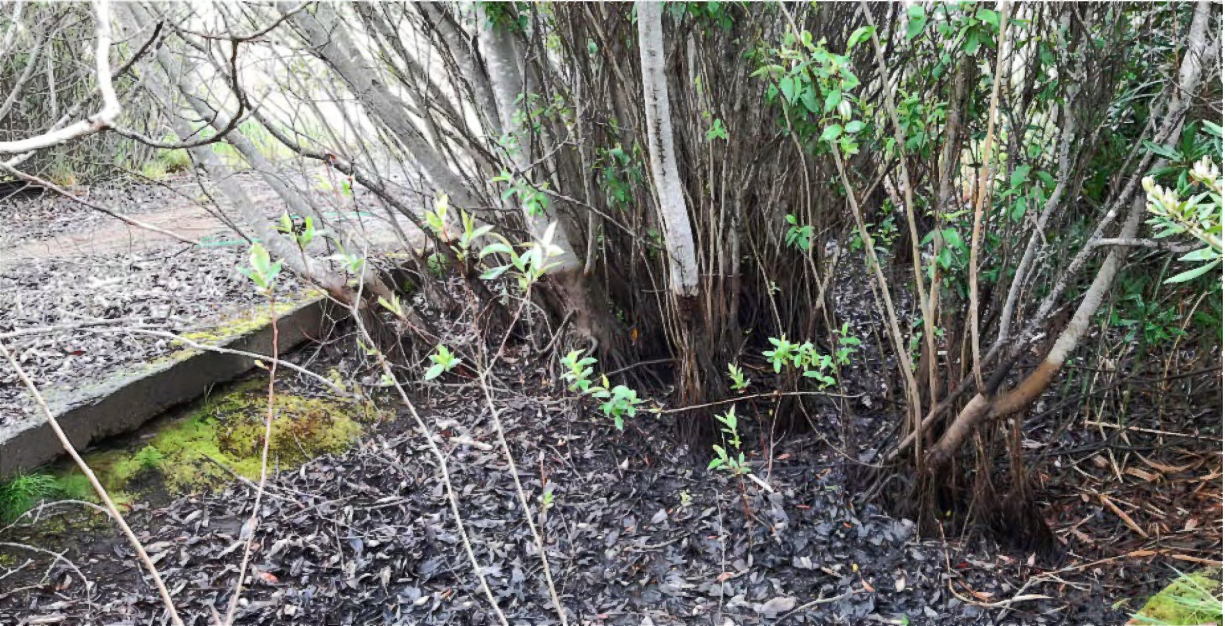
Photograph 16: Artificial aquatic feature at TP64 and TP65- an abandoned concrete vault and foundation that has developed into a three-parameter wetland.

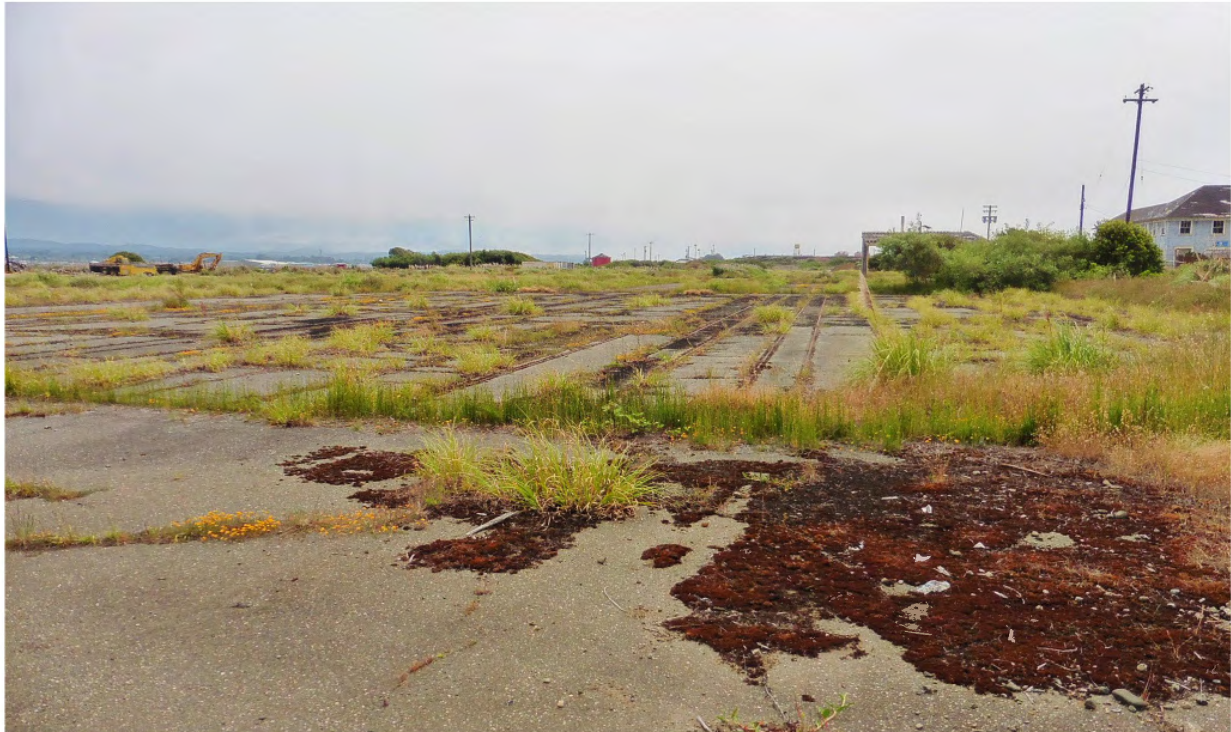
Photograph 17: Artificial aquatic feature- abandoned drying shed foundations beginning to incorporate three parameters. Photograph taken May 28, 2020.

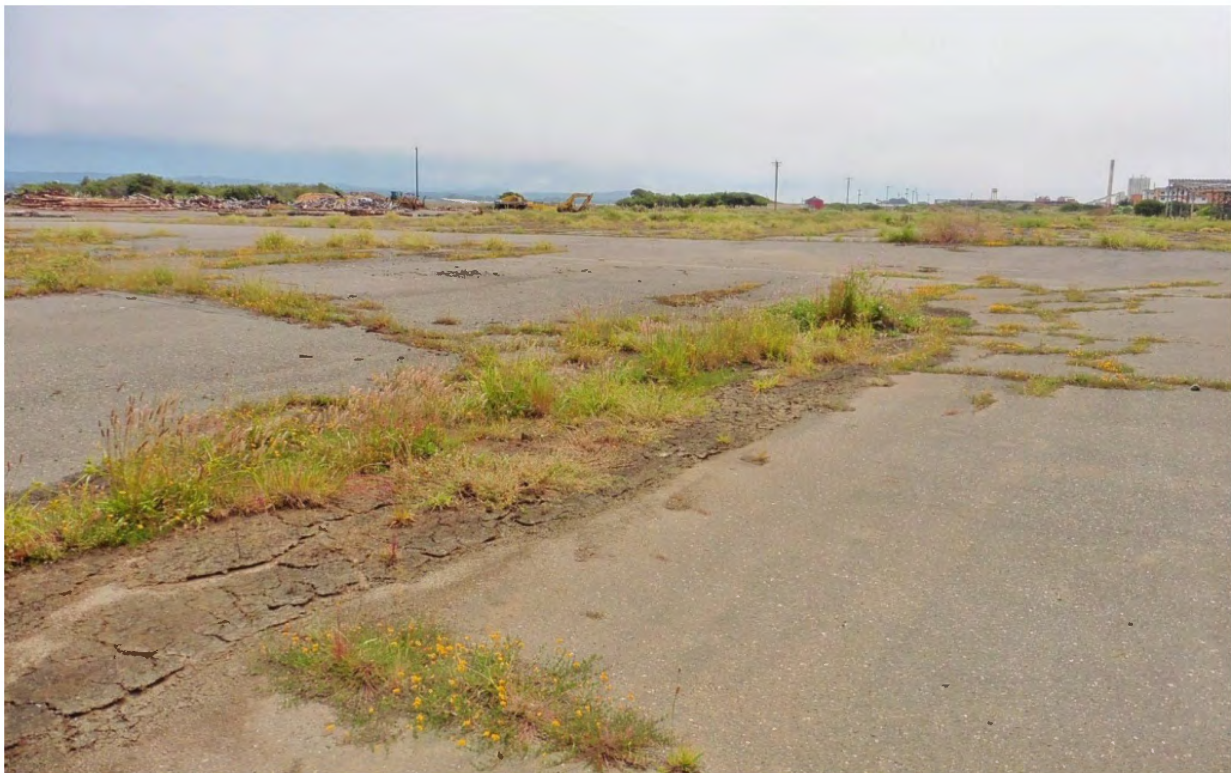
Photograph 18: Artificial aquatic feature- abandoned drying shed foundations beginning to incorporate three parameters. Photograph taken May 28, 2020.

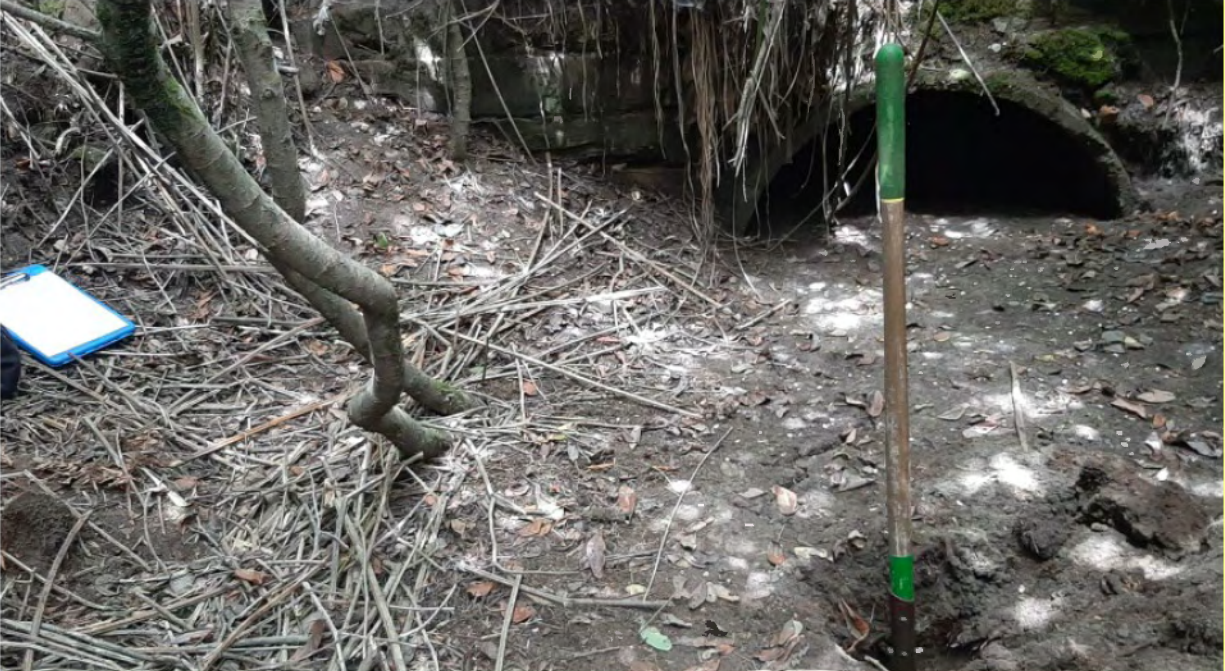
Photograph 19: Artificial aquatic feature- stormwater collection system at TP86. Culvert drains impervious surfaces formerly used for chip storage. Photograph taken on June 28, 2022.

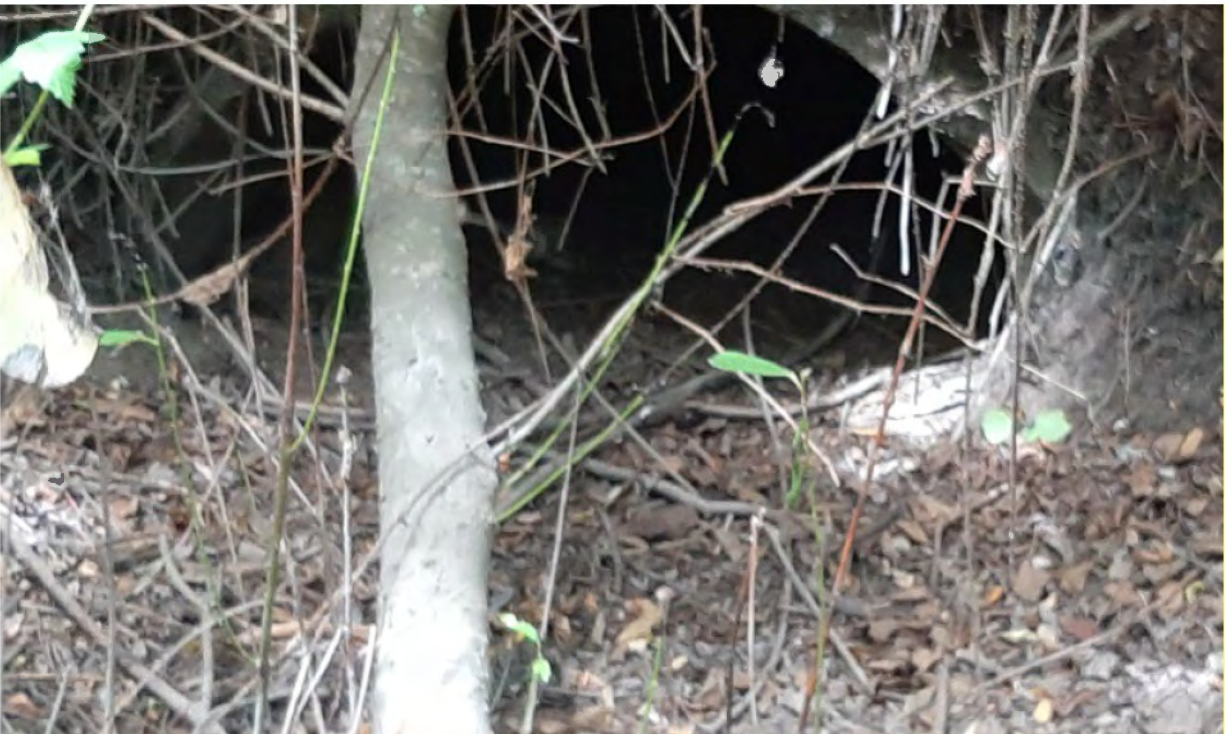
Photograph 20: Artificial aquatic feature- stormwater collection system near TP87. One of several stormwater culverts that drain into this feature. Photograph taken on June 29, 2022.

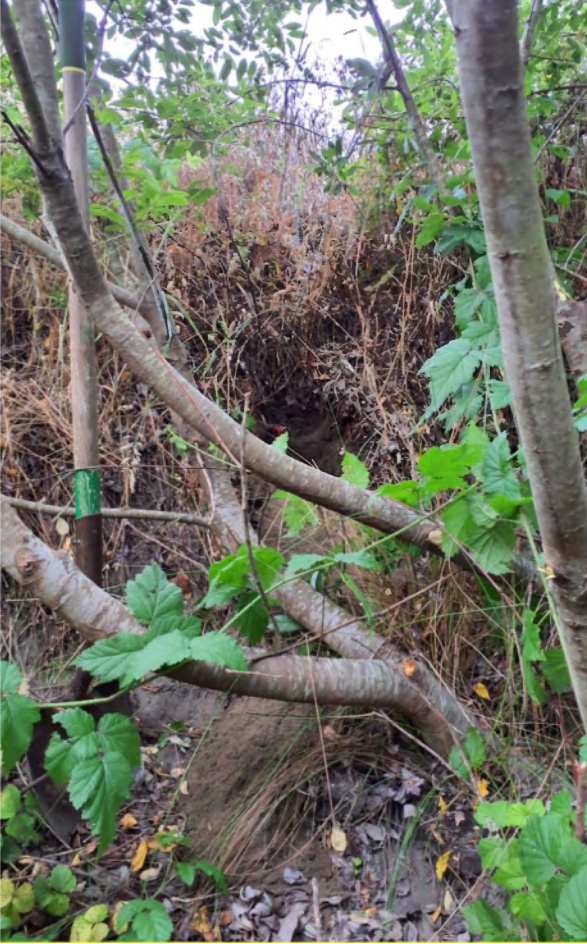
Photograph 21: Artificial aquatic feature-stormwater collection system near TP88. Photograph taken on August 2, 2022.

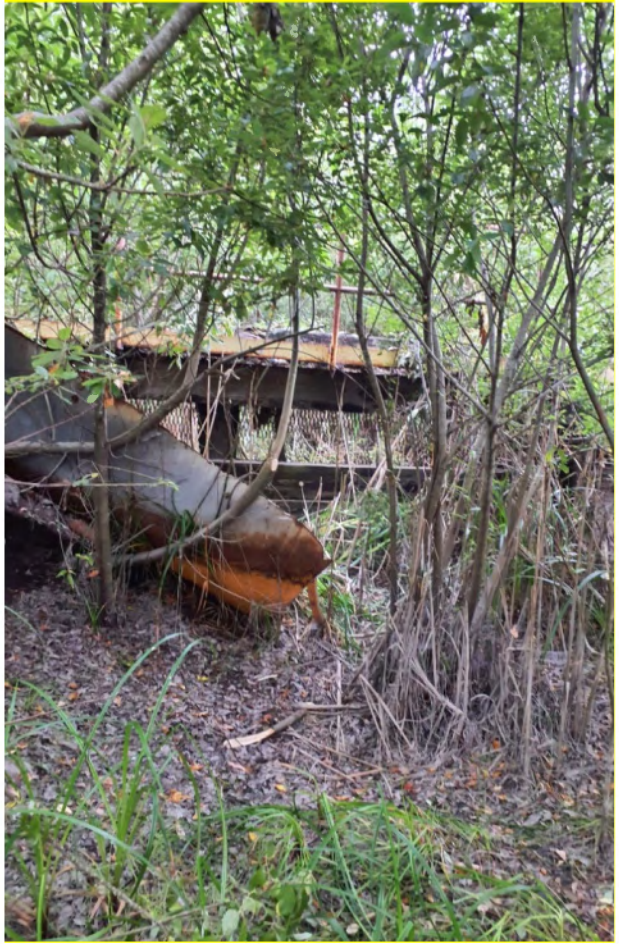
Photograph 22: Artificial aquatic feature-stormwater collection system near TP88, near one of weirs before the entrance to Humboldt Bay. Photograph taken on August 2, 2022.

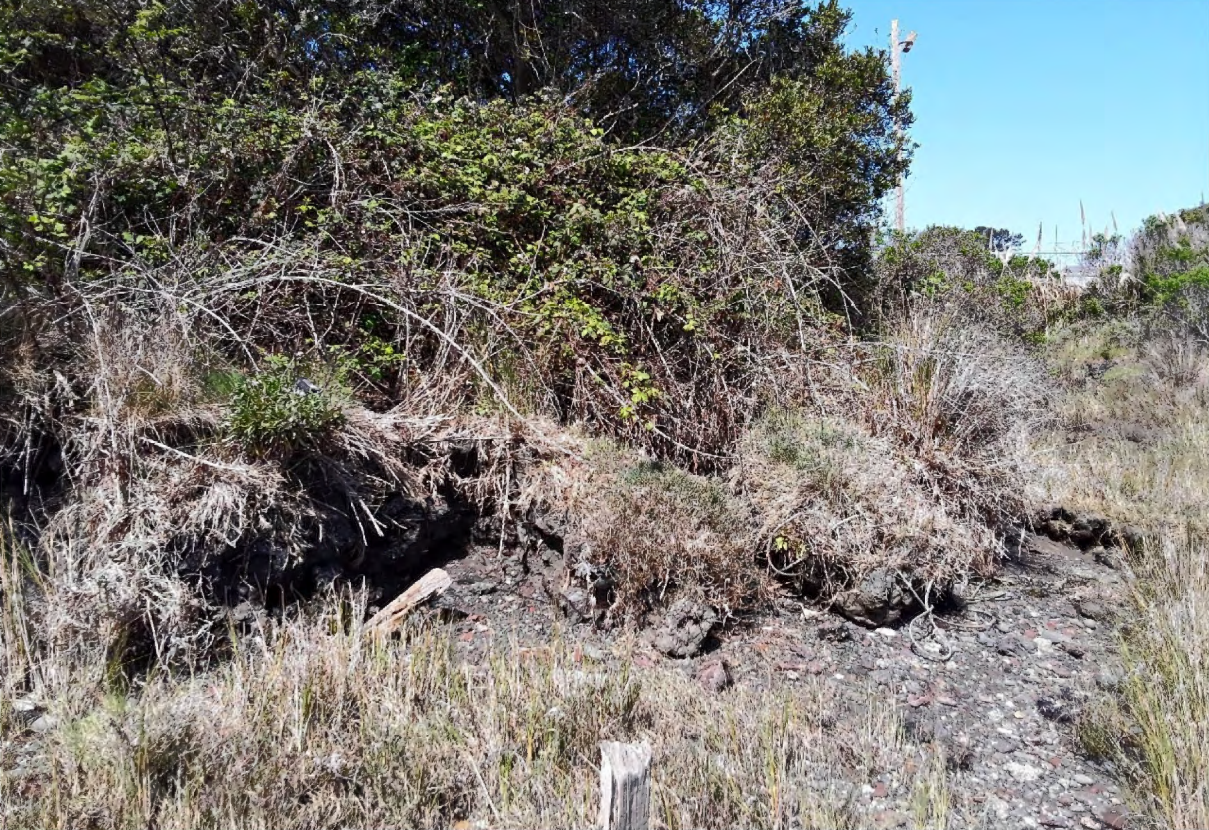
Photograph 23: An example of Estuarine Intertidal Shoreline, looking west toward Wetland 15. Note narrow band of estuarine wetland between the MHHW and upland conditions. Photograph taken April 5, 2022.

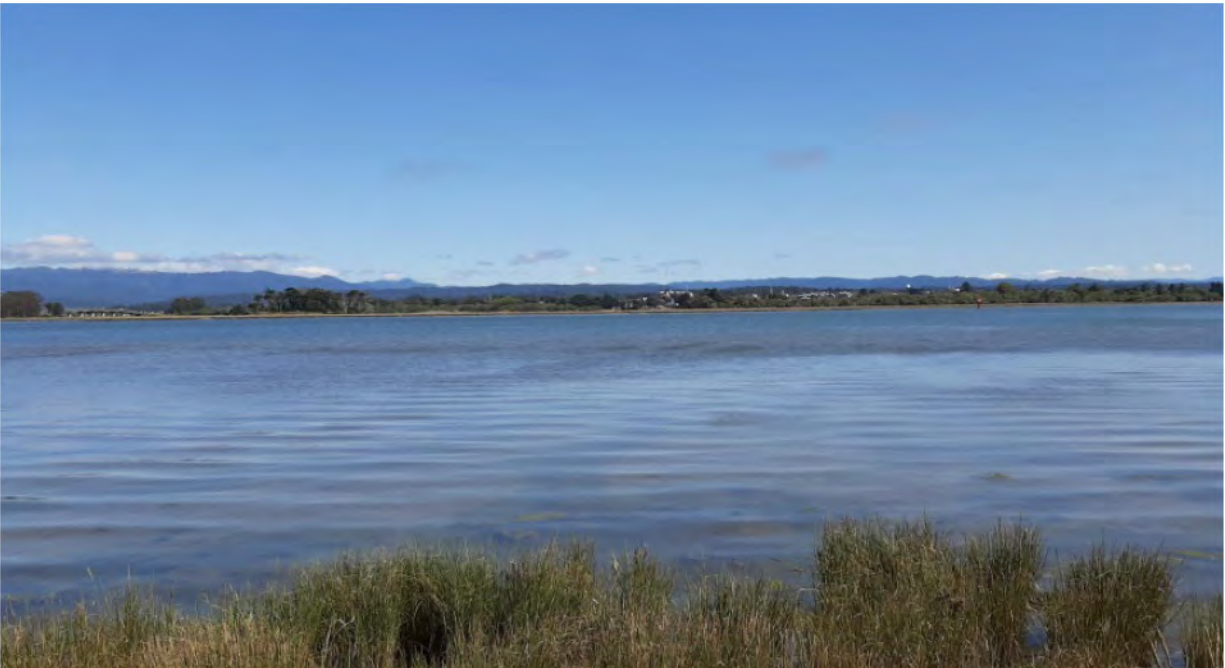
Photograph 24: An example of Estuarine Intertidal Shoreline, east of Wetland 03, looking across Humboldt Bay towards Eureka. Photograph taken July 7, 2022.

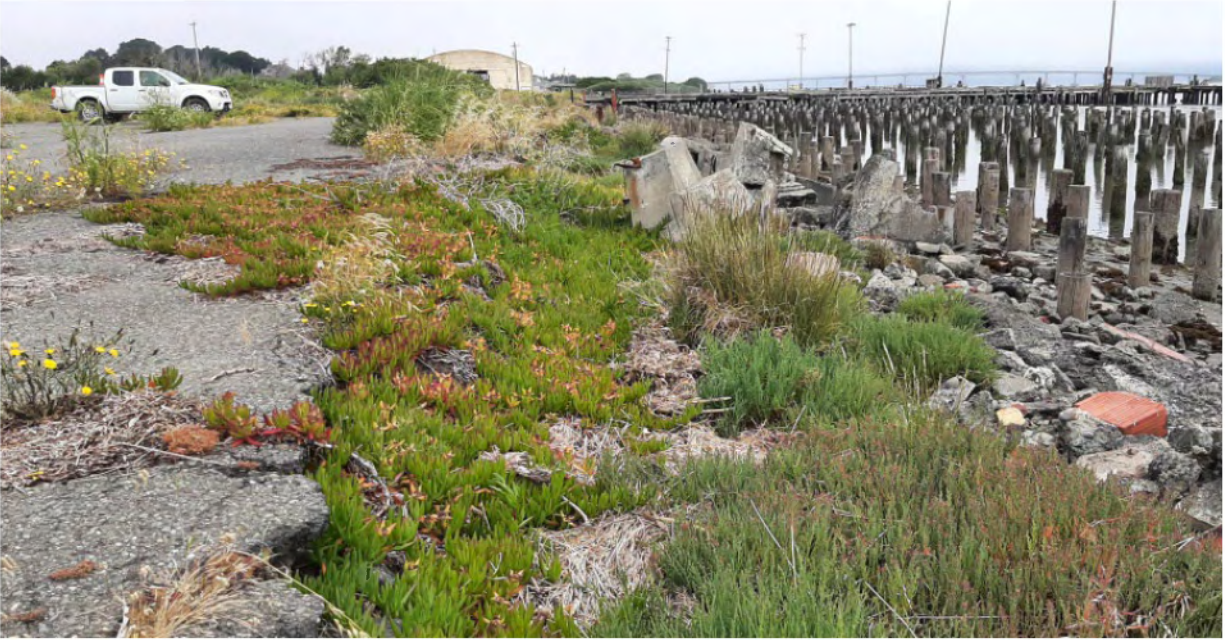
Photograph 25: An example of Estuarine Intertidal Shoreline with saltmarsh vegetation within armored shoreline, east of TP71, looking north. Note MHHW demarked roughly by the wrack line between the saltmarsh vegetation and upland ruderal vegetation. Photograph taken July 8, 2022.

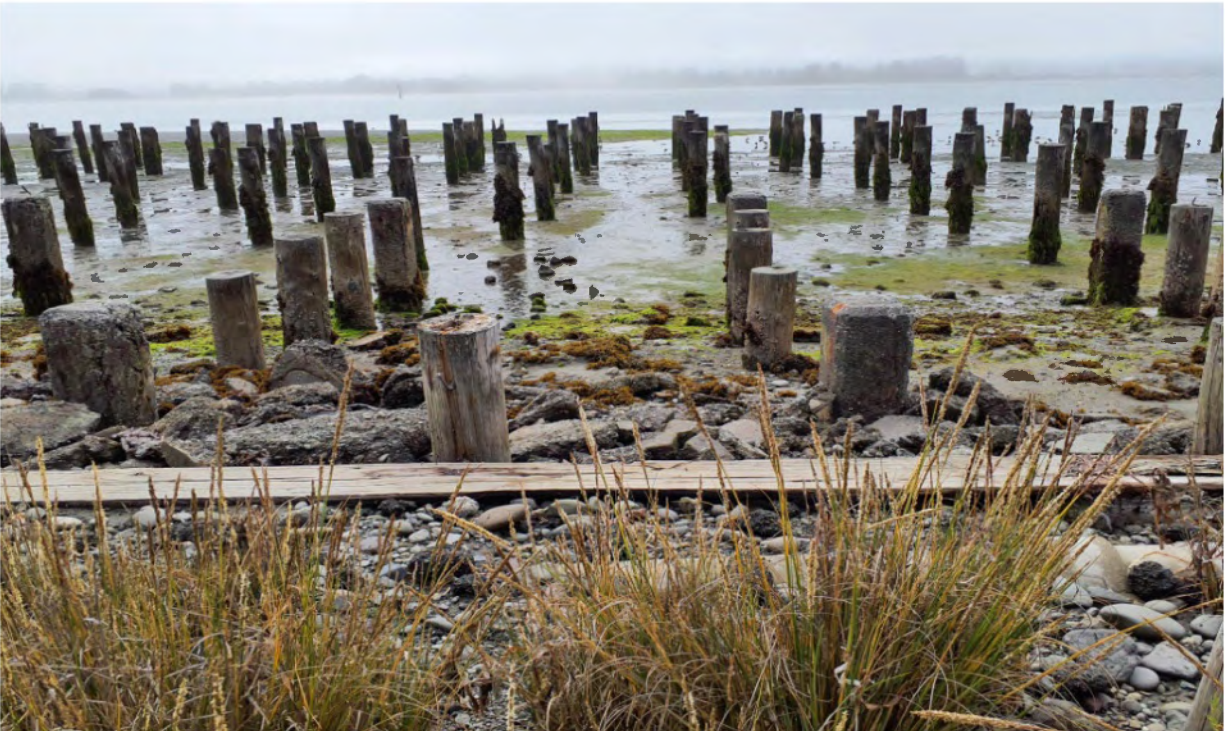
Photograph 26: An example of Estuarine Intertidal Shoreline, with armored shoreline east of TP71, looking east towards Eureka. Photograph taken August 2, 2022.

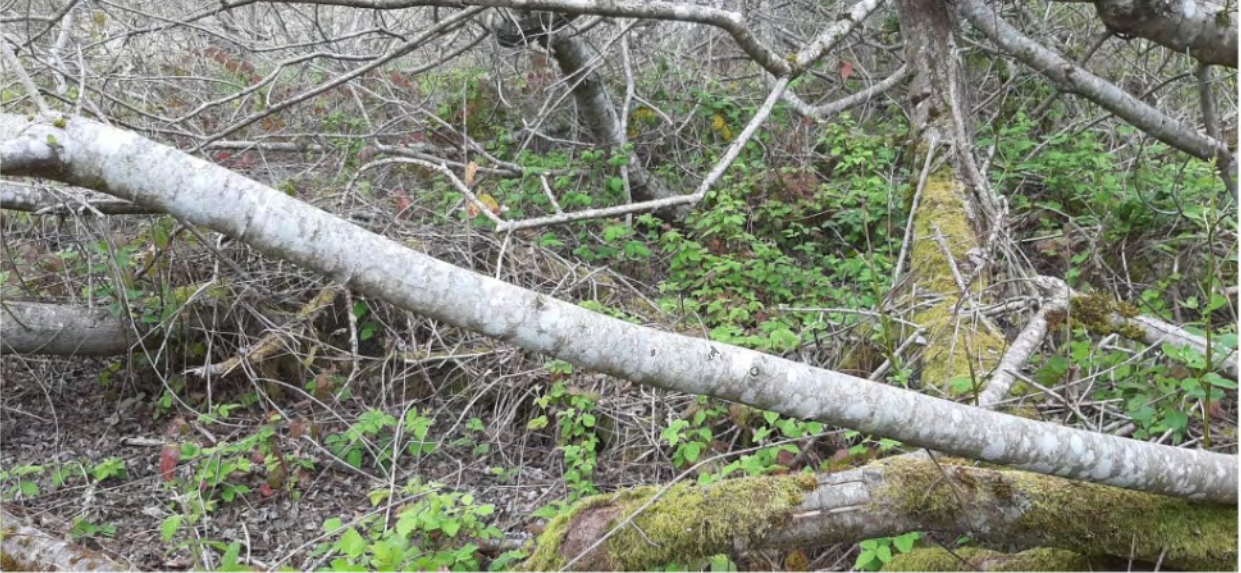
Photograph 27: Typical vegetation type in OF1, OF2, OF3, and OF4, adjacent to Palustrine Forested or Scrub-shrub Wetlands. Taken near TP34 on May 4, 2022.

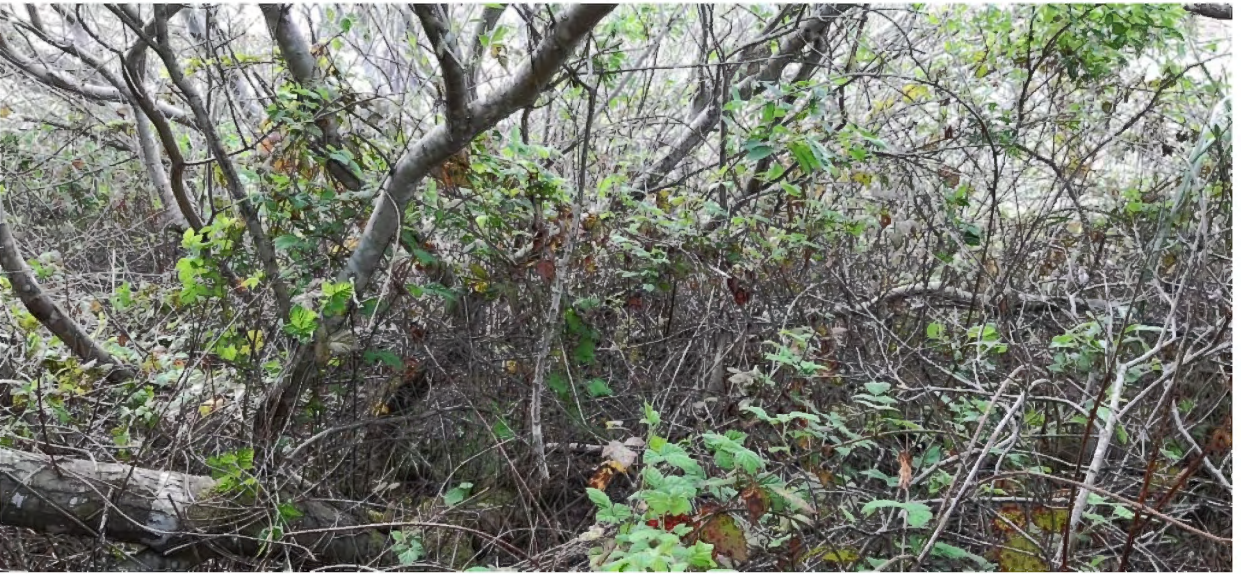
Photograph 28: Typical vegetation type in OF1, OF2, OF3, and OF4, adjacent to Palustrine Forested or Scrub-shrub Wetlands. Taken near TP61 on May 13, 2022.

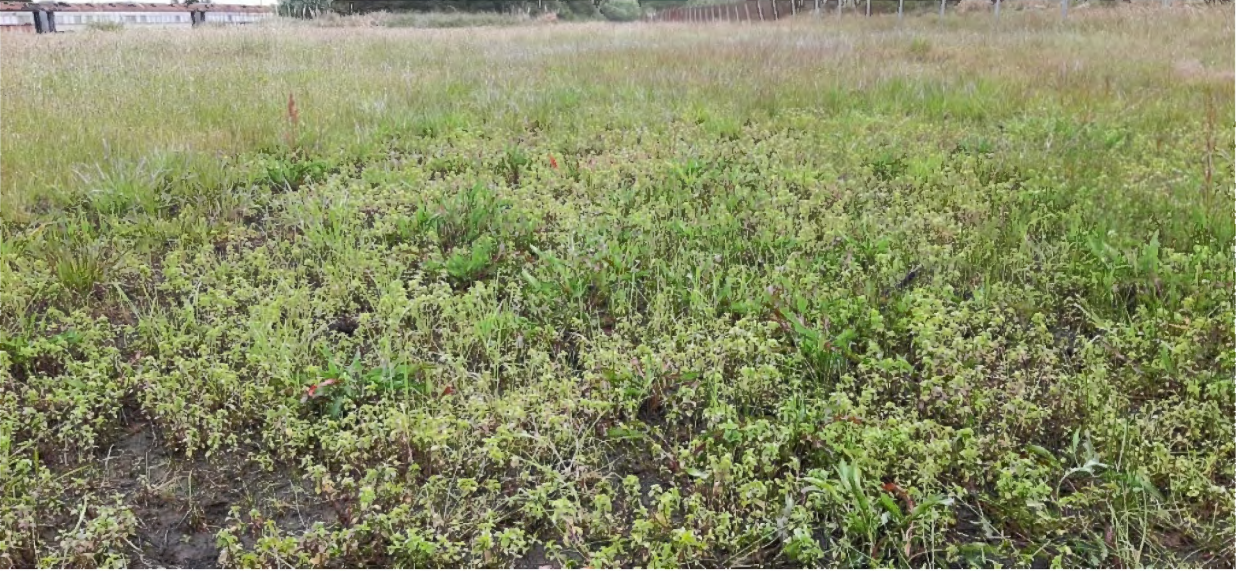
Photograph 29: Typical vegetation type in OF5, OF6, OF7, and OF8, adjacent to Palustrine Emergent Wetlands. Taken near TP49 on May 12, 2022.

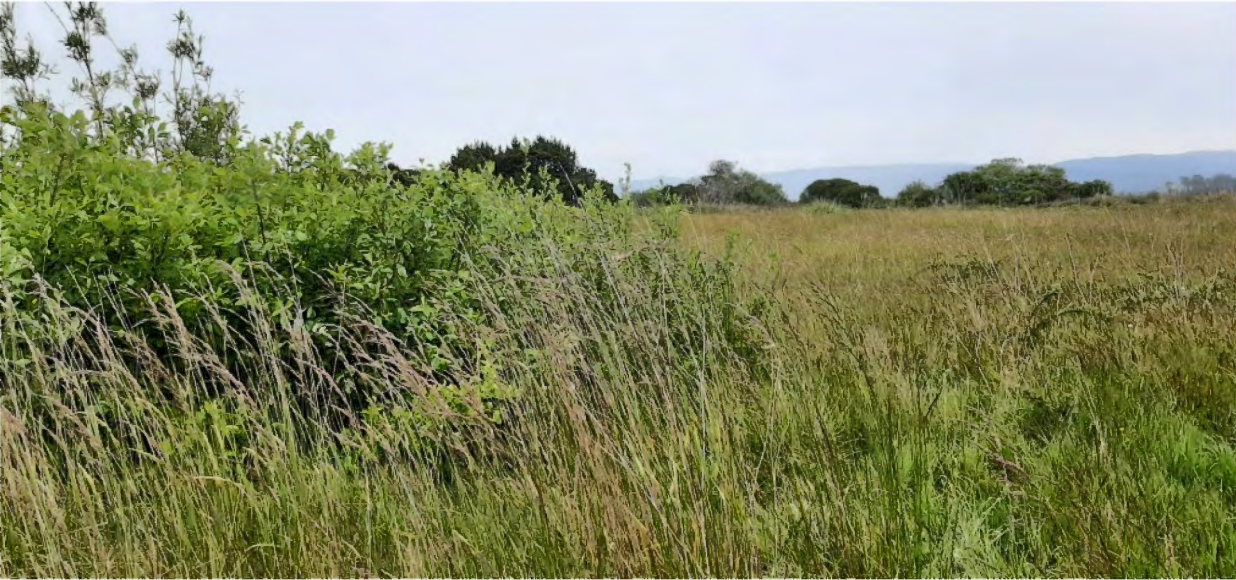
Photograph 30: Typical vegetation type in OF5, OF6, OF7, and OF8, adjacent to Palustrine Emergent/Palustrine Scrub-shrub Wetlands. Taken near TP53 on May 12, 2022.

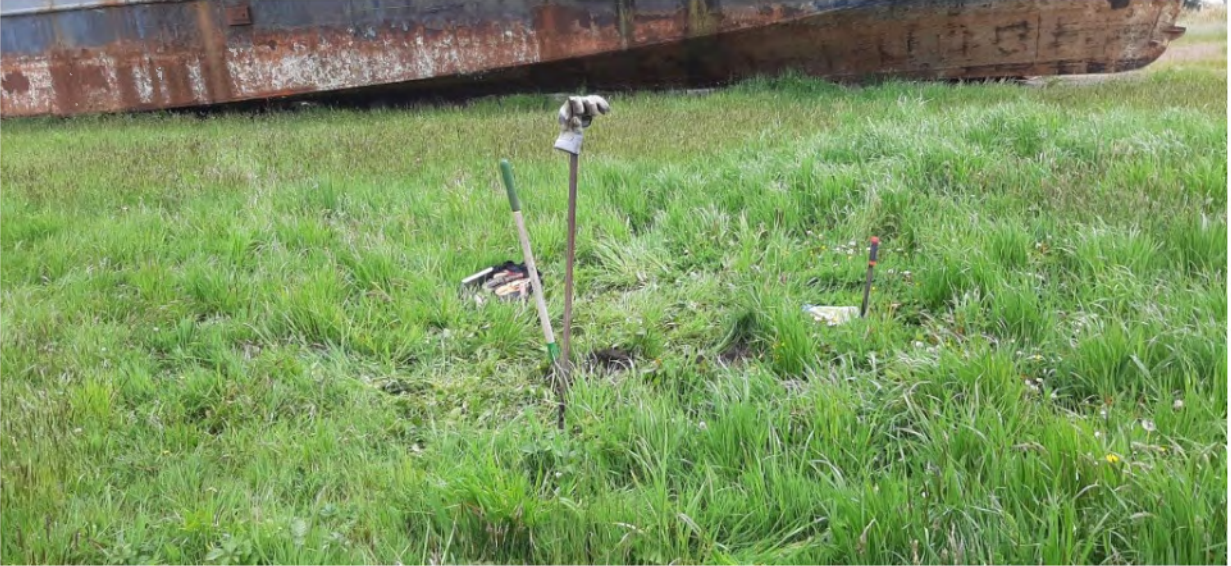
Photograph 31: Typical vegetation type in OF5, OF6, OF7, and OF8, adjacent to Palustrine Emergent Wetlands. Taken near TP51 on May 12, 2022.

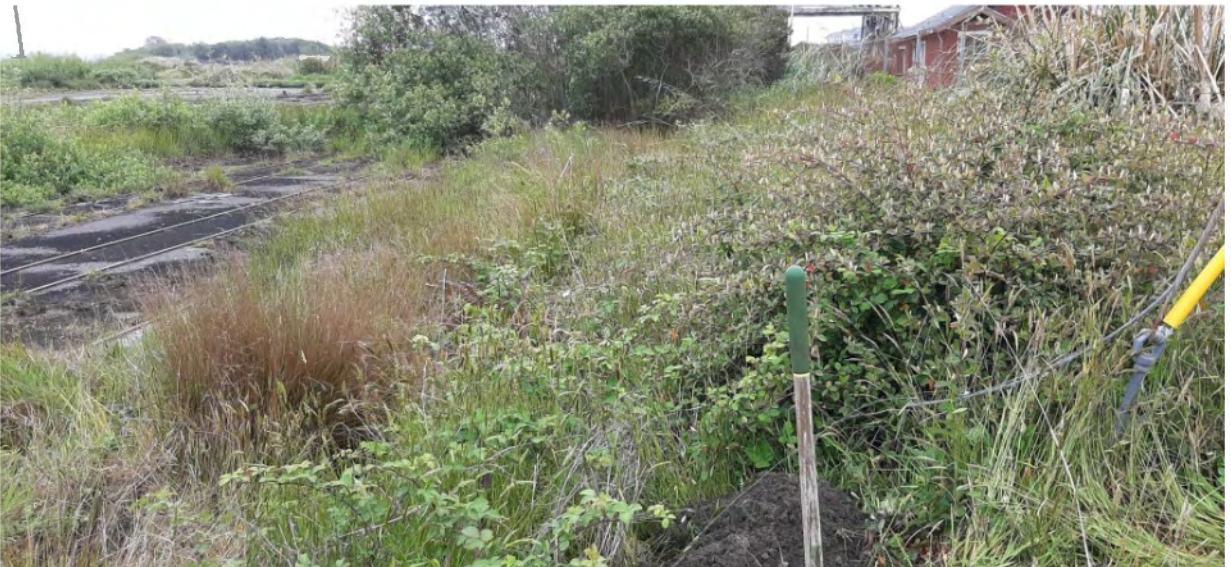
Photograph 32: Wetland OF9 in swale between the artificial aquatic features (drying racks) and an upland berm. Shovel is at upland TP68, taken on May 14, 2022.

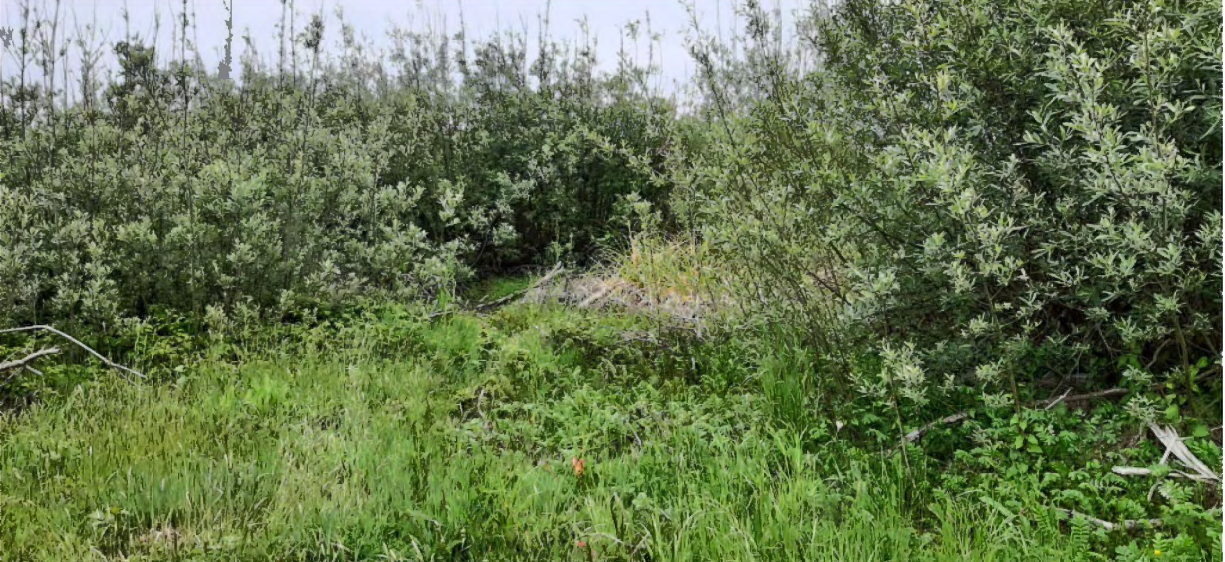
Photograph 33: Typical vegetation for OF11, a one-parameter feature (hydrophytic vegetation) adjacent to a Palustrine Scrub-shrub Wetland, taken near TP69 on May 17, 2022.

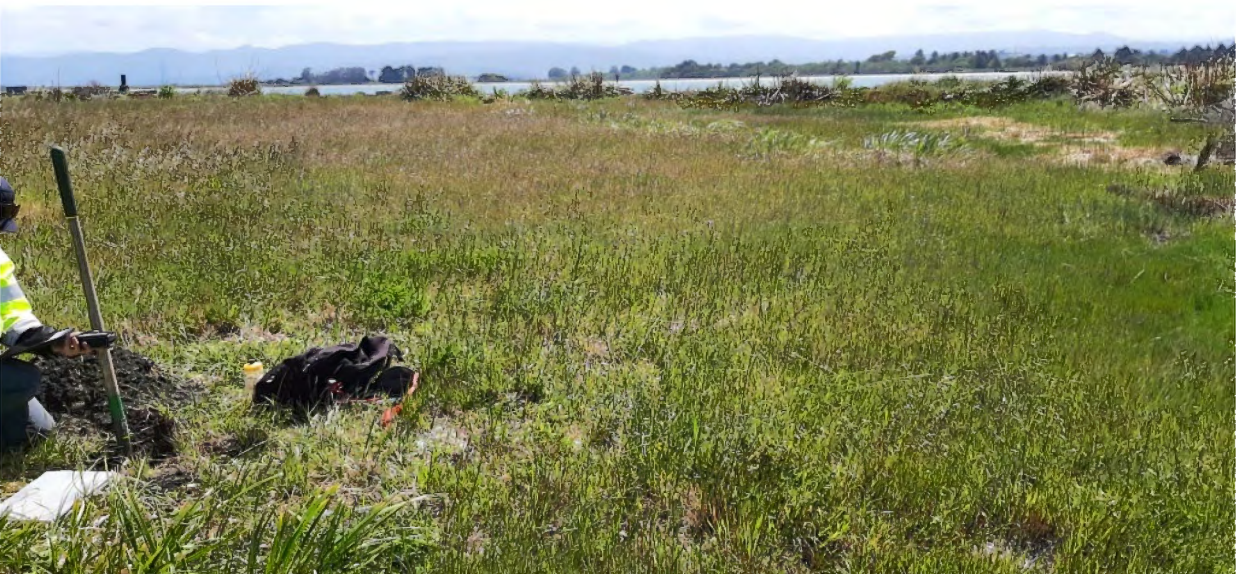
Photograph 34: Typical vegetation for OF12, a two-parameter feature (hydrophytic vegetation and hydrology), taken near TP71 on May 17, 2022.

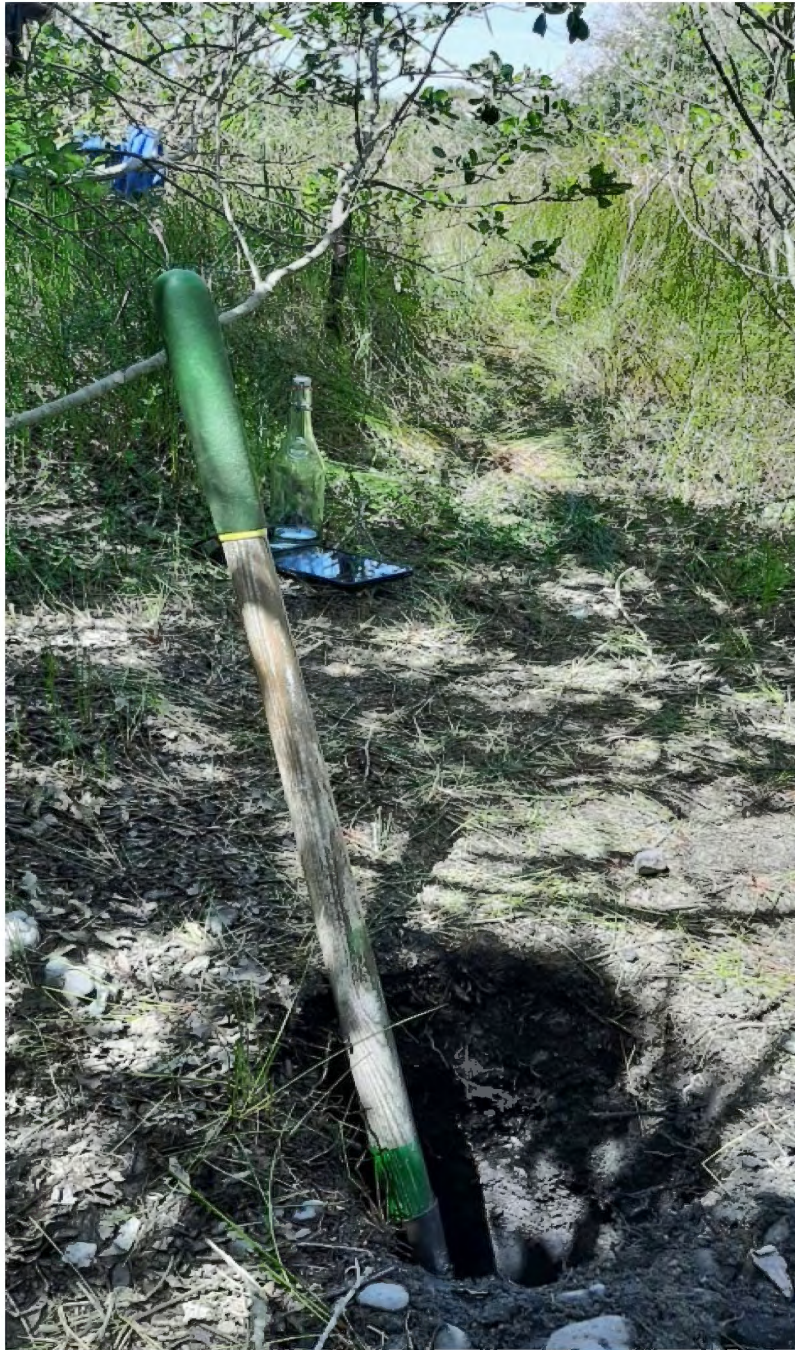
Photograph 35: Typical vegetation for OF14, a two-parameter feature (hydrophytic vegetation and hydrology), taken at TP75 on May 18, 2022.

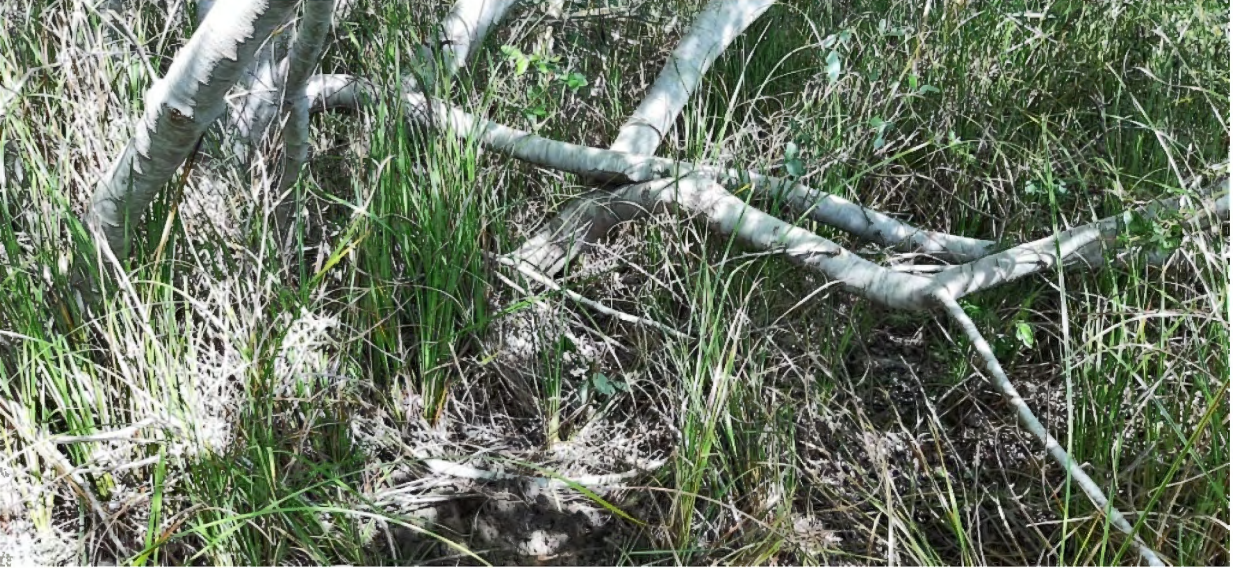
Photograph 36: Typical vegetation for OF15, a two-parameter feature taken near TP76 on May 18, 2022.

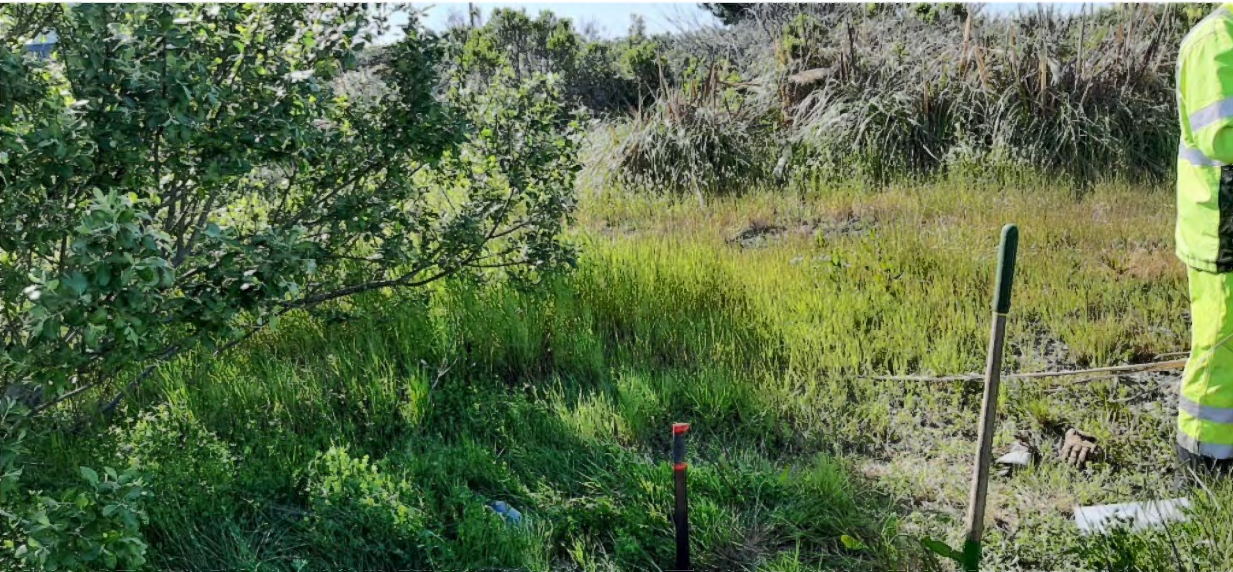
Photograph 37: Typical vegetation for OF16, two-parameter feature (hydrophytic vegetation and hydrology), taken near TP77 on May 18, 2022.

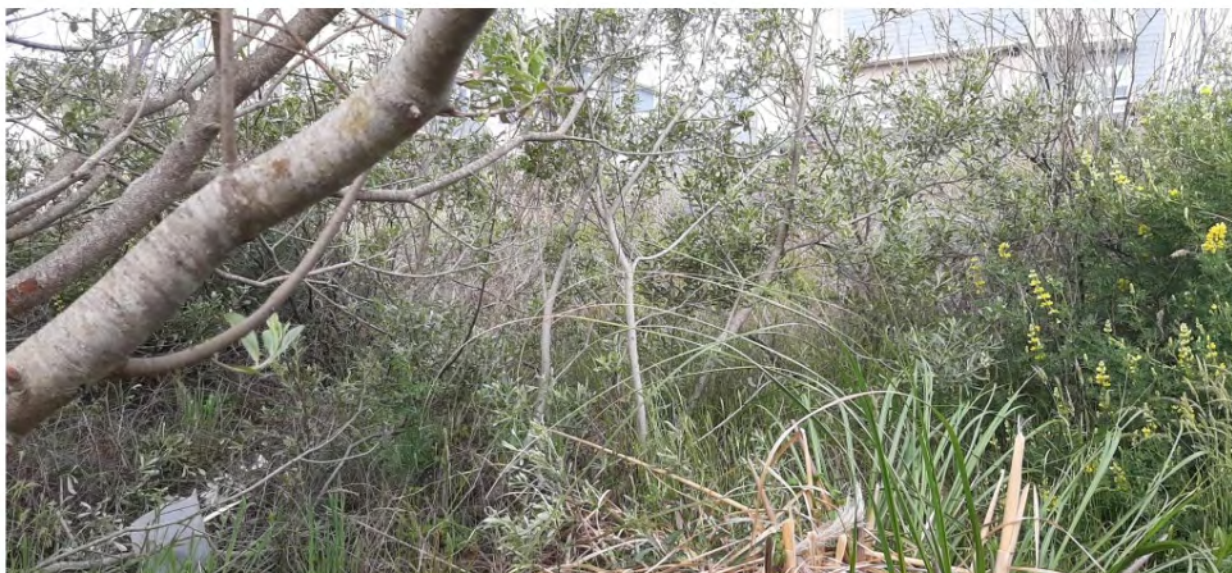
Photograph 38: Typical vegetation for OF17, a one-parameter hydric soil feature, taken near TP78 on May 19, 2022.

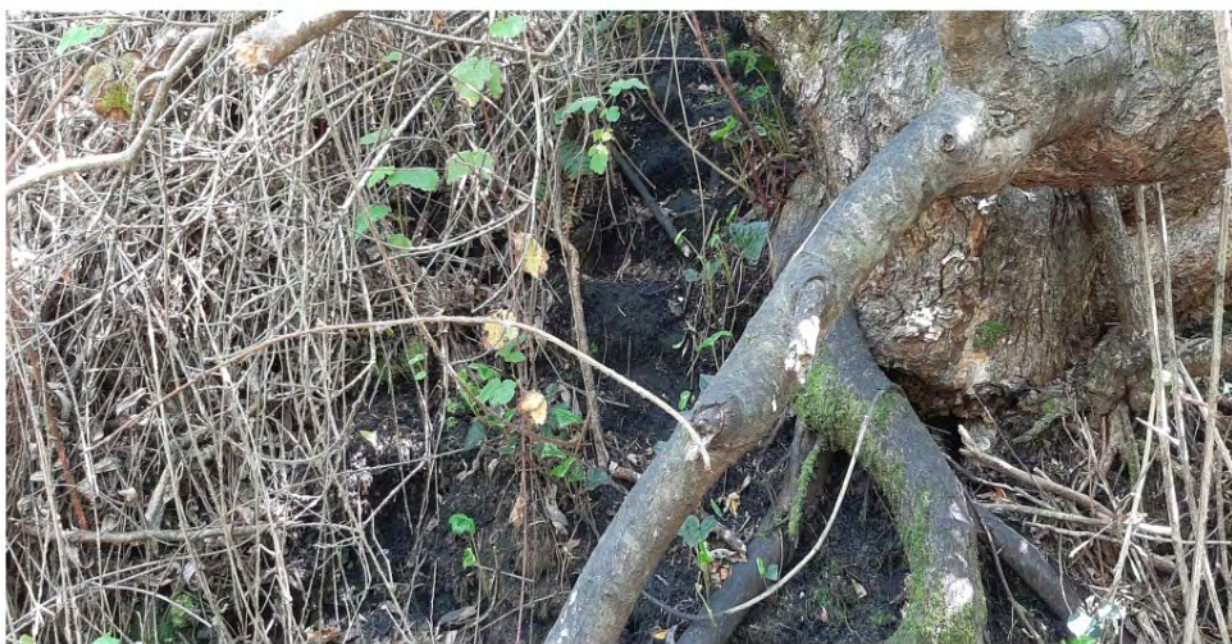
Photograph 39: Typical vegetation for OF18, a two-parameter feature (hydrophytic vegetation and hydrology), taken near TP84 on May 19, 2022. Note black fly ash on soil surface.
