**DRAFT Project Report**  
Swain Slough Bridge on Pine Hill Road

Federal Project No. BRLO-5904 (112)  
Existing Bridge No. 04C0173  
New Bridge No. 04C0260

Prepared For:  
**County of Humboldt**  
Department of Public Works

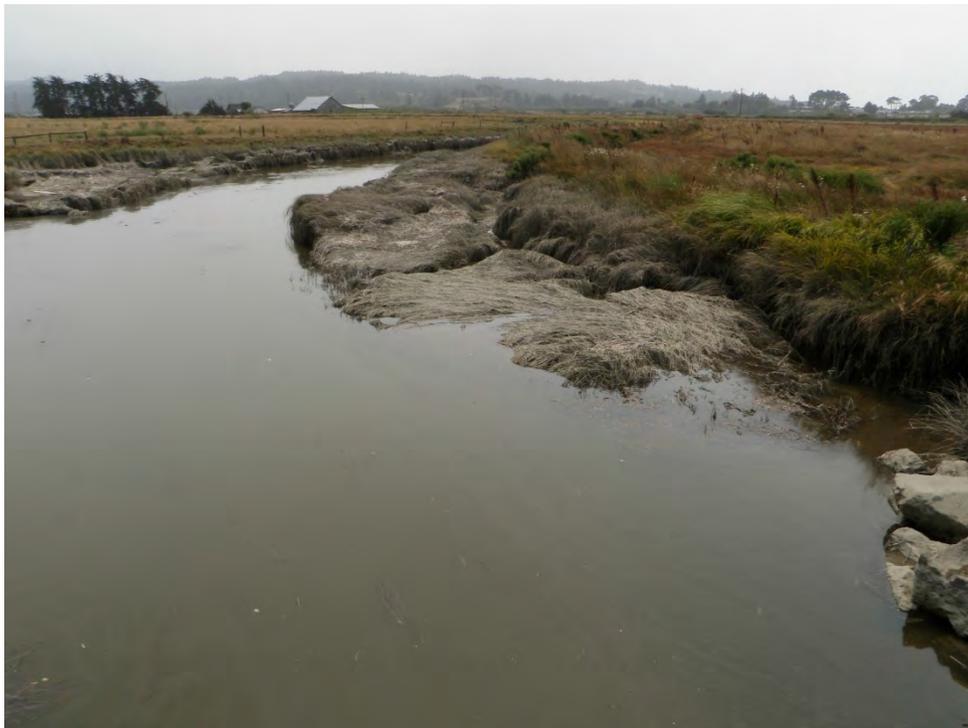
Photograph 5. Looking west at DP 5 (shovel) and DP 6 (bookbag) which document the vegetated ditch (VD 5) on the east end of the study area. The bridge is in the background.

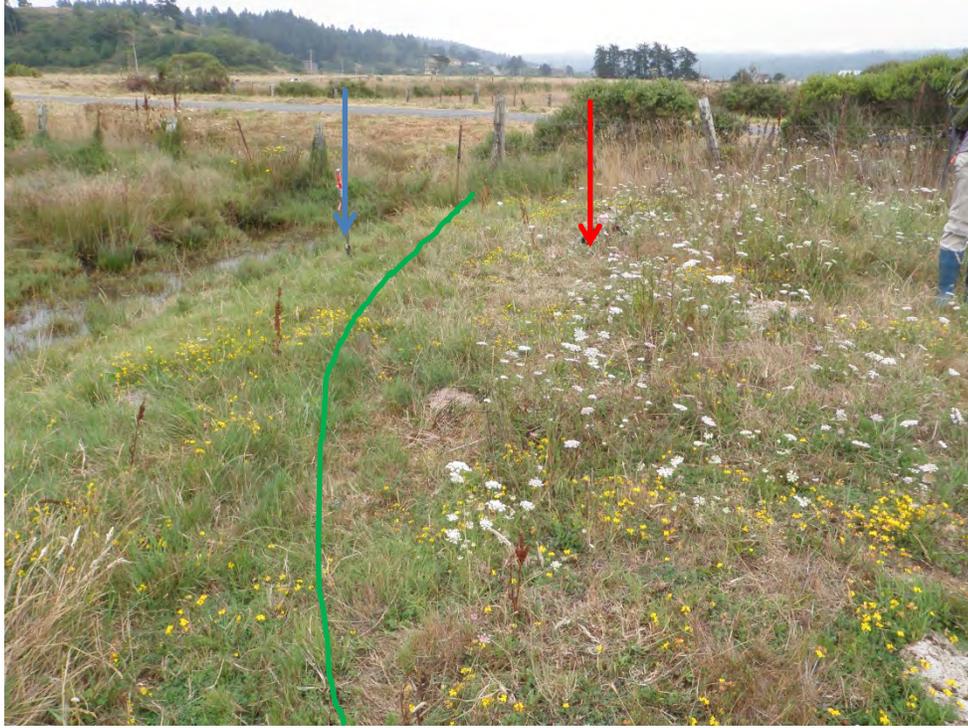
Photograph 10. Looking north at the west bridge footing. Note the sediment deposits and watermarks (blue arrow), and the drift on the pipe in the background. These high marks indicate the monthly high tide of 8.61 feet. The green arrow indicates the 6.91-foot high tide observed on July 30, 2013. This photograph was taken between high and low tide.

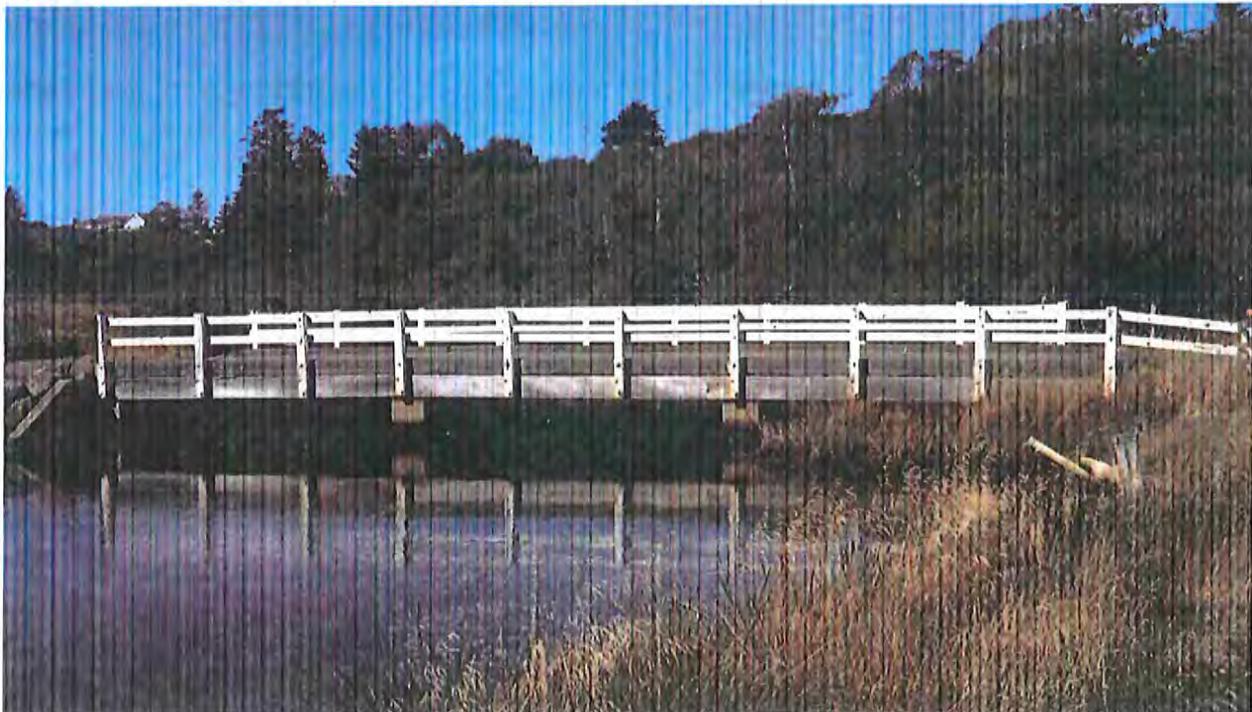
Photo 2 – Profile of existing bridge looking north

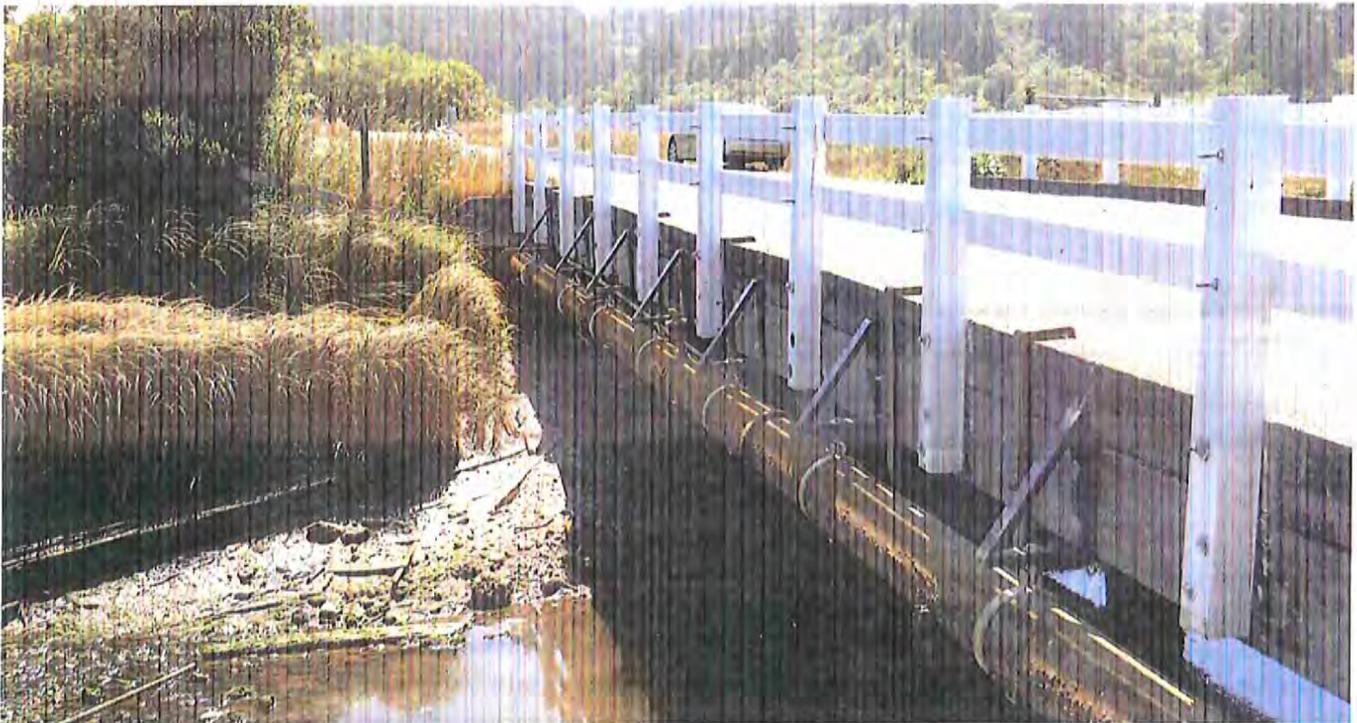
Photo 4 – Looking east at 12" water line

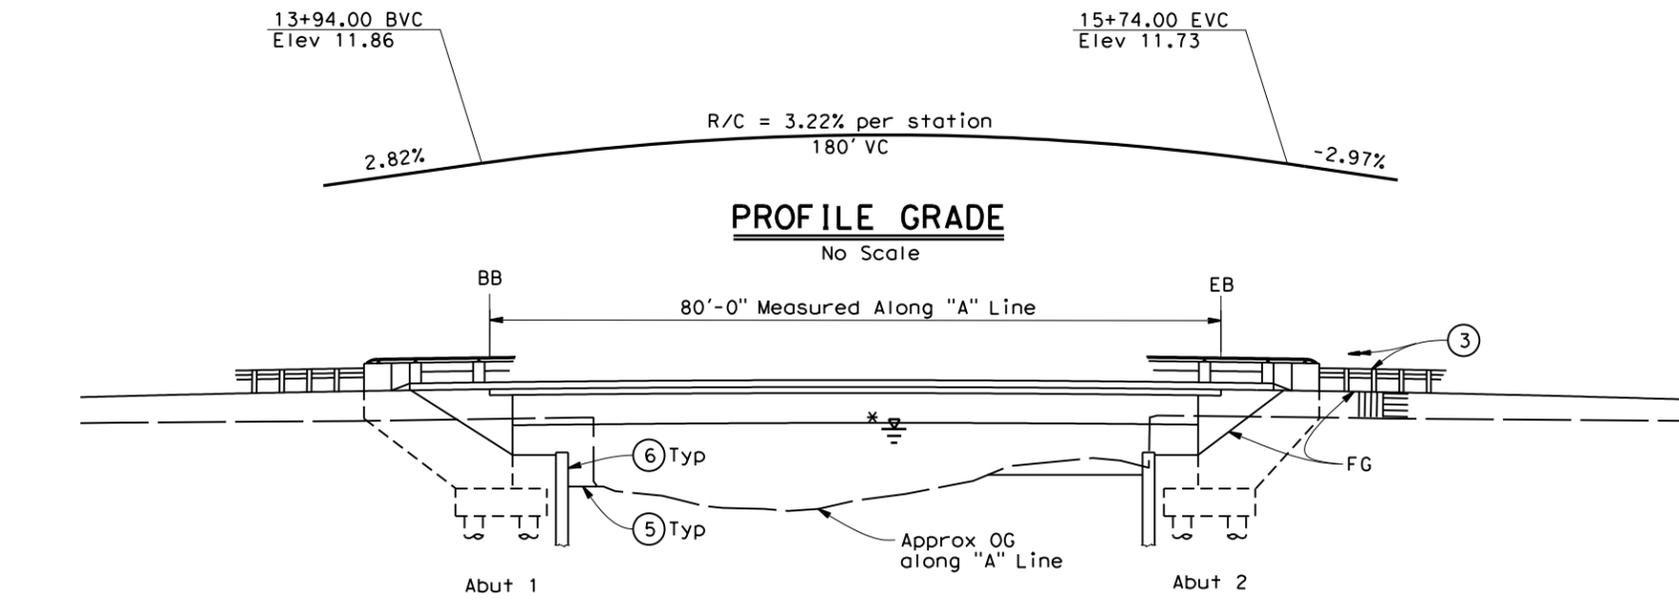
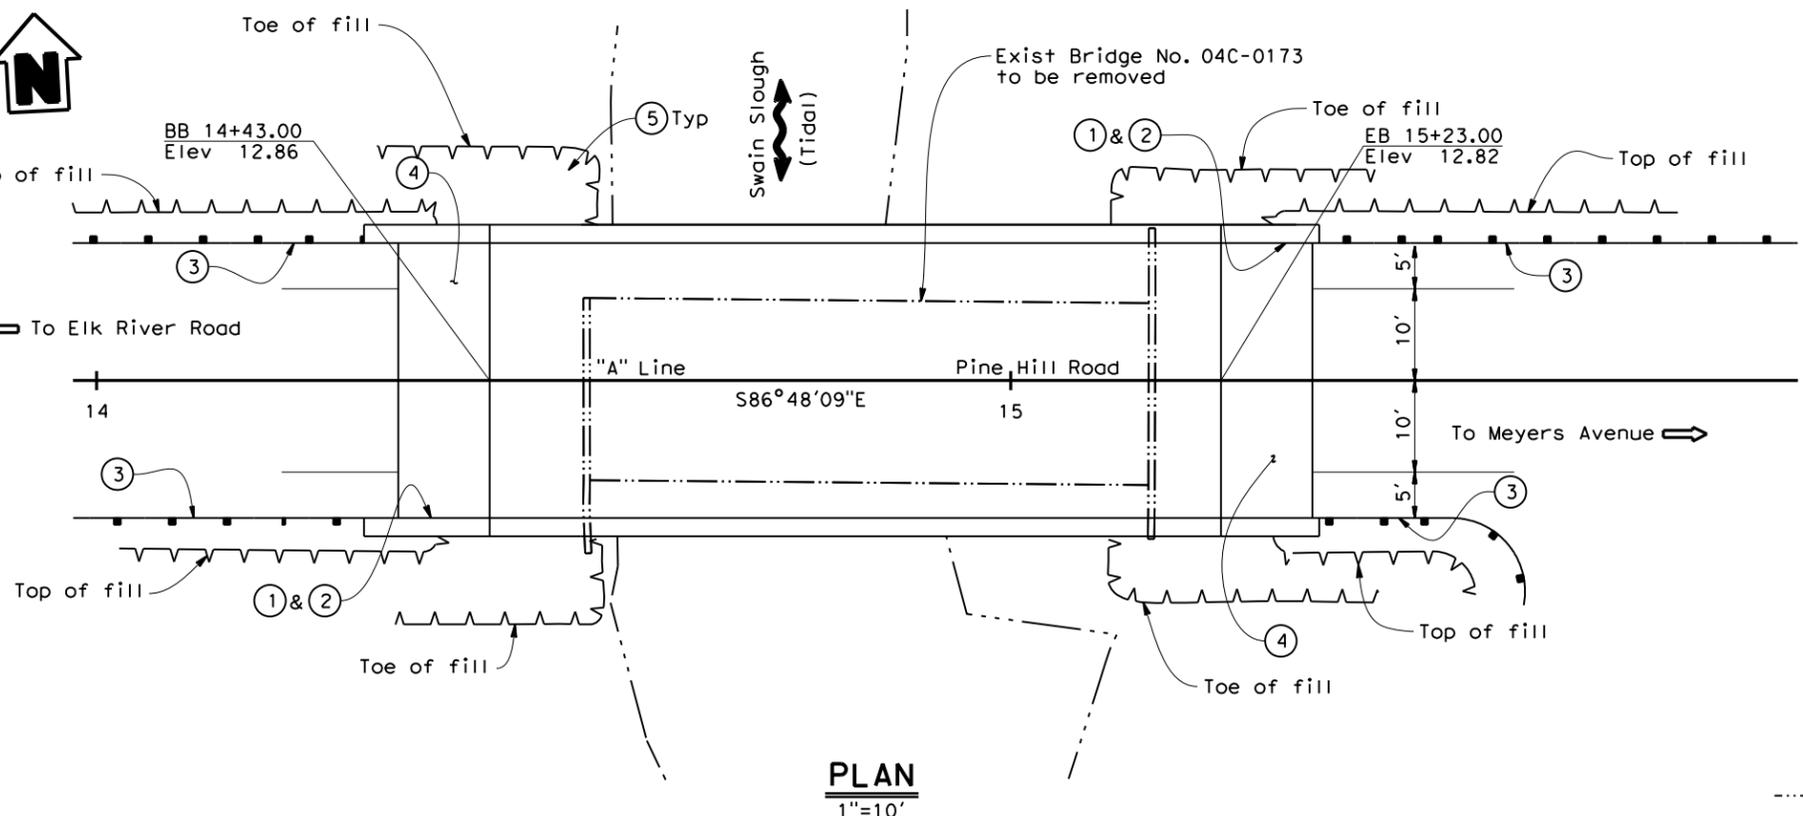
- Notes:
- ① Paint Bridge Number "Bridge No. 04C0260"
  - ② Paint "Swain Slough Bridge"
  - ③ MGS, see Road Plans
  - ④ Structure Approach Type EQ(10)
  - ⑤ Contour Grading, see Road Plans
  - ⑥ Permanent Sheet Pile shoring, see "Miscellaneous Details" sheet.
- \* King Tide water surface elevation = 8.5' NAVD
- Existing structure, Br. No. 04C0173, to be removed

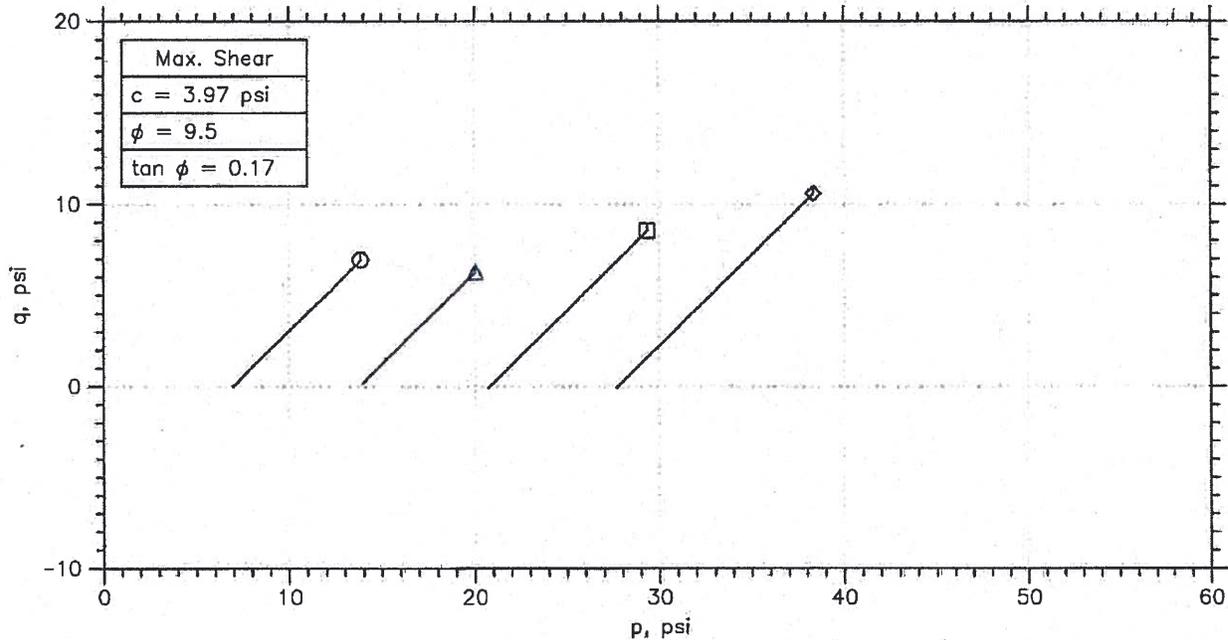
## CONSOLIDATED UNDRAINED TRIAXIAL TEST by ASTM D4767

Symbol	⊙	△	□	◇
Sample No.	12-830	12-831	12-832	12-833
Test No.	12-830	12-831	12-832	12-833
Depth	11'	21'	31'	41'
Initial	Diameter, in	2.82	2.82	2.82
	Height, in	6.05	6.6	6.1
	Water Content, %	35.2	38.2	41.5
	Dry Density, pcf	88.96	83.18	79.91
	Saturation, %	111.4	104.7	105.2
Before Shear	Void Ratio	0.818	0.944	1.02
	Water Content, %	31.4	34.6	37.1
	Dry Density, pcf	89.15	85.33	82.38
	Saturation*, %	100.0	100.0	100.0
	Void Ratio	0.814	0.895	0.96
Back Press., psi	29.99	44.98	29.99	
Ver. Eff. Cons. Stress, psi	6.939	13.9	20.84	
Shear Strength, psi	6.957	6.293	8.537	
Strain at Failure, %	9.52	5.51	8.23	
Strain Rate, %/min	0.16	0.08	0.08	
B-Value	0.98	0.95	0.97	
Estimated Specific Gravity	2.59	2.59	2.59	
Liquid Limit	---	32	---	
Plastic Limit	---	20	---

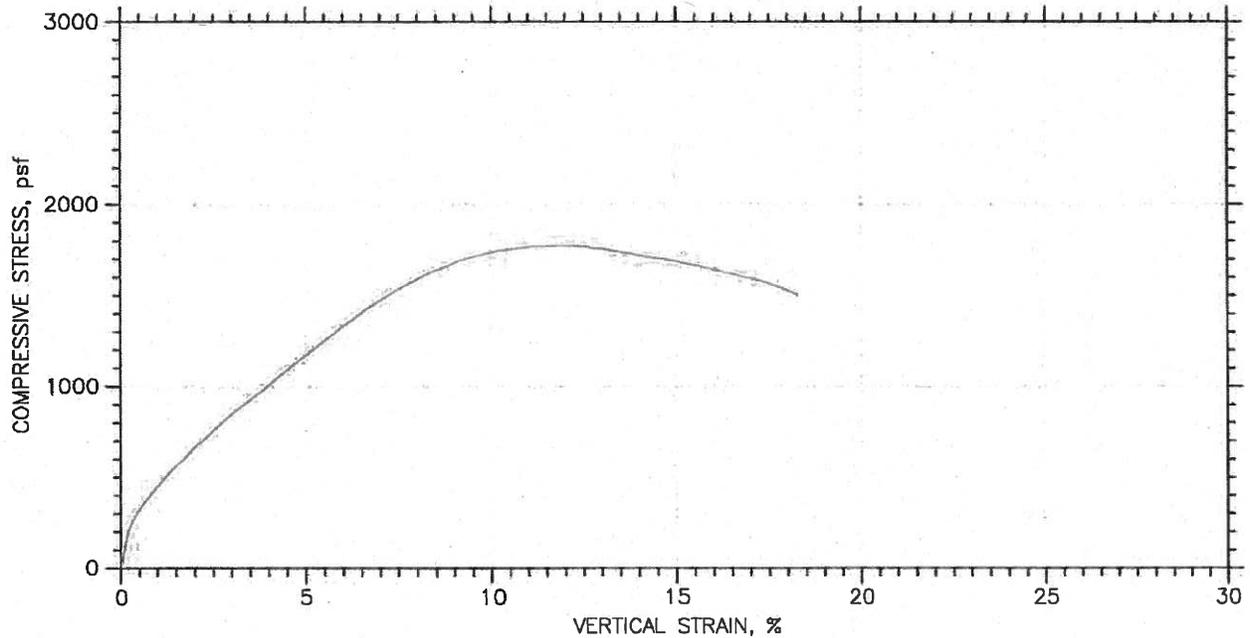
## UNCONFINED COMPRESSION TEST REPORT

Symbol					
Test No.		12-835			
Initial	Diameter, in	2.42			
	Height, in	5.7			
	Water Content, %	50.34			
	Dry Density, pcf	68.574			
	Saturation, %	94.44			
	Void Ratio	1.4125			
Unconfined Compressive Strength, psf		1776.6			
Undrained Shear Strength, psf		888.28			
Time to Failure, min		12.75			
Strain Rate, %/min		1			
Specific Gravity		2.65			
Liquid Limit		0			
Plastic Limit		0			
Plasticity Index		0			
Failure Sketch		_____	_____	_____	_____

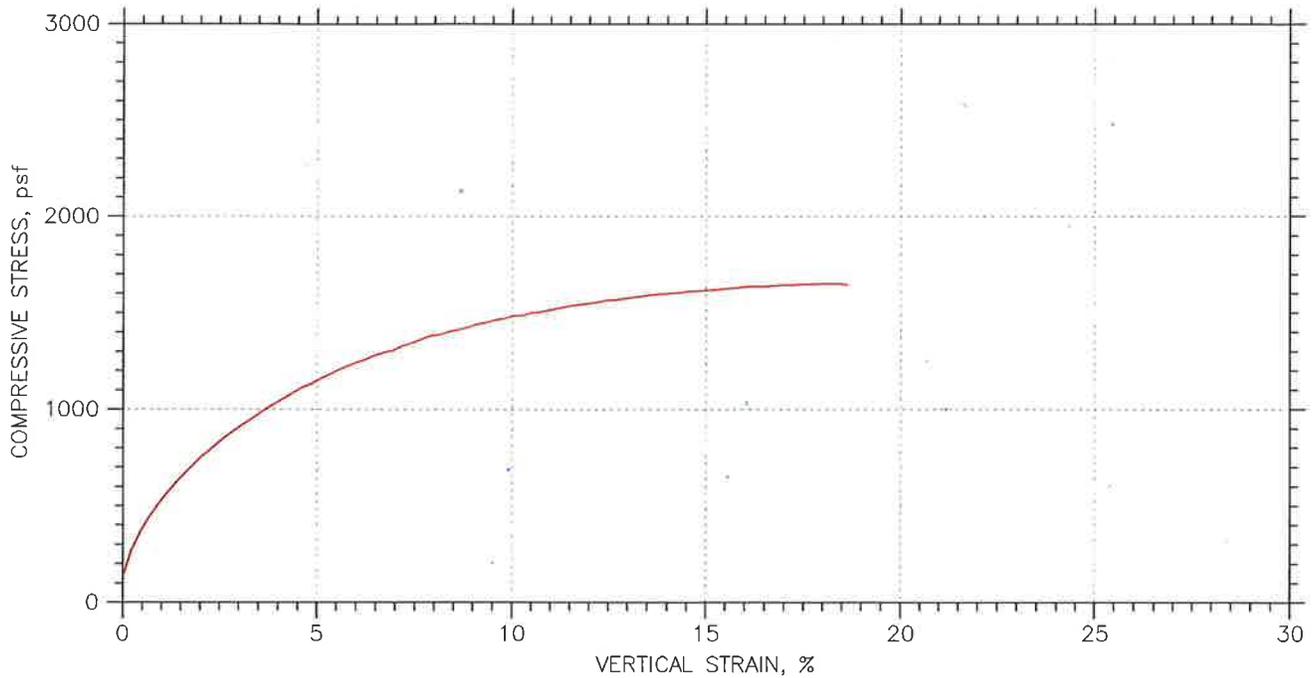
# UNCONFINED COMPRESSION TEST REPORT

Symbol				
Test No.		15-488		
Initial	Diameter, in	2.35		
	Height, in	4.9		
	Water Content, %	25.68		
	Dry Density, pcf	101.77		
	Saturation, %	107.52		
	Void Ratio	0.6378		
Unconfined Compressive Strength, psf		1652.1		
Undrained Shear Strength, psf		826.07		
Time to Failure, min		19.504		
Strain Rate, %/min		1		
Specific Gravity		2.67		
Liquid Limit		34		
Plastic Limit		19		
Plasticity Index		15		
Failure Sketch

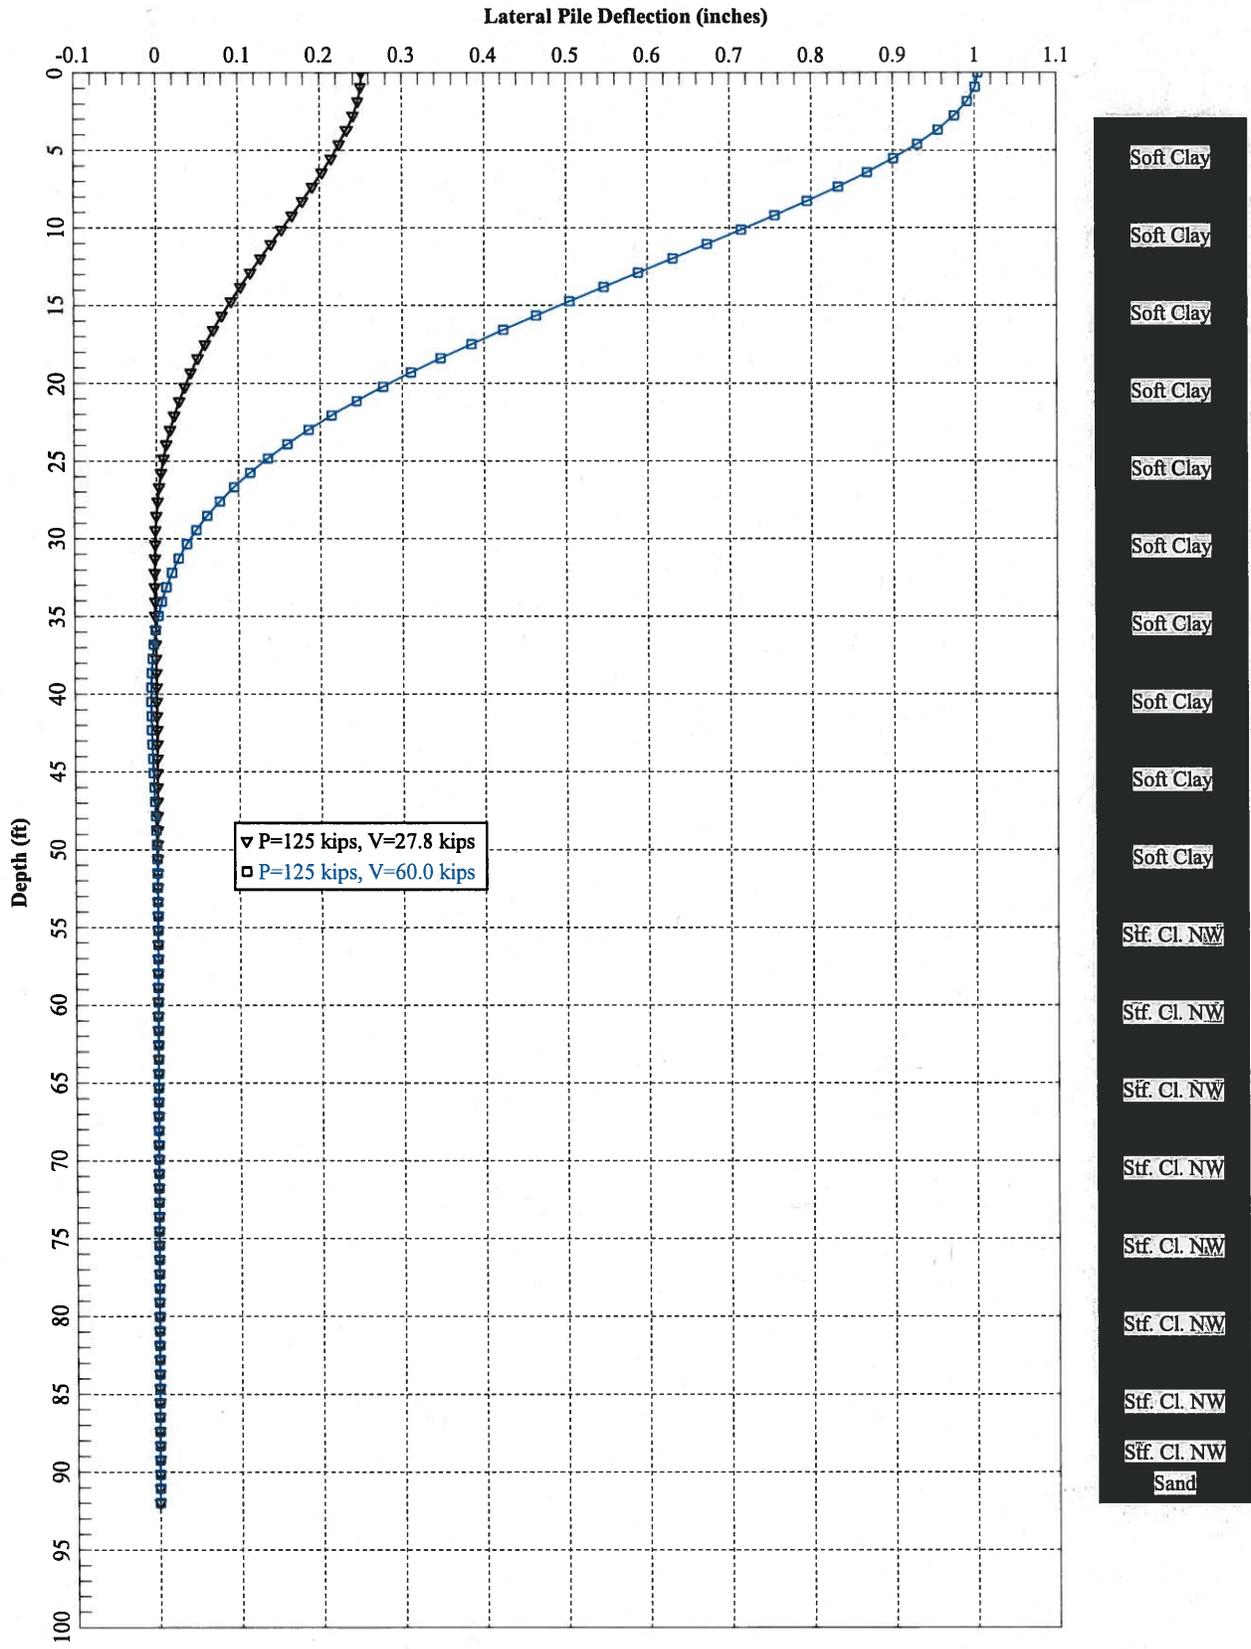
PP24X0.75 CISS Pile - Fixed Head Condition

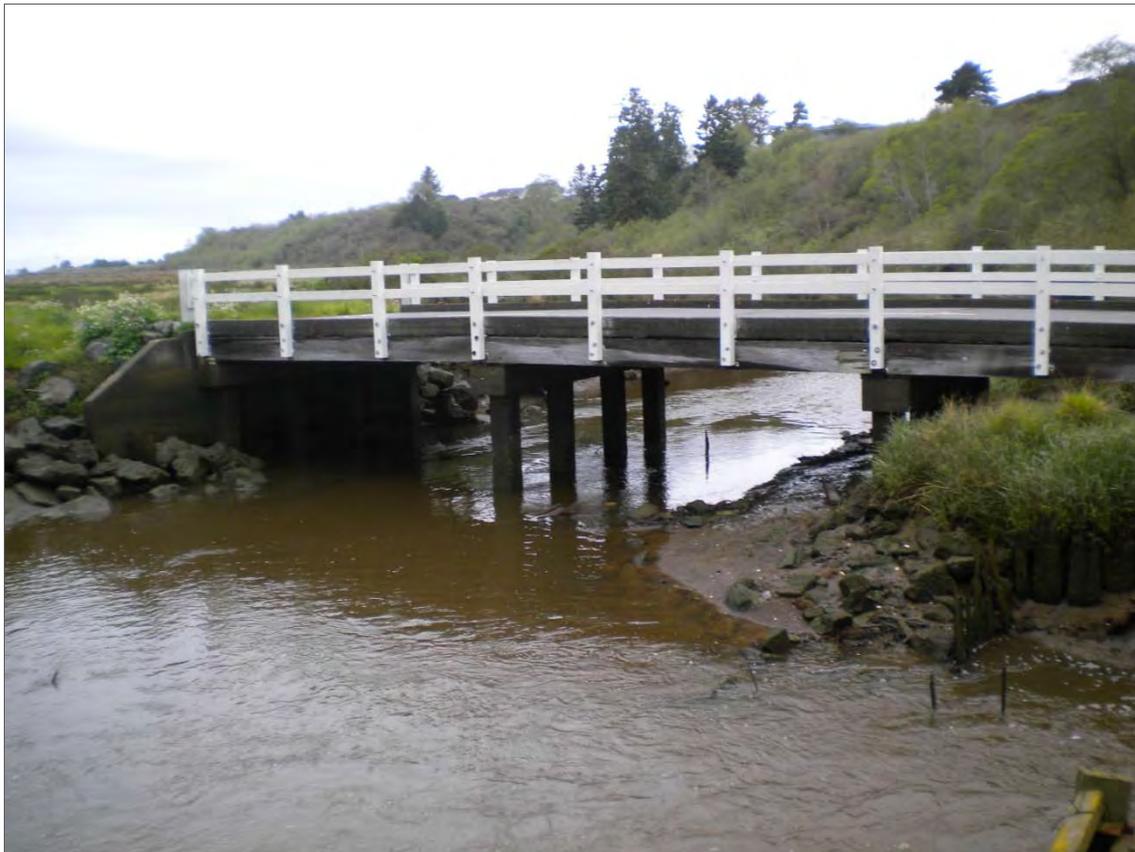
**Photo 1. Existing Bridge (Looking North/Downstream)**

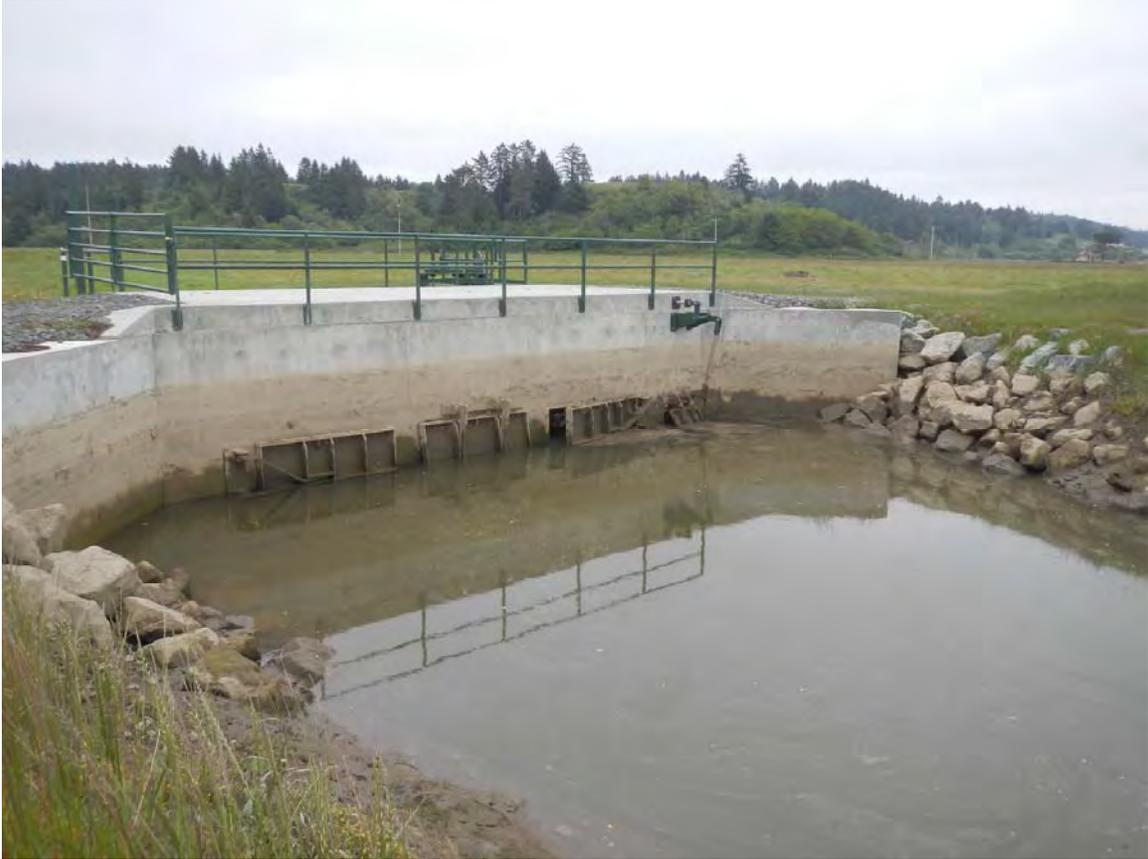
**Photo 2. Tide Gates (Looking East from the Bridge)**

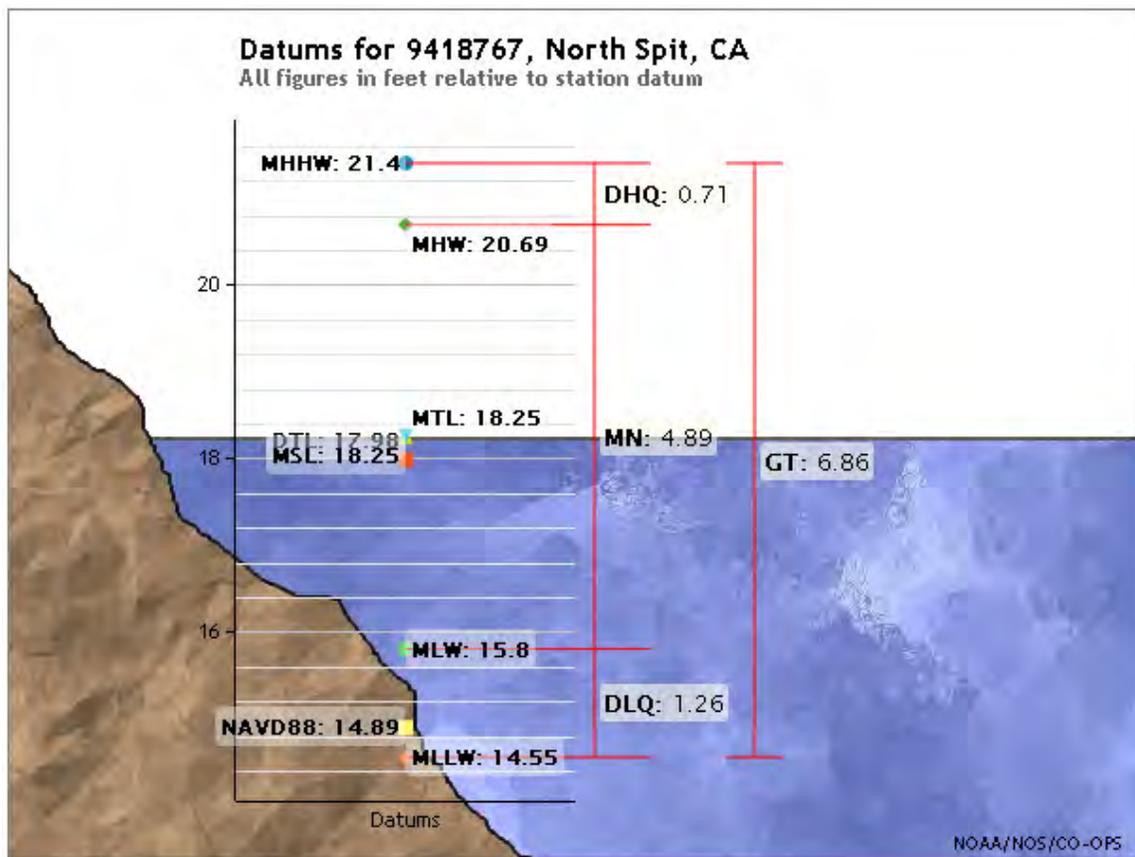
Figure 7. Tidal Elevations at North Spit Tide Gage

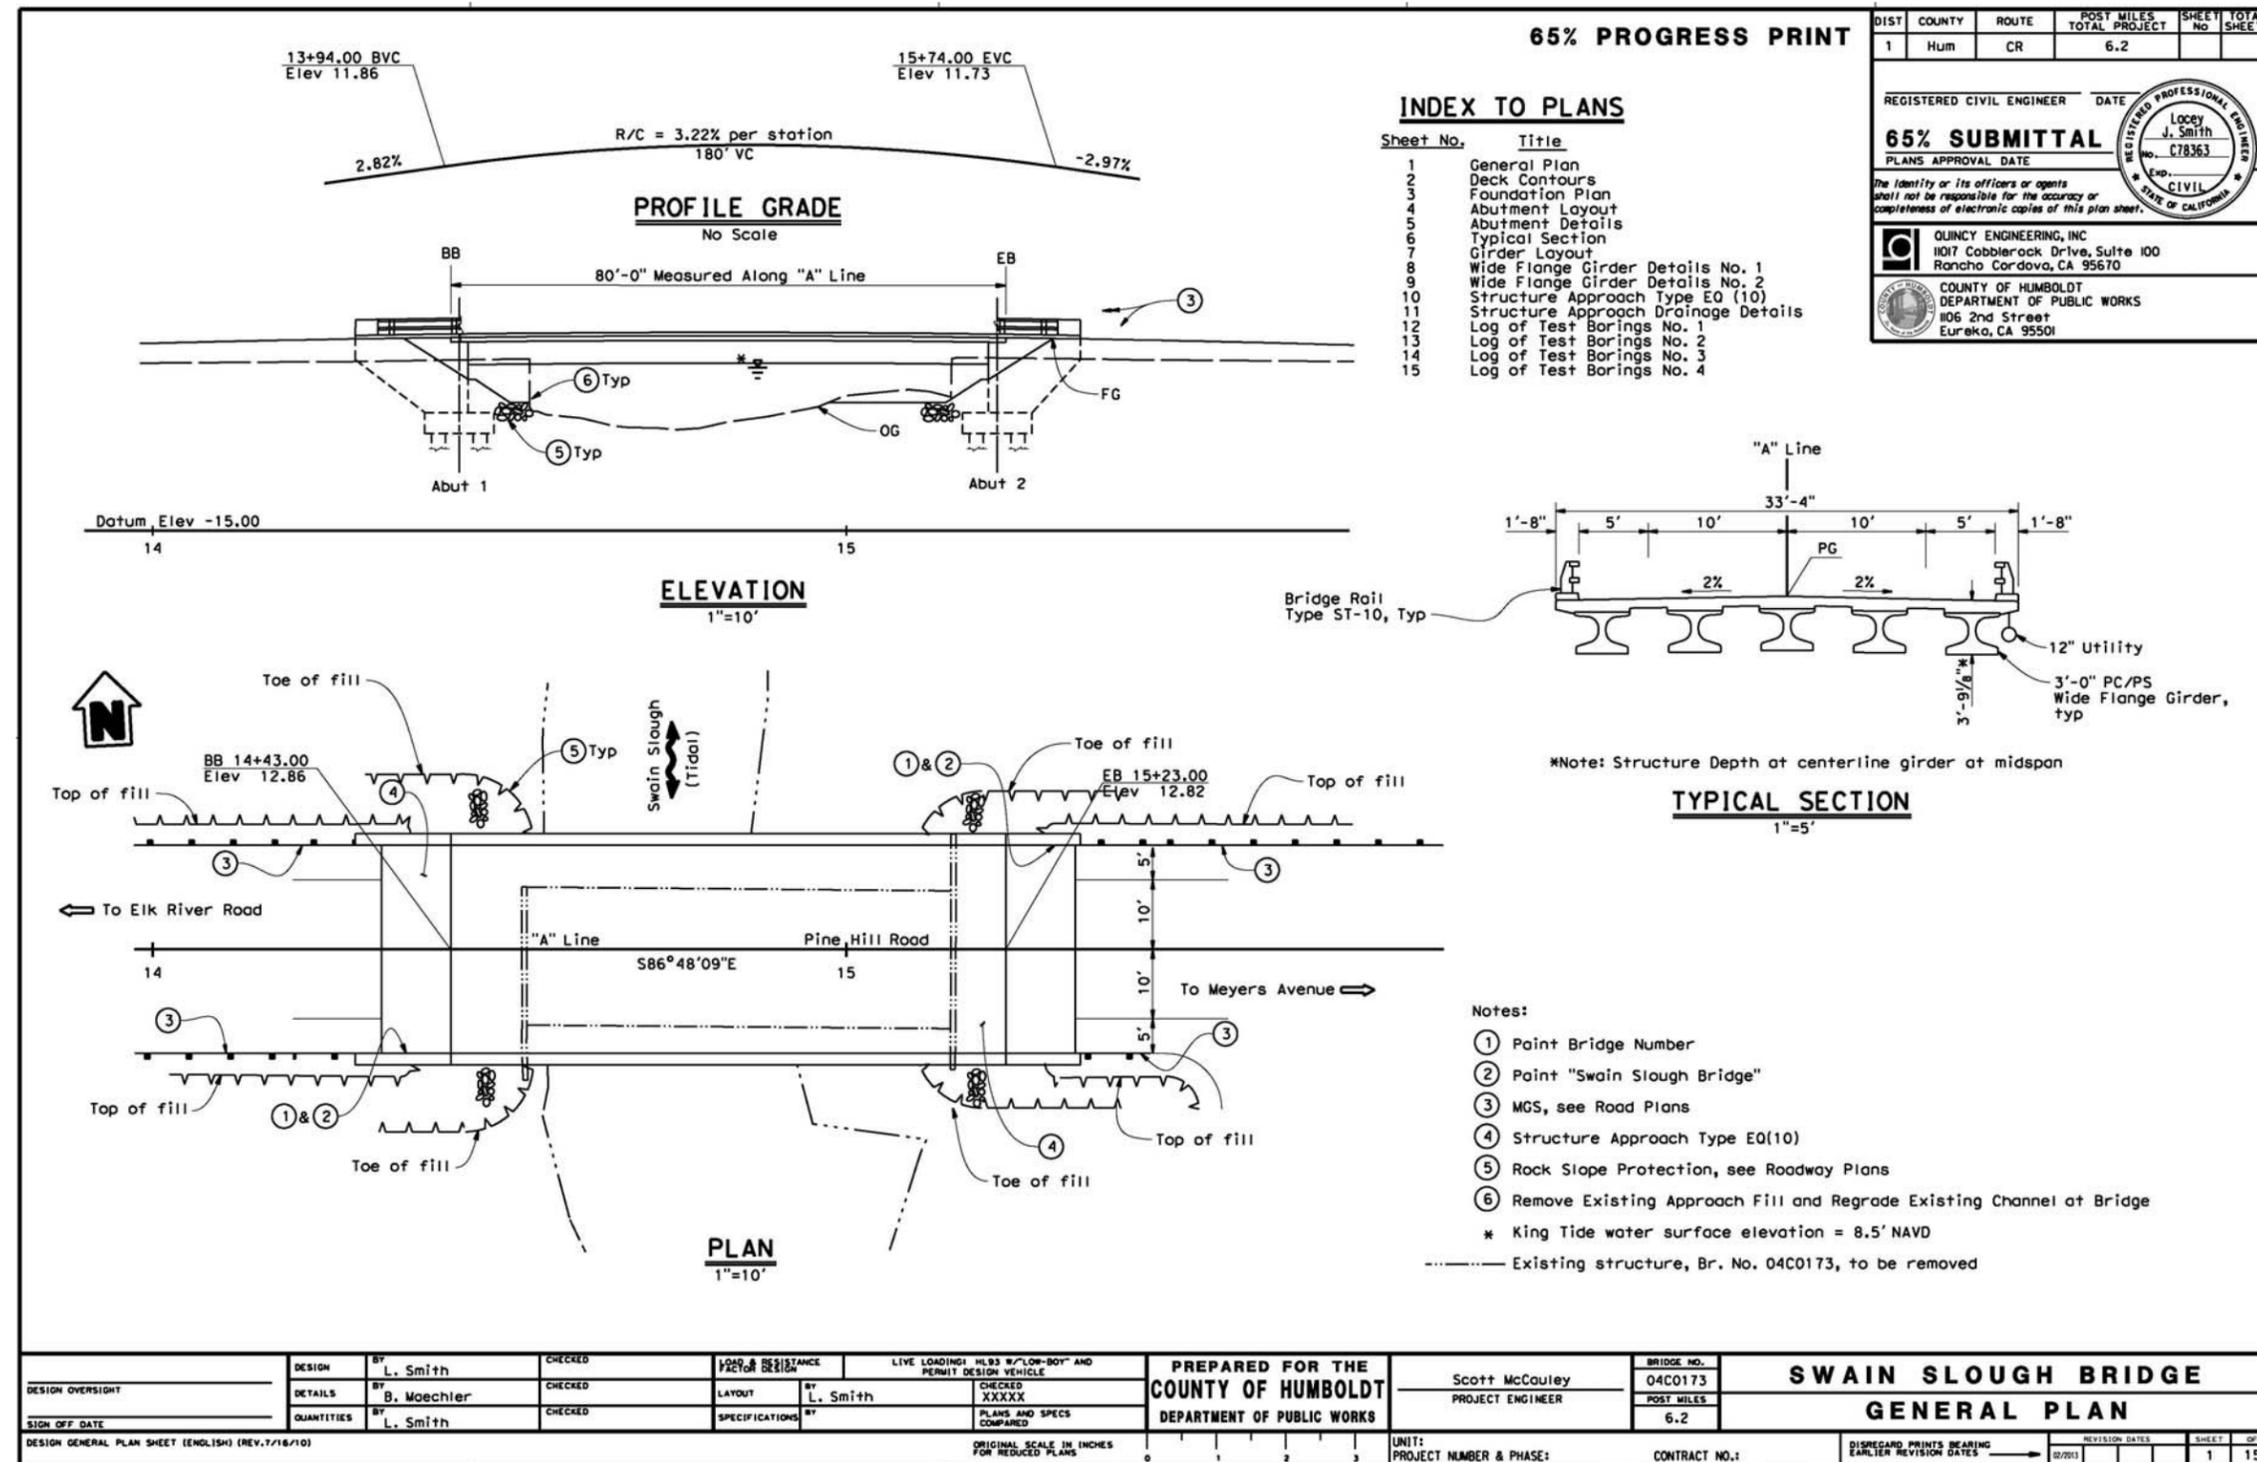
Figure 4. Proposed Bridge General Plan

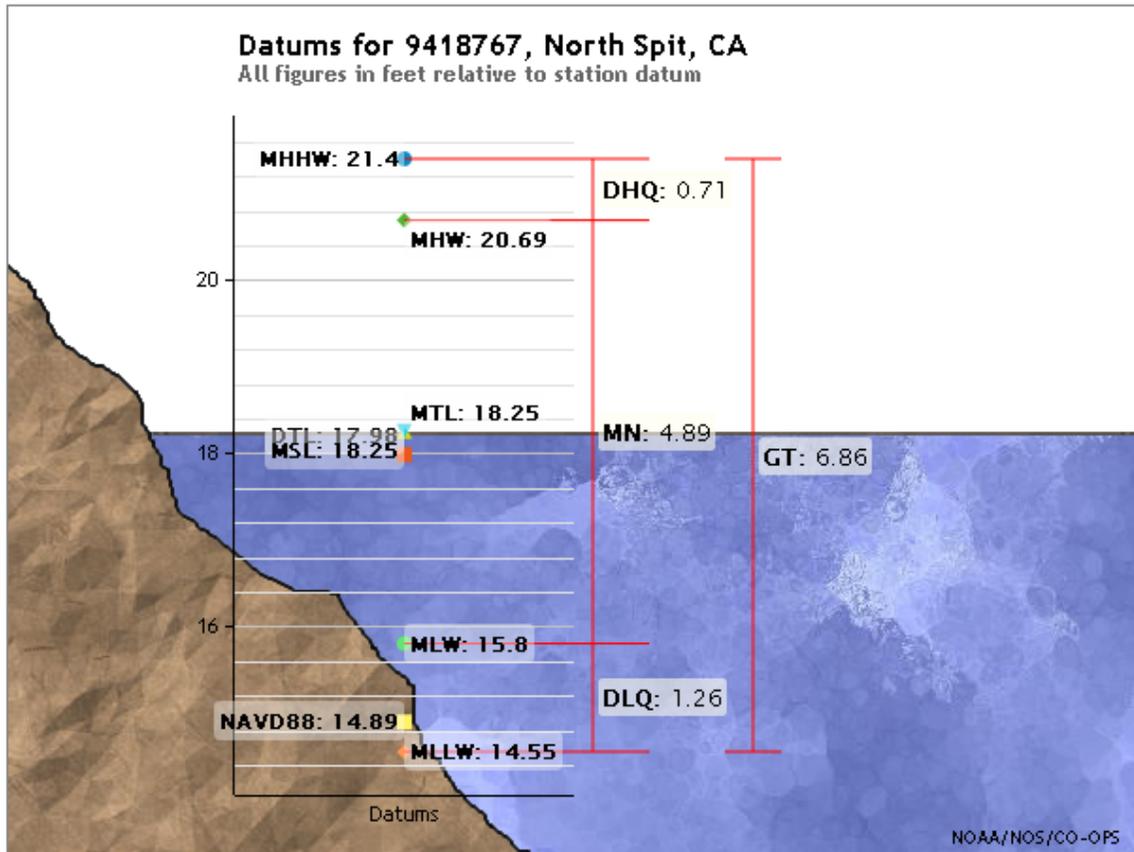
**Figure 7. Tidal Elevations at North Spit Tide Gage**
