Phase I Environmental Site Assessment

1938 King Salmon Avenue and Assessor's Parcel Numbers
305-162-006, -008, and -011
Eureka, California

Humboldt Bay Harbor, Recreation & Conservation District

December 2017

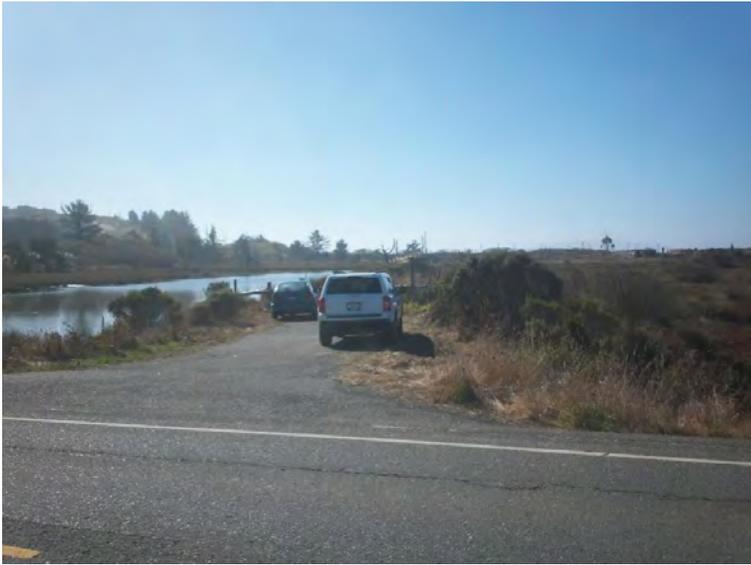
Photograph No. 1:
Gated entrance to the subject property as viewed from the northeastern side of King Salmon Avenue. Image taken facing southwest. The lagoon of the subject property is visible on the left hand side of the image.

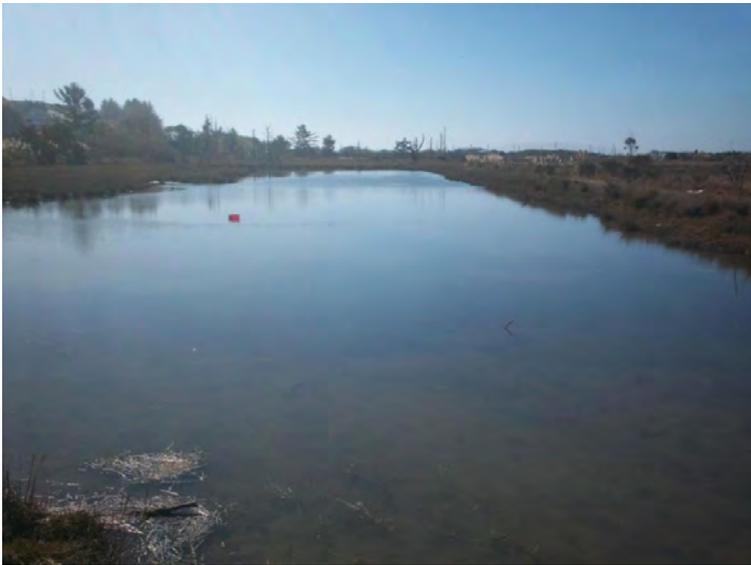
Photograph No. 2:
Tidal inundation of the lagoon located on the subject property. Image taken from King Salmon Avenue facing southwest.

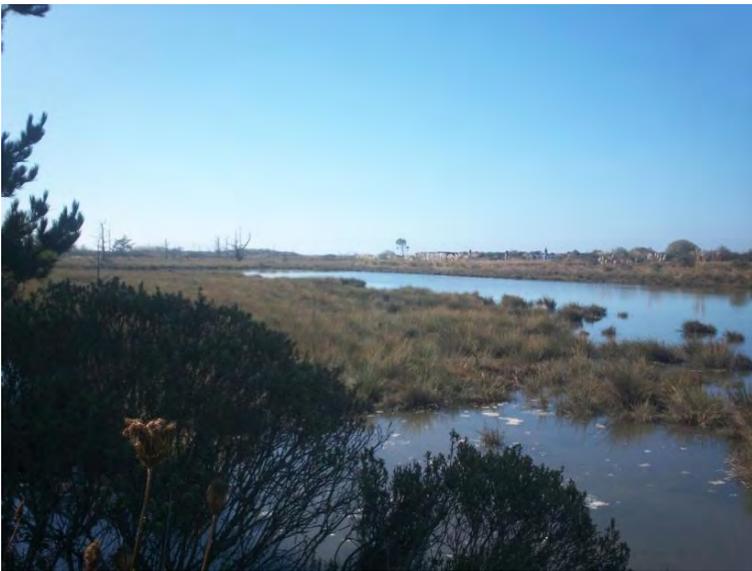
Photograph No. 5:
The subject property as viewed from near the eastern property boundary. The lagoon is visible in the mid-ground, and the supports for the Ship Wreck masts are visible in the background.

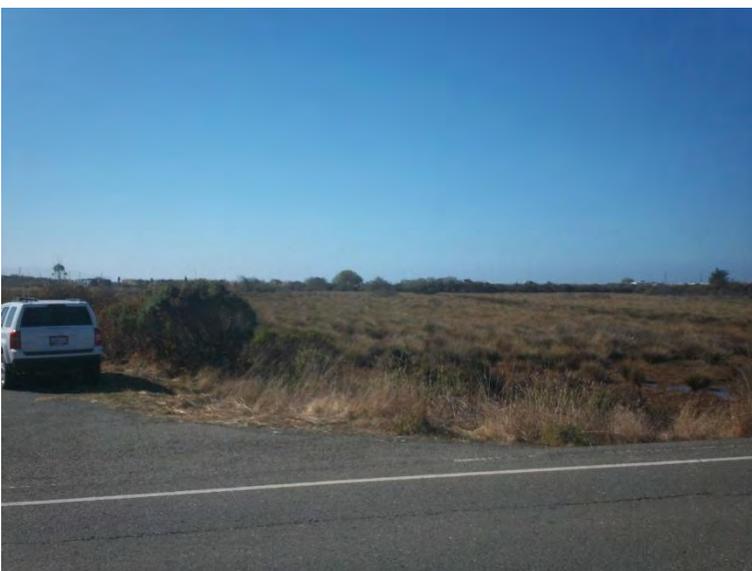
Photograph No. 6:
The adjoining property to the north as viewed from the eastern side of King Salmon Avenue. The subject property driveway is visible on the left hand side of the image.

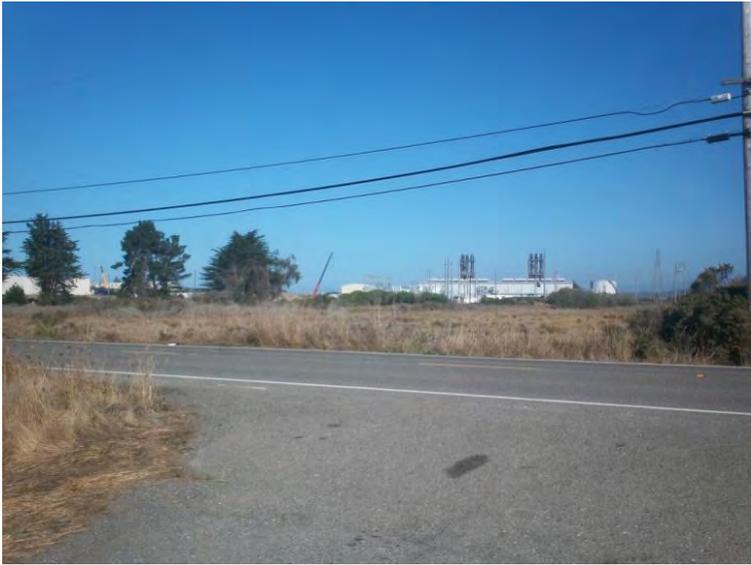
Photograph No. 7:

The adjoining parcel to the north; Humboldt Bay Generation Station is visible in the central portion of the image, and structures associated with Humboldt Bay Power Plant, an active diesel and nuclear power plant decommissioning project, are visible near the left hand margin of the image. Buhne Slough is visible north of King Salmon Avenue (in foreground).

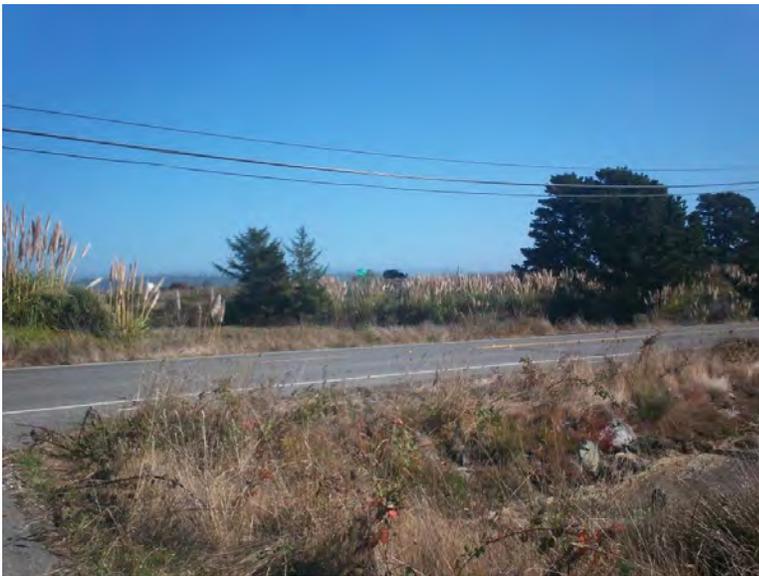
Photograph No. 8:

Adjoining parcel to the east, serving as a railroad right of way, as viewed from the subject property driveway. Image taken facing east.

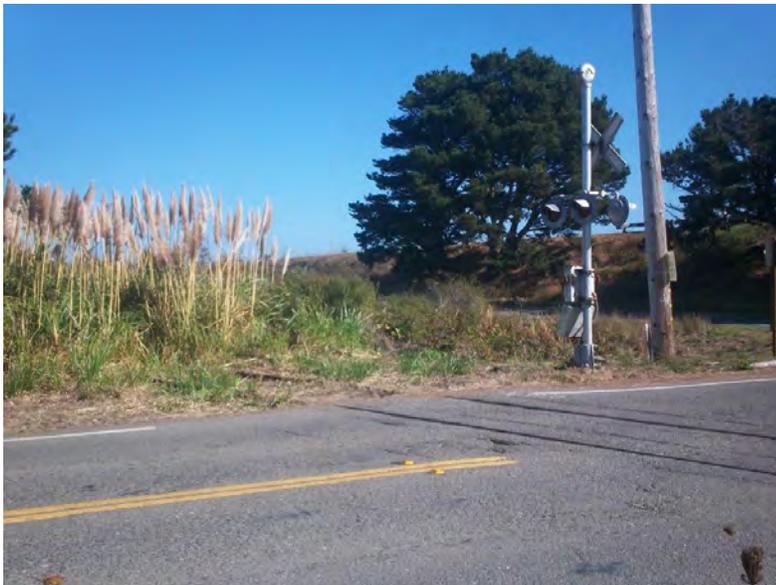
Photograph No. 9:

Adjoining parcel to the east, serving as a railroad right of way, as viewed from the western side of King Salmon Avenue. Image taken facing southeast.

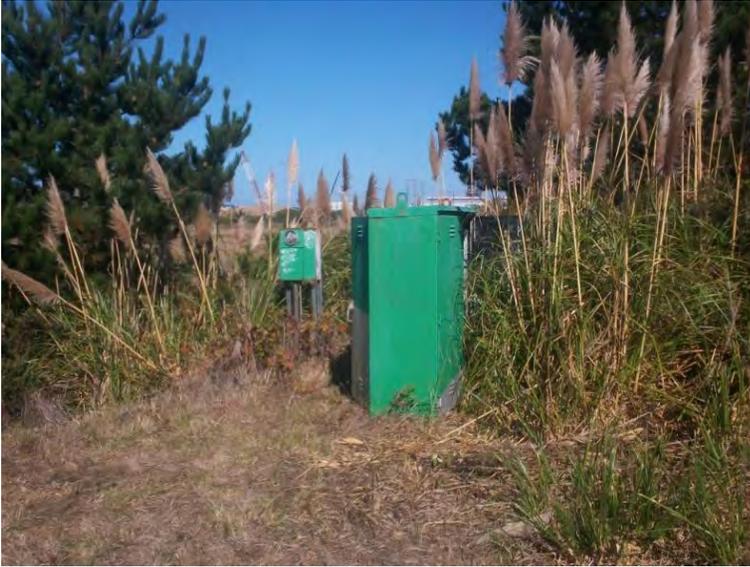
Photograph No. 10:
A power meter and mostly empty relay box on the adjoining parcel to the east.

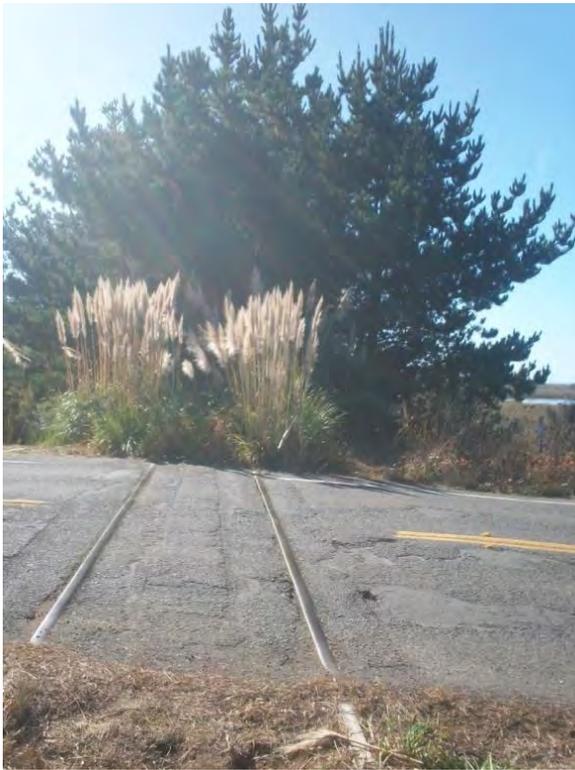
Photograph No. 11:
The adjoining parcel to the east, a railroad right of way, as viewed from the eastern side of King Salmon Avenue (in foreground). The subject property is visible near the right hand side of the image.

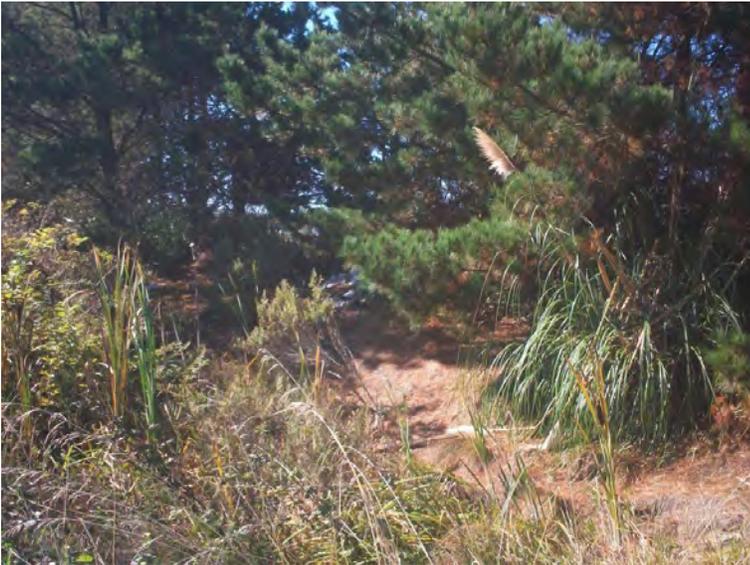
Photograph No. 12:
The adjoining parcel to the east, a railroad right of way. Pathways, abundant garbage, clothing, and suit cases were among features/items observed in this homeless encampment. The presence of this encampment and the uncertain nature of extent of the site, and number and condition of potential occupants, lead the environmental professional to determine the location not safe for entry.

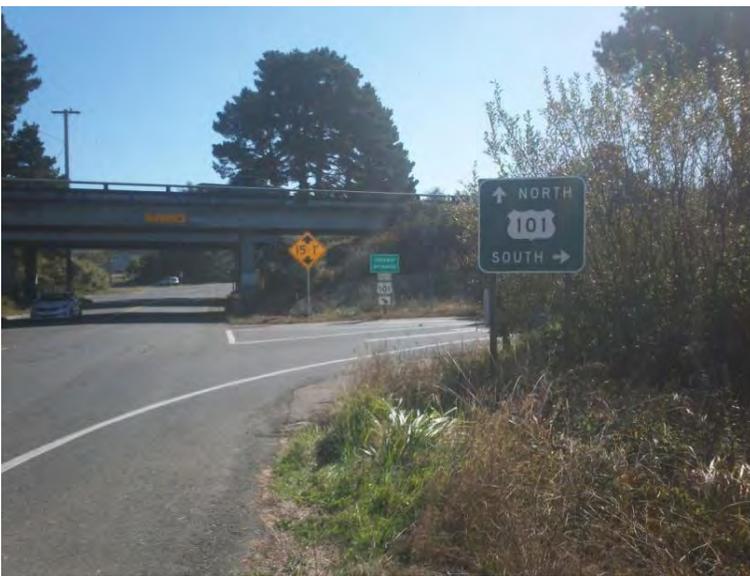
Photograph No. 13:
Entrance to Highway 101 south bound. The onramp is located on the eastern side of the adjoining railroad parcel to the east.

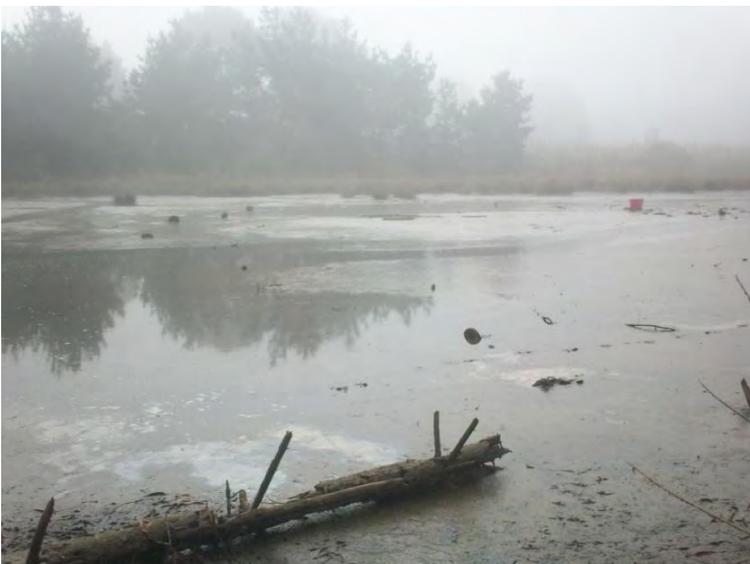
Photograph No. 14:
The subject property lagoon at low tide. Vinyl records, a disk brake rotor and a tub, as well as organic matter, are visible in the image. Image taken from the subject property driveway facing south.

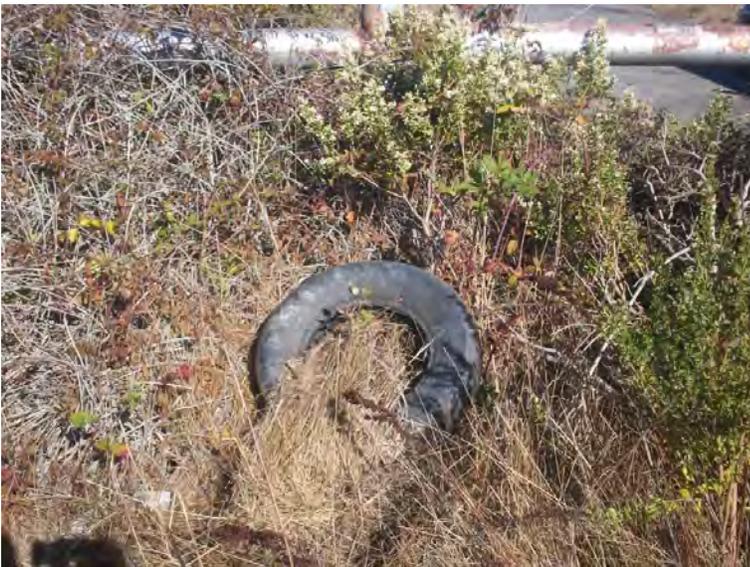
Photograph No. 18:
An example of abandoned items near the locked gate for the driveway accessing the subject property. Image taken facing northeast.

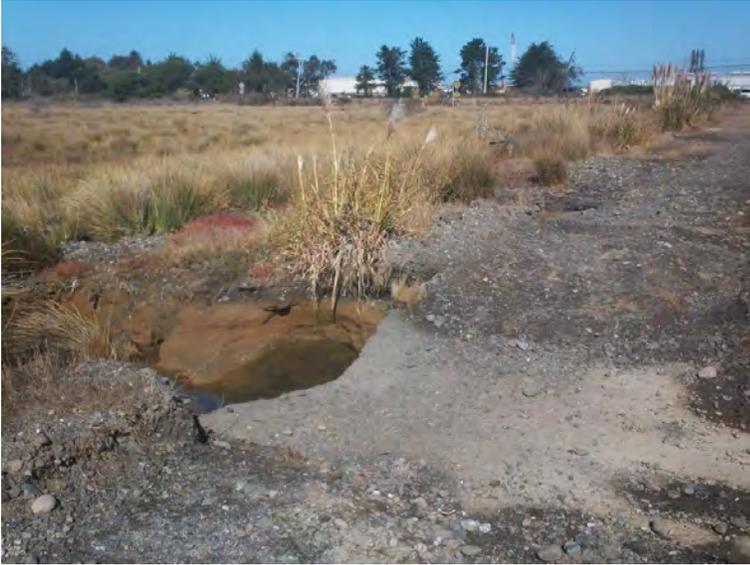
There is one entrance to the subject parcels from King Salmon Avenue (Figure 2). The asphalt driveway, built on imported fill of an unknown source, has a river run gravel veneer from an unknown source that may be greater than 2 feet thick at multiple locations. A locked gate prohibits vehicle entry to the subject property. Periodically, vehicles will be abandoned on the King Salmon Avenue side of the gate; observations include vandalism and parting out of vehicles prior to removal. Broken automotive glass, broken tail light reflectors, automotive parts, and staining of the asphalt surface by automotive fluids was observed in addition to random household garbage (such as, empty food containers and clothing). The portion of parcel -008 south of the driveway, and extending to the adjoining railroad parcel to the south, is occupied by tidal flats; minor debris (such as, vinyl records, car parts, and household garbage) is present. Erosional features, including eroded gravel and scour holes presumed to be associated with tidal inundation, were observed approximately 350 feet southwest of King Salmon Avenue, and have resulted in the river run gravel overlying the asphalt driveway being eroded to the asphalt surface and deposited on the adjoining property to the north. Scour features also appear in the imported fill underlying the asphalt driveway, allowing for characterization of the fill soils as sandy silt/silty sand. An approximately 1-foot wide trench was observed

Photograph No. 20:
River run gravel fill (unknown origin), the asphalt driveway, imported sandy silt/silty sand fill (unknown origin), and erosional scour along the northern side of the subject property driveway. The adjoining parcels to the north, including HBPP, are visible in the background. Erosion is interpreted to be associated with tidal inundation of the subject property. Image taken facing north-northeast.

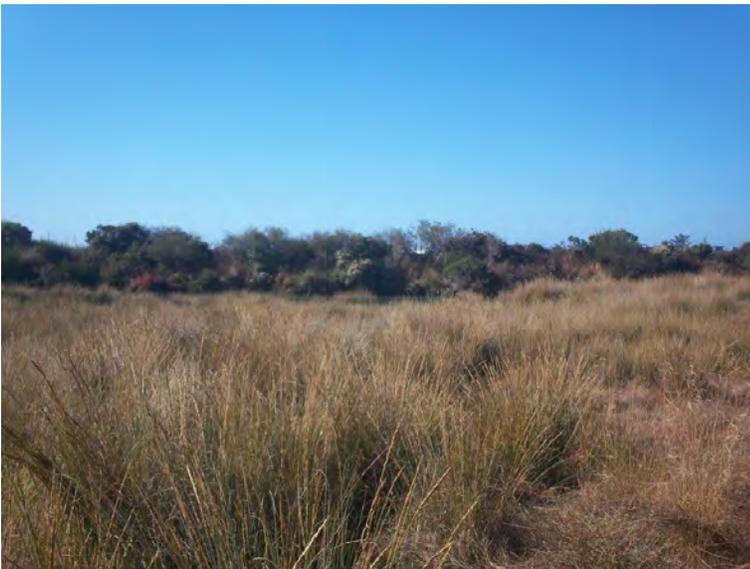
Photograph No. 23:
The levy that comprises the subject property western boundary. Tidal flats are present on the opposite side of the levy. A homeless encampment was encountered on the levy. Image taken facing northwest.

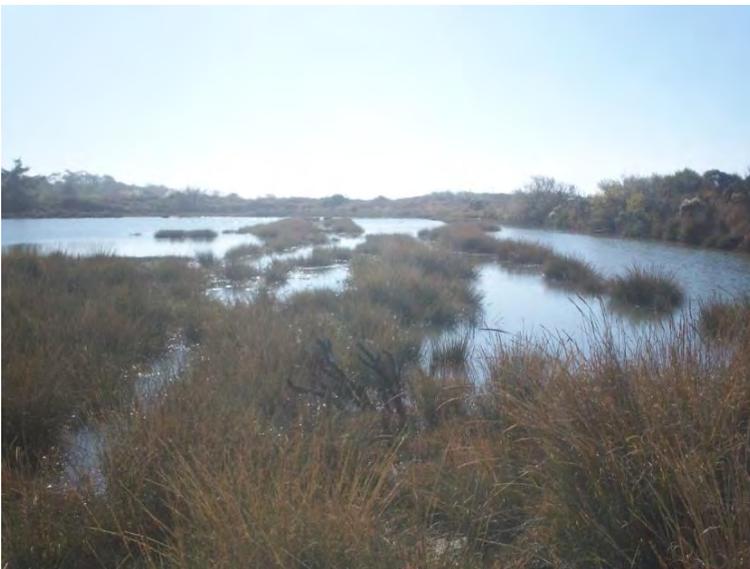
Photograph No. 24:
Tidally influenced lagoon of the subject property. The western property boundary levy is visible on the right hand side of the image. The adjoining property to the south is in the far background. Image taken facing south.

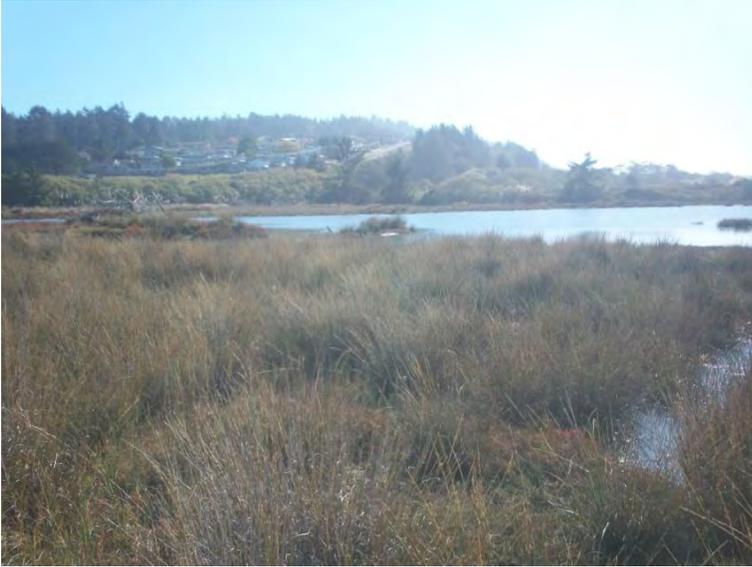
Photograph No. 25:
Tidally influenced lagoon of the subject property. Humboldt Hill is in the background. Highway 101 is obscured by trees. Image taken facing south.

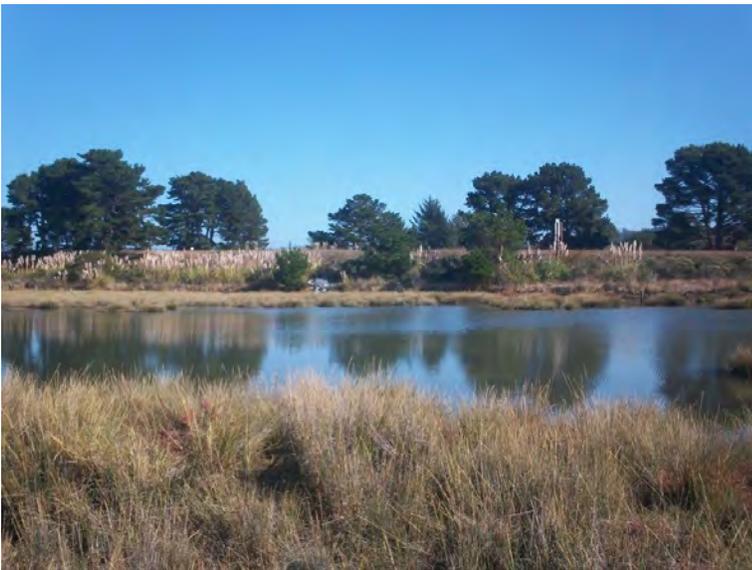
Photograph No. 26:
Northern boundary of the northern parcel as viewed from the northwestern corner of the northern parcel. Adjoining parcel to the northeast is visible in background. Light colored feature in the central portion of the image is a garbage pile; homeless encampments interfered with inspection of the property. Image taken facing east.

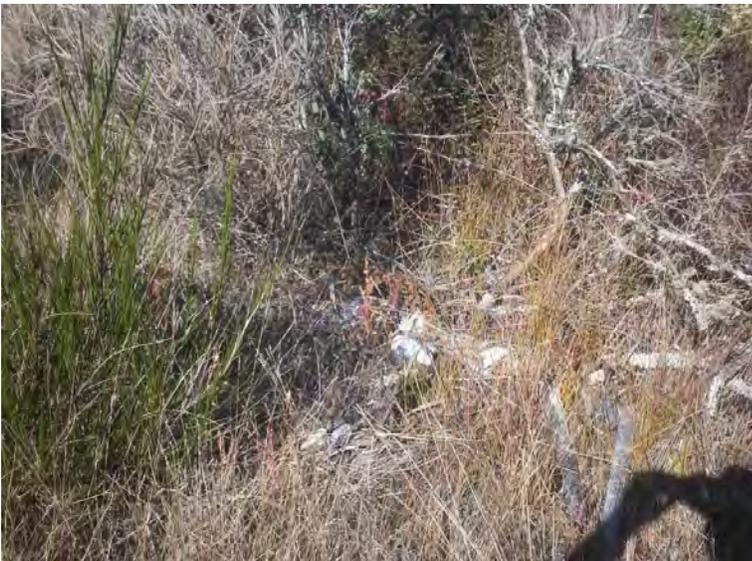
Photograph No. 27:
Spray paint cans and other debris in vegetation near the northern property boundary.

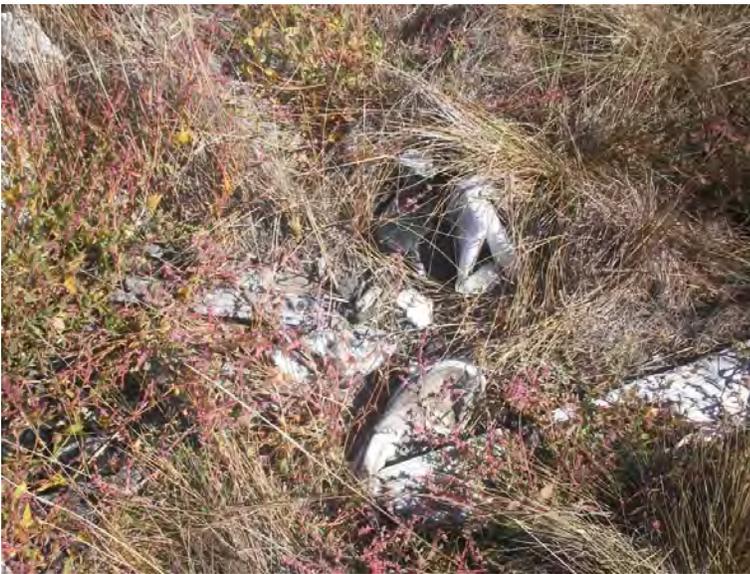
Photograph No. 29:
Random debris in vegetation, including a shoe, a
tire, and wood. Location is near the northern
property boundary.

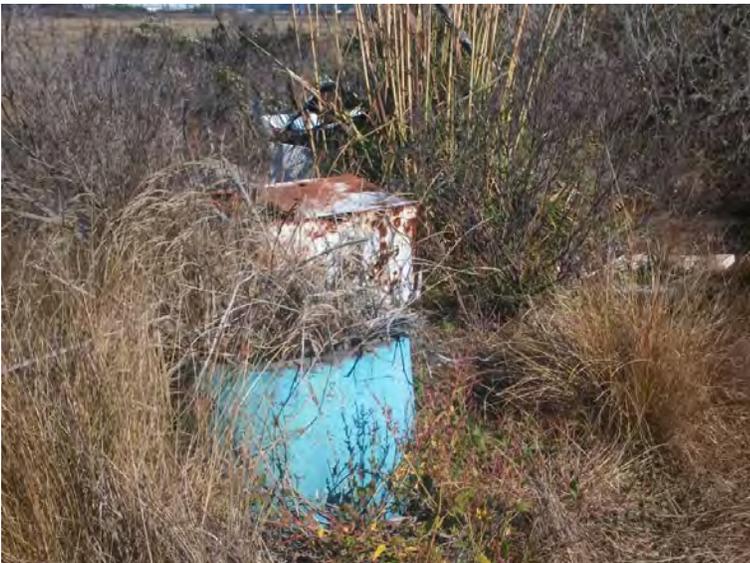
Photograph No. 30:
Discarded appliances and a planter box near the
northern property boundary.

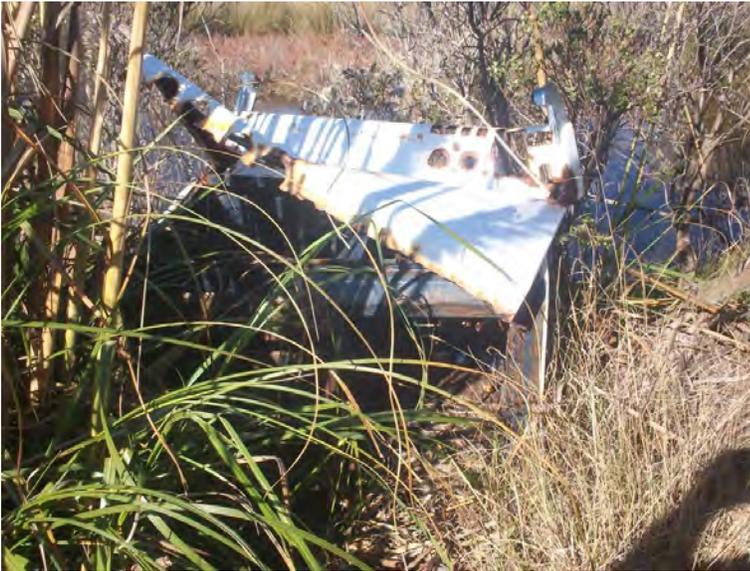
Photograph No. 31:
A discarded stove at the northern property boundary.

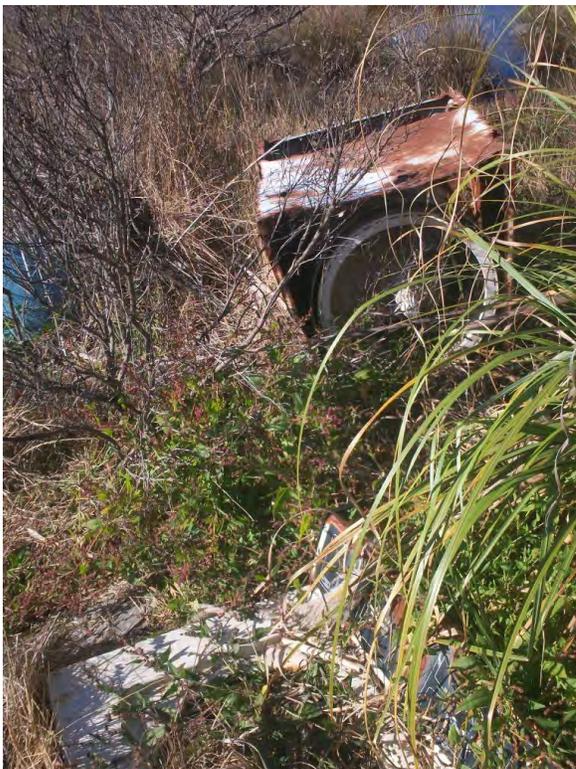
Photograph No. 32:
A discarded washing machine at the northern property boundary.

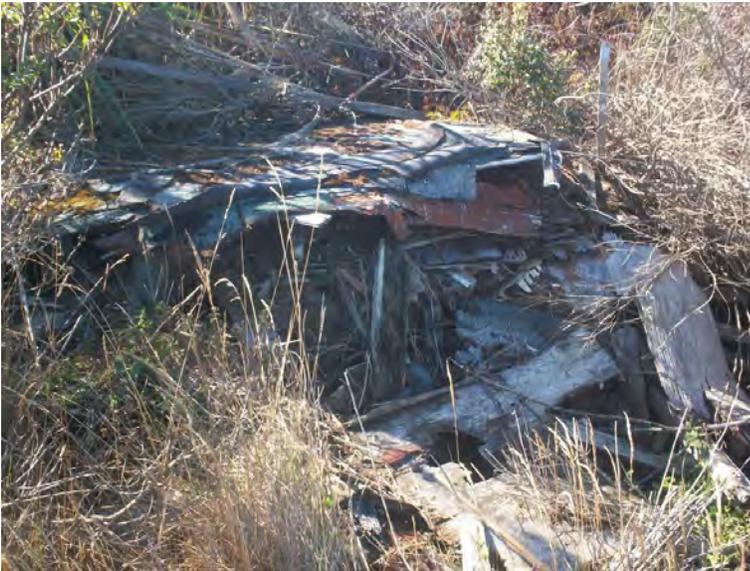
Photograph No. 34:
Construction debris (asphalt roofing shingles,
wood) near the northern property boundary.

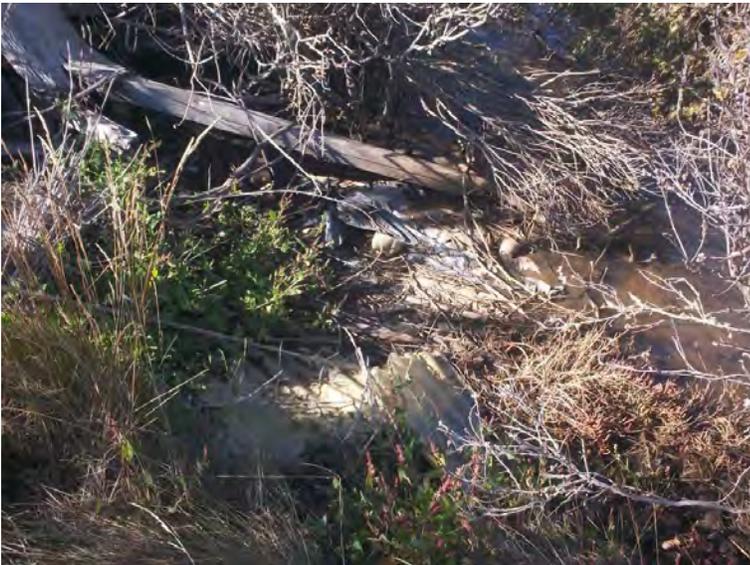
Photograph No. 35:
Corrugated fiberglass panels at the northern
property boundary.

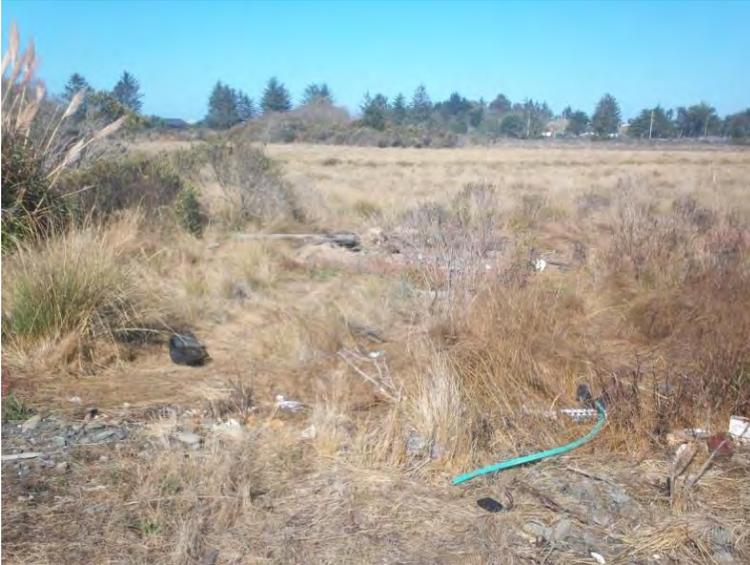
Photograph No. 36:

A hoses and random garbage at the northern property boundary, adjoining parcel to the north visible in background. Image taken facing north.

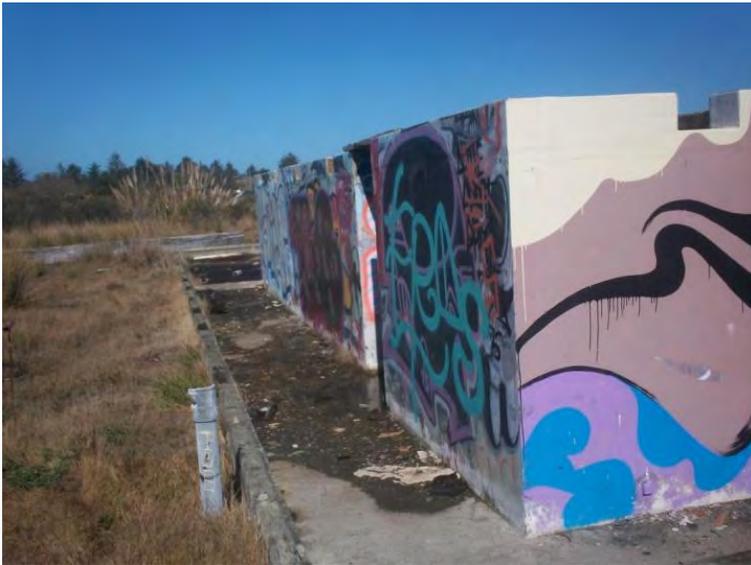
Photograph No. 39:
Several of the concrete cells of the pump house as viewed from the southwest corner of the structure. An electrical conduit riser (?) is visible in the lower left hand portion of the image.

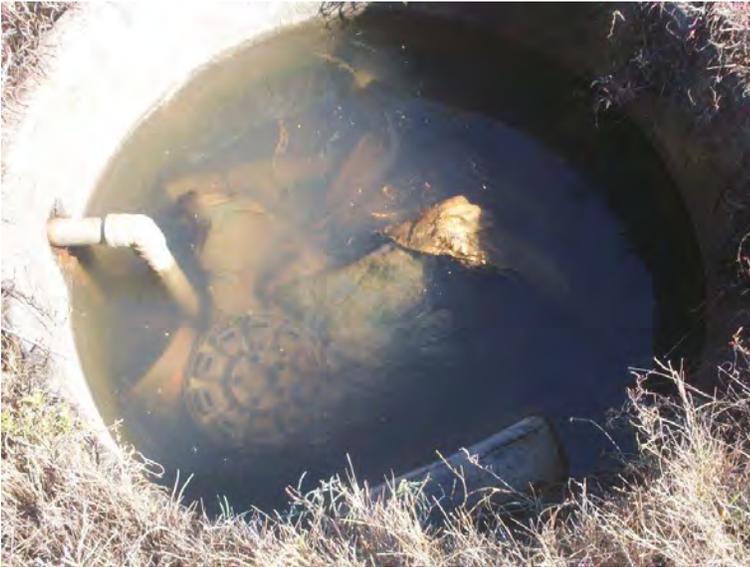
Photograph No. 42:
A water and debris filled sump located off of the southeastern corner of the pump house.

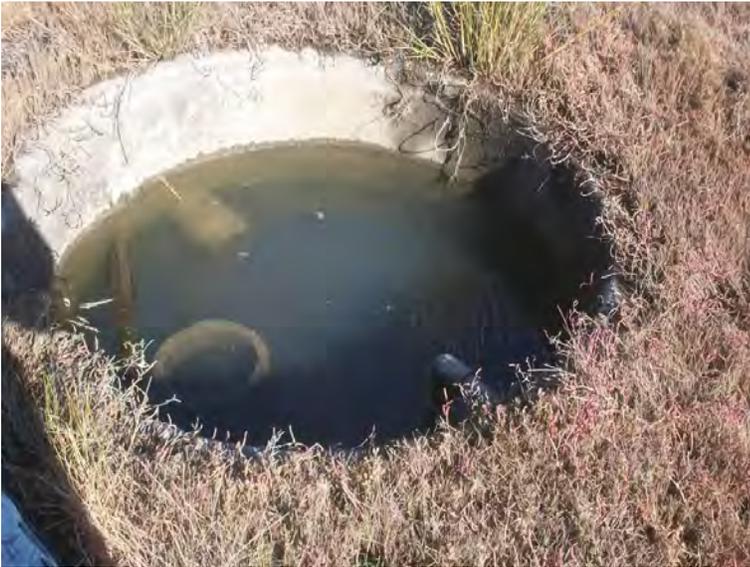
Photograph No. 44:
The sump that appears in Photograph 43.

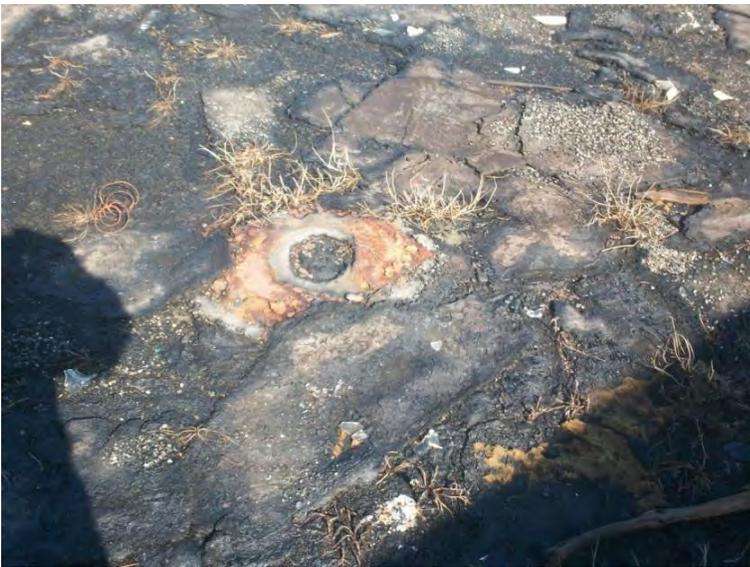
Photograph No. 45:
A floor drain amongst roofing materials from the former pump house structure.

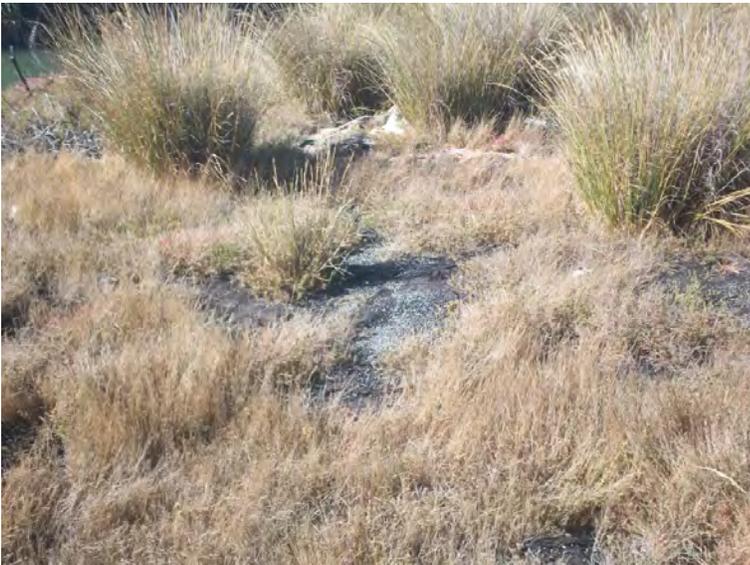
Photograph No. 46:
Carpet (in vegetation in the background) and tar and gravel roofing of the former pump house on the ground surface west of the pump house.

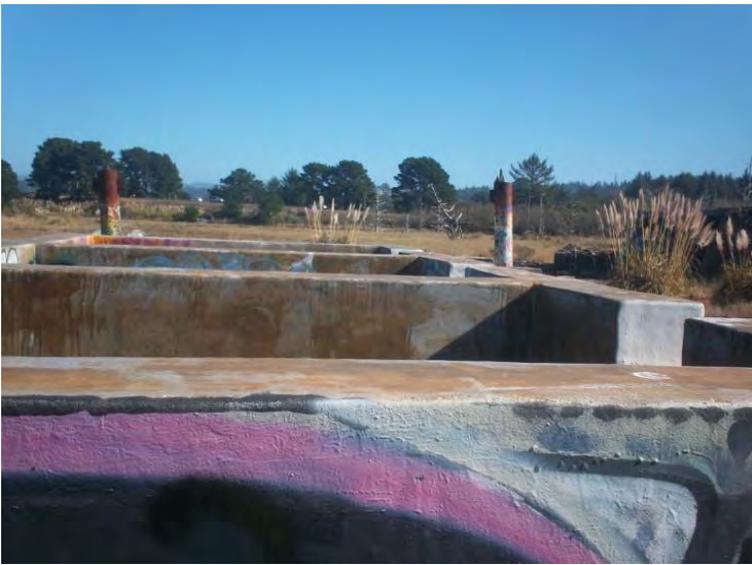
Photograph No. 48:
The pump house concrete cells as viewed facing east.

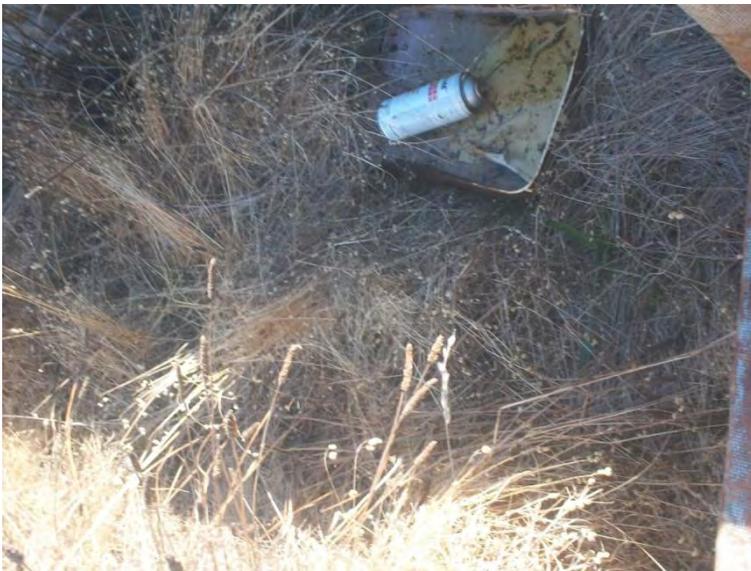
Photograph No. 51:
Garbage inside one of the concrete cells of the pump house.

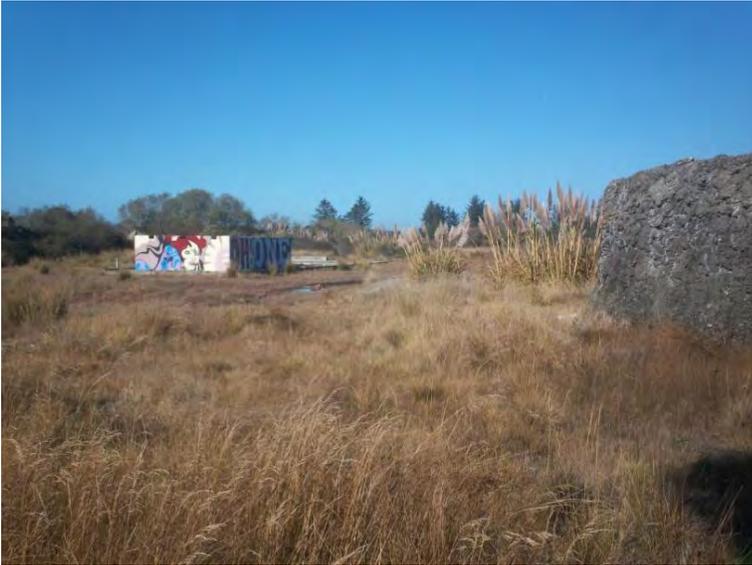
Photograph No. 52:
The pump house and Ship Wreck structure
“rock.” Image taken facing northwest.

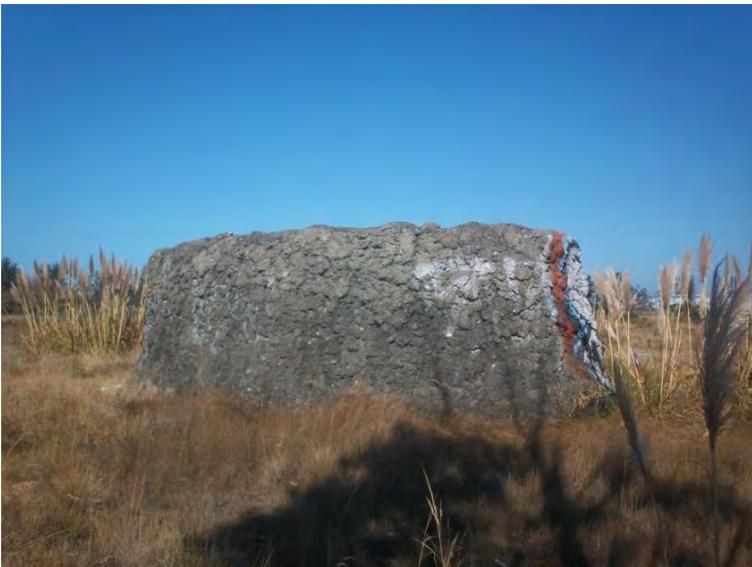
Photograph No. 53:
The exterior of the “rock” located at the bow of
the Ship Wreck structure. Interviews with
children of the former owner indicate that this
was a storage area. Image taken facing north.

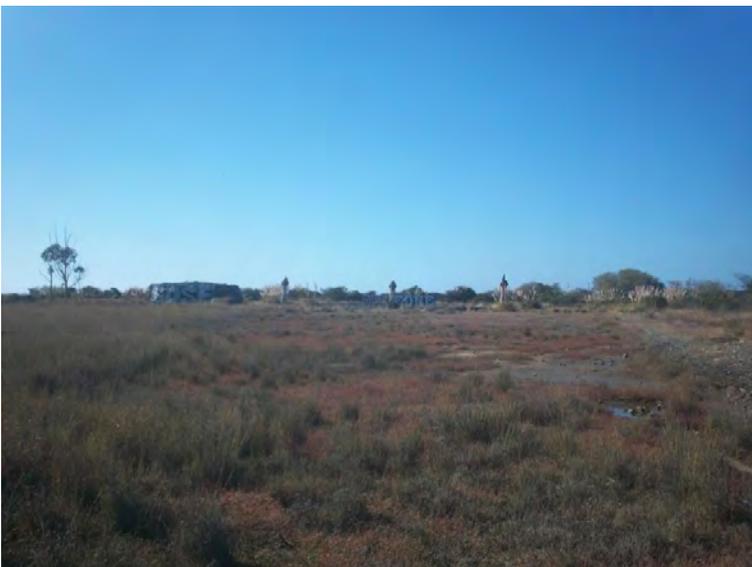
Photograph No. 54:
Remnants of the former Ship Wreck structure,
with the former parking area in the foreground.
Image taken facing west.

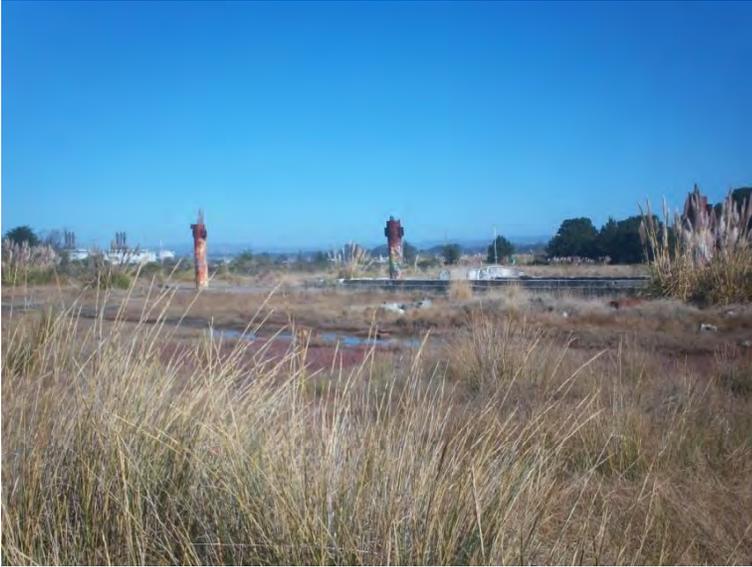
Photograph No. 55:
Mast supports and concrete foundation for the former Ship Wreck structure. Image taken facing northeast.

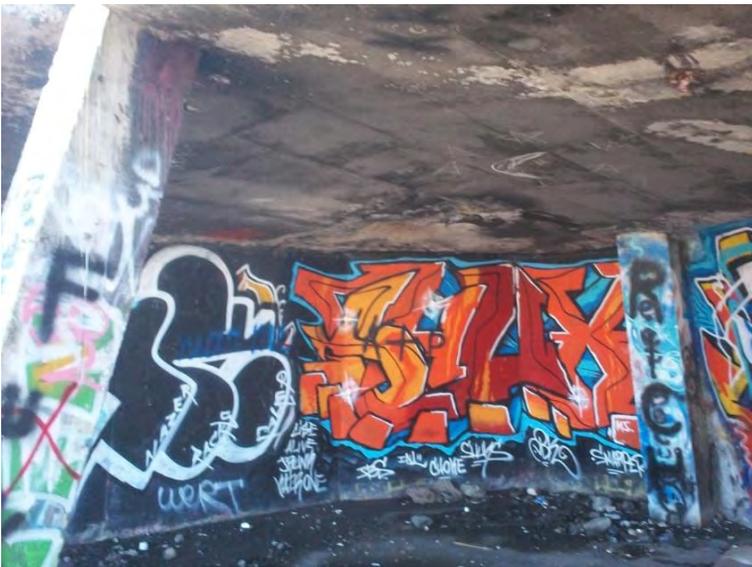
Photograph No. 56:
Inside view of the "rock" at the ship bow. Garbage and vandalism are apparent.

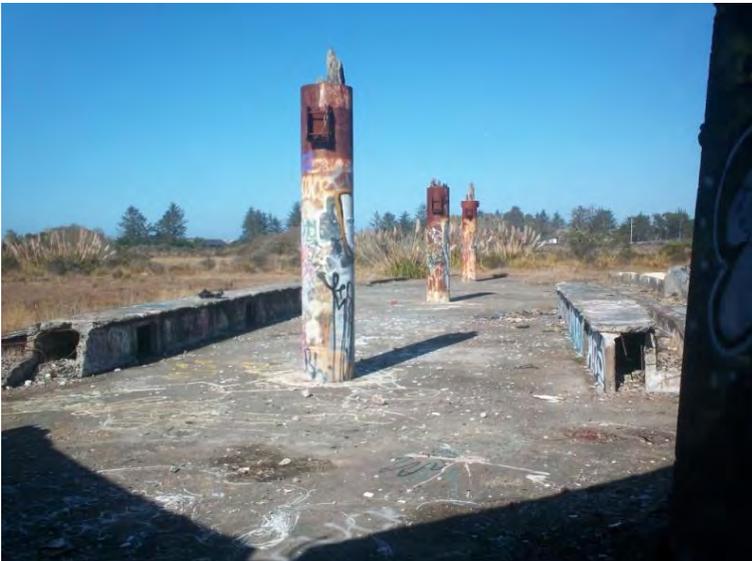
Photograph No. 57:
Ship Wreck mast supports, concrete floor, foundation, vandalism, and ceramic shards are visible in this image.

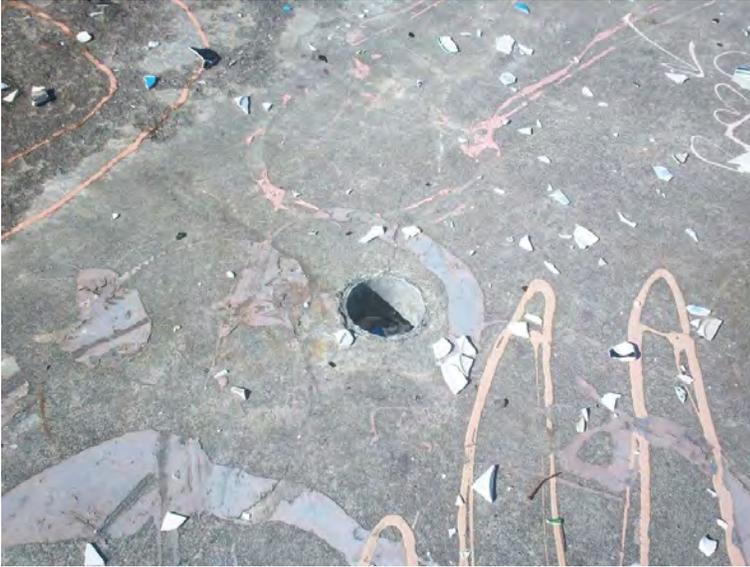
Photograph No. 58:

A drain for an unknown purpose. A restaurant and public toilets were features present in the structure. Paint and broken ceramic shards are visible.

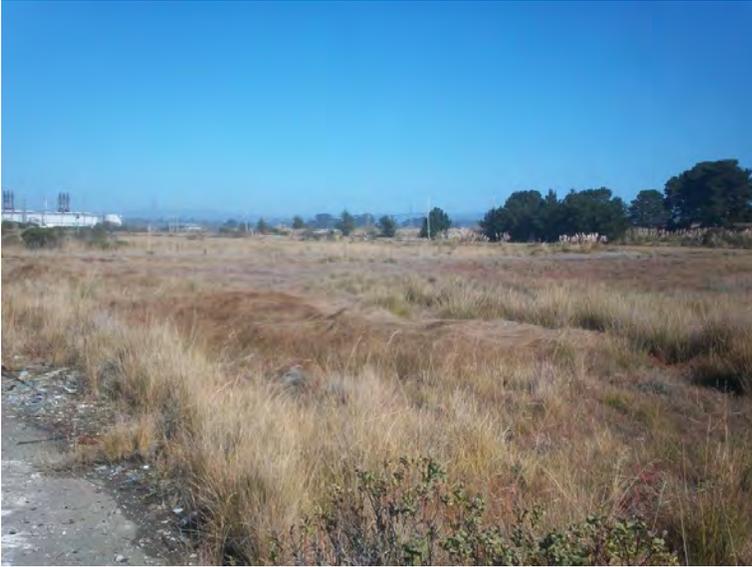
Photograph No. 62:

The former parking area as viewed from the remnants of the Ship Wreck structure. Image taken facing east. Concrete and garbage visible in the lower left hand corner of the image.

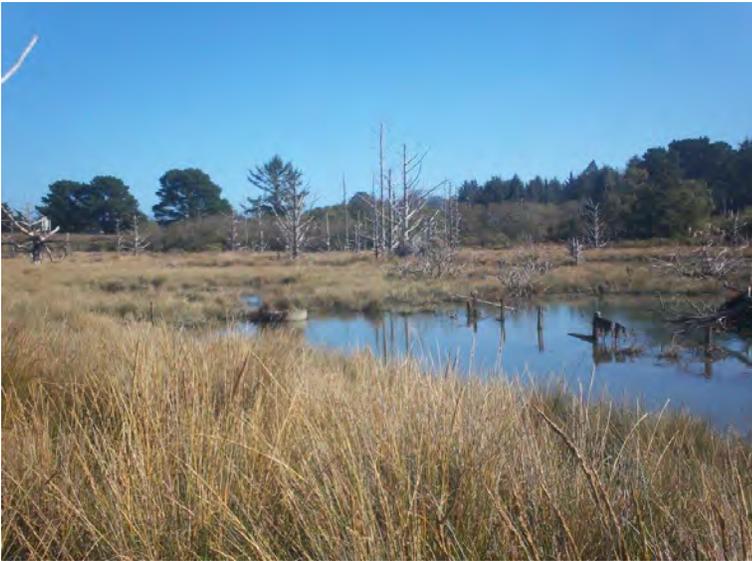
Photograph No. 63:

A fence and concrete container in a flooded portion of the central part of the subject property. Image taken facing east.

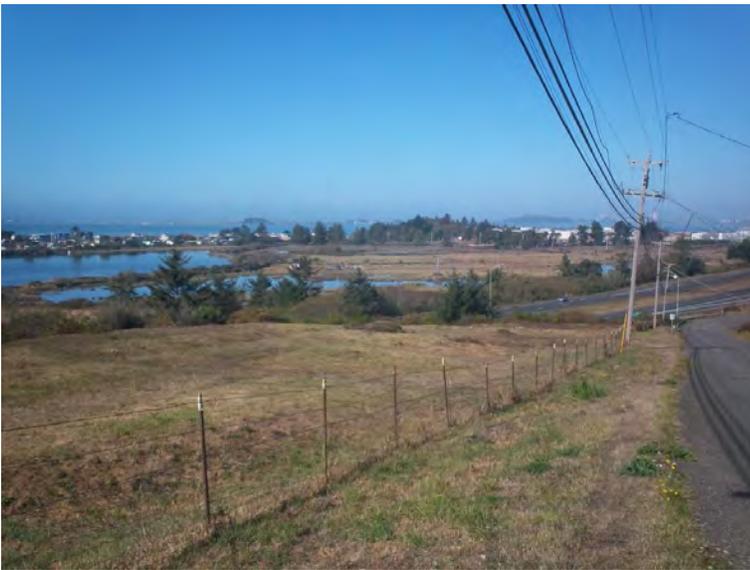
Photograph No. 66:
The subject property and adjoining properties as viewed from Humboldt Hill. Image taken facing north.

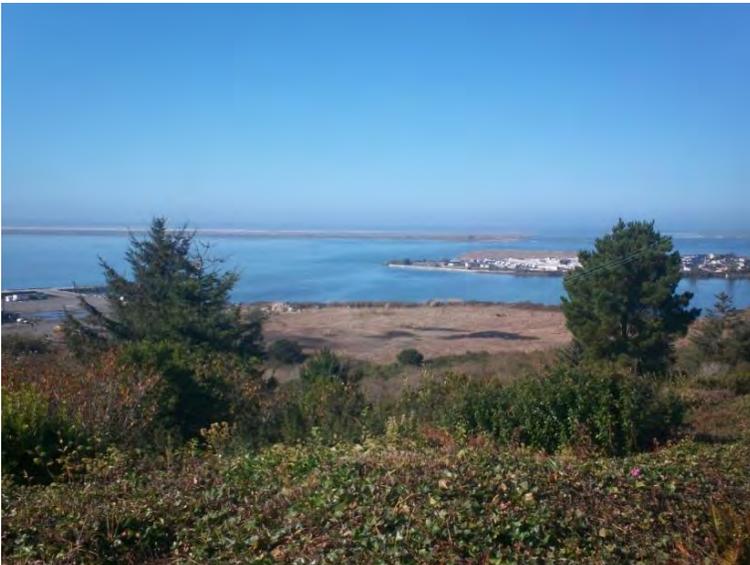
Photograph No. 67:
The Humboldt Bay Forest Products site that adjoins the subject property to the south as viewed from Humboldt Hill. Image taken facing west.
